Leon County Courthouse Annex

**Bank of America Building
Stair, Elevator Shaft, & Building Pressurization**

Photographic Record of Existing Conditions In Tenant Suites Scheduled for Window Replacement

17 May 2012

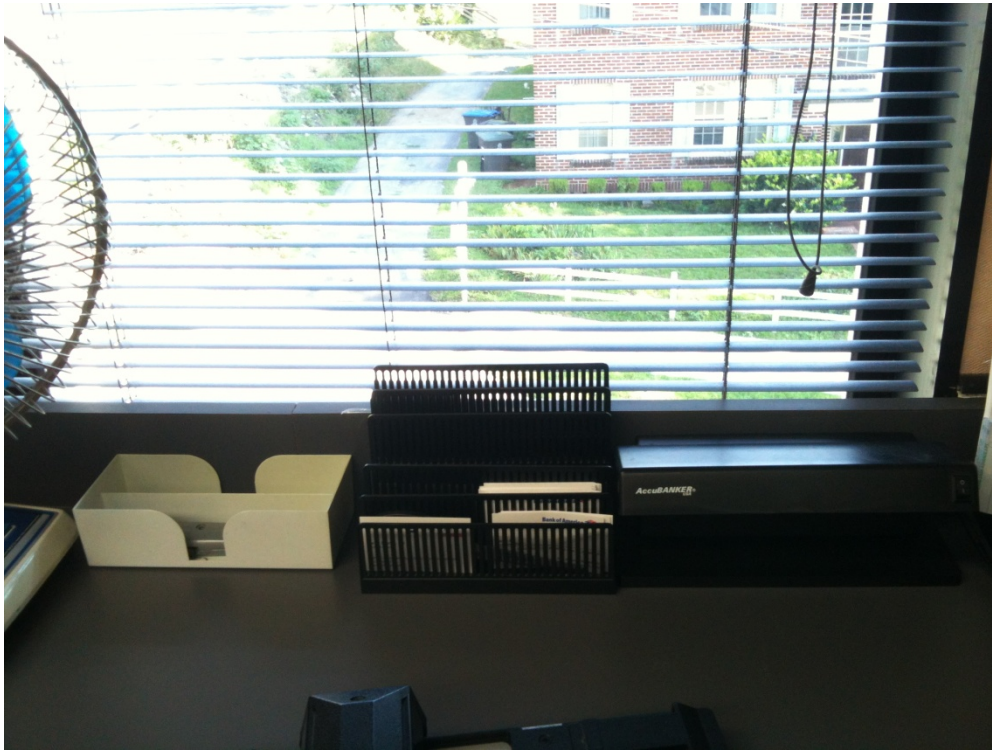
First Floor:
North Suite – Bank of America

Counter obstruction at window – Actual sill condition assumed: Vinyl Base.

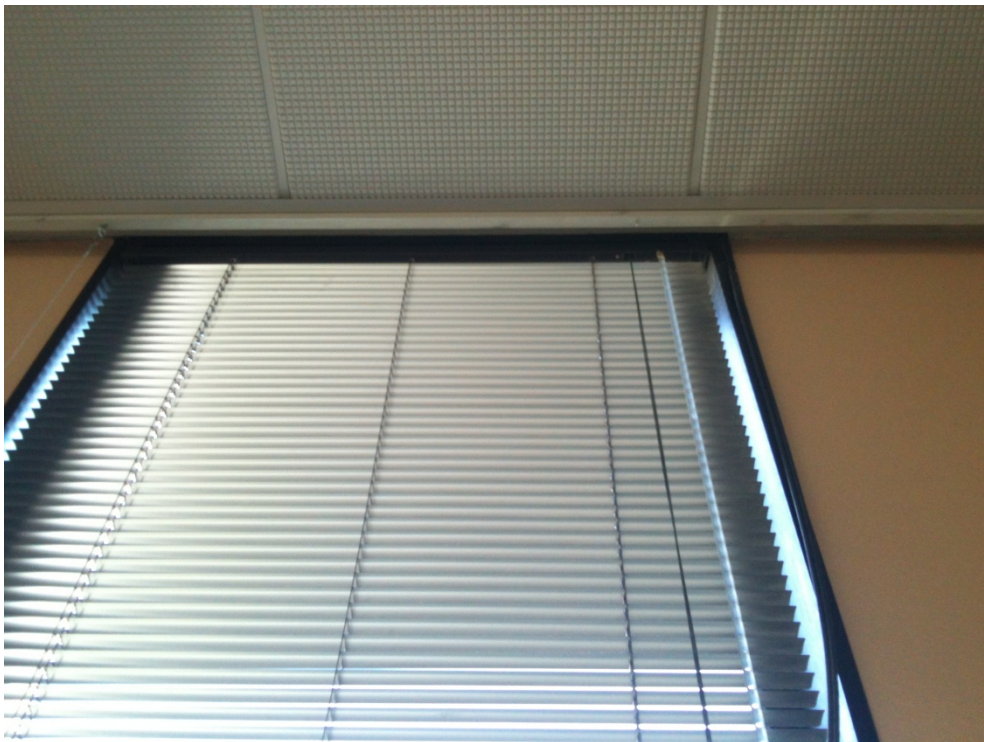
1st Floor North – BOA – Head Detail: slightly dropped gypsum bulkhead with A.C.T.

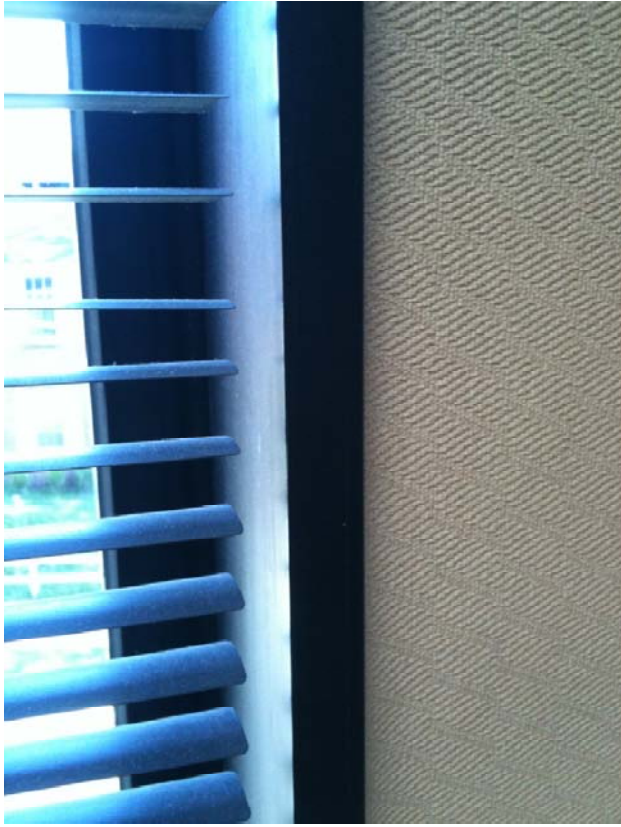
1st Floor North – BOA – Jamb Detail: Wall Covering

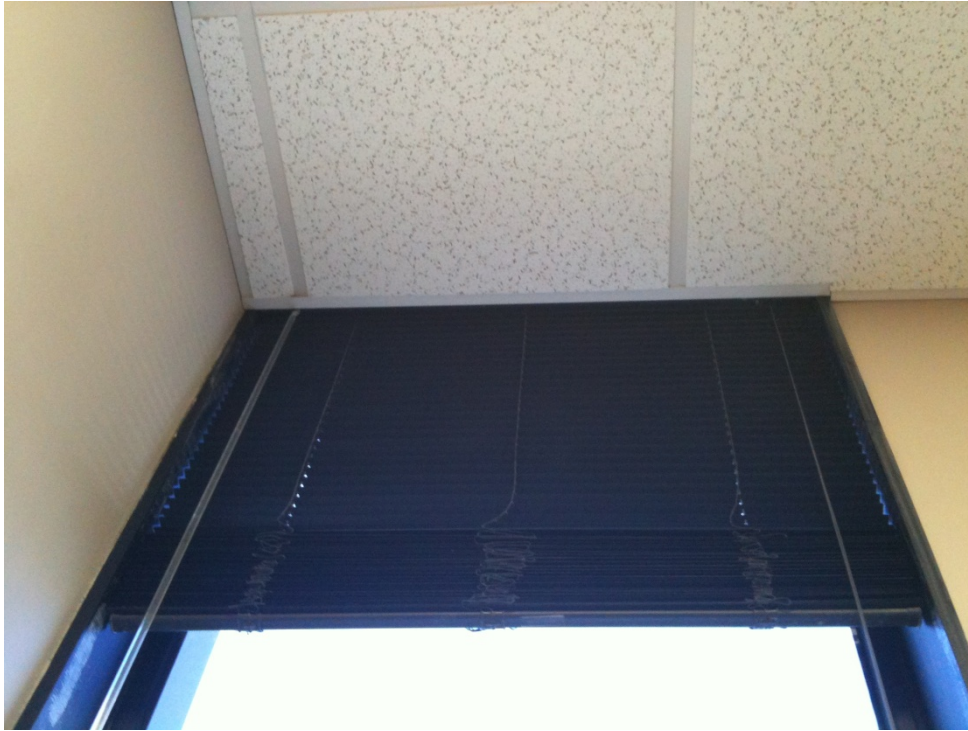
1st Floor South – LC Supervisor of Elections – Head Detail: A.C.T. – Jamb: Painted GWB

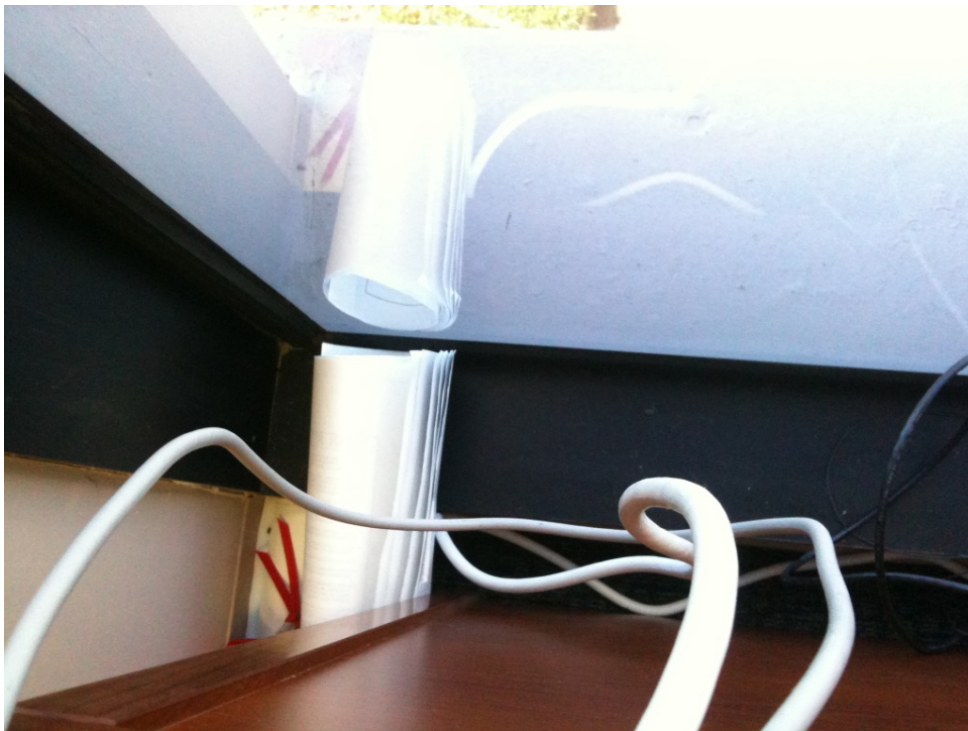
1st Floor South LC Supervisor of Elections Sill Detail: Vinyl Base

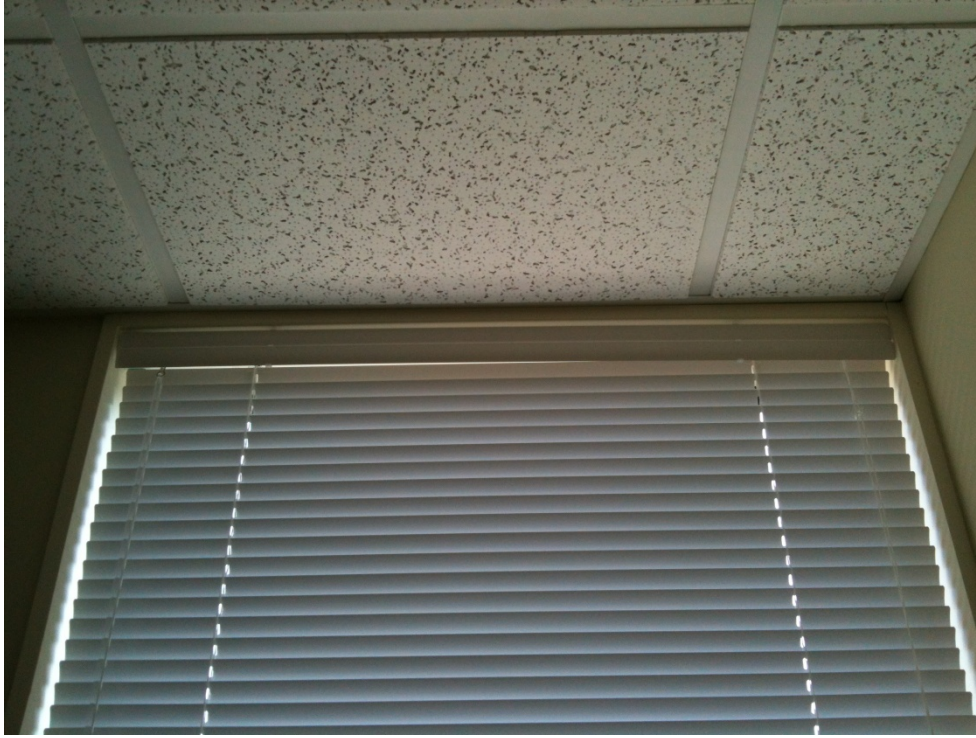
2nd Floor – Unoccupied – Head Detail – A.C.T. – Window frame painted off-white.
Metal blinds

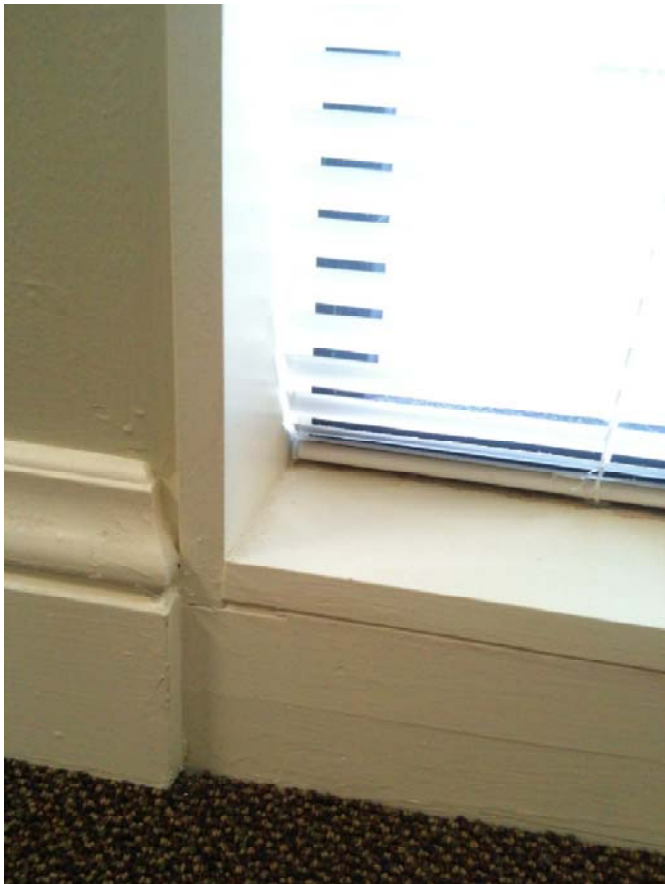
2nd Floor – North – Unoccupied Sill Detail: Wood Base/Painted Existing window
frame/Painted

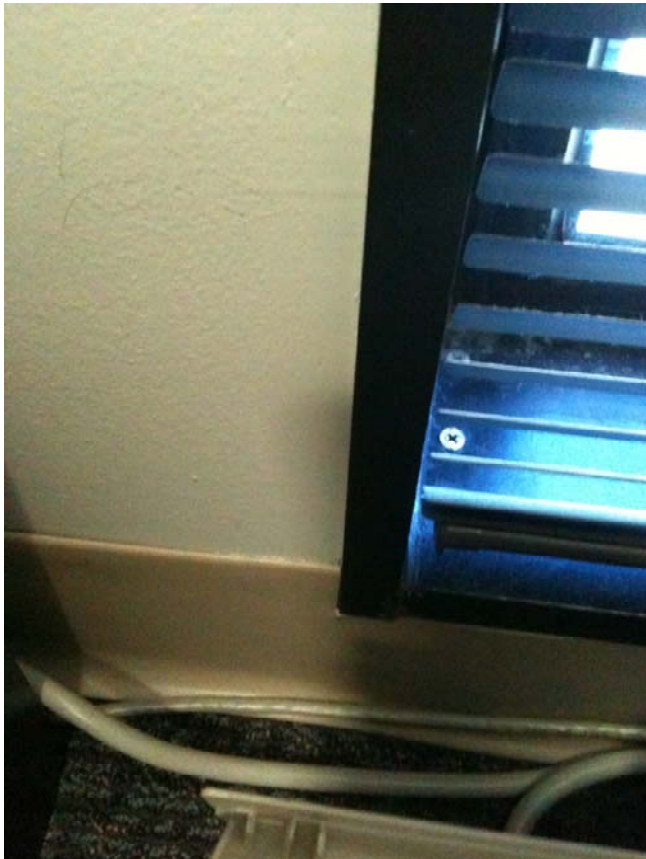
2nd Floor – South- Tax Collector's Office – Sill condition: Vinyl Base- Jamb Painted GWB

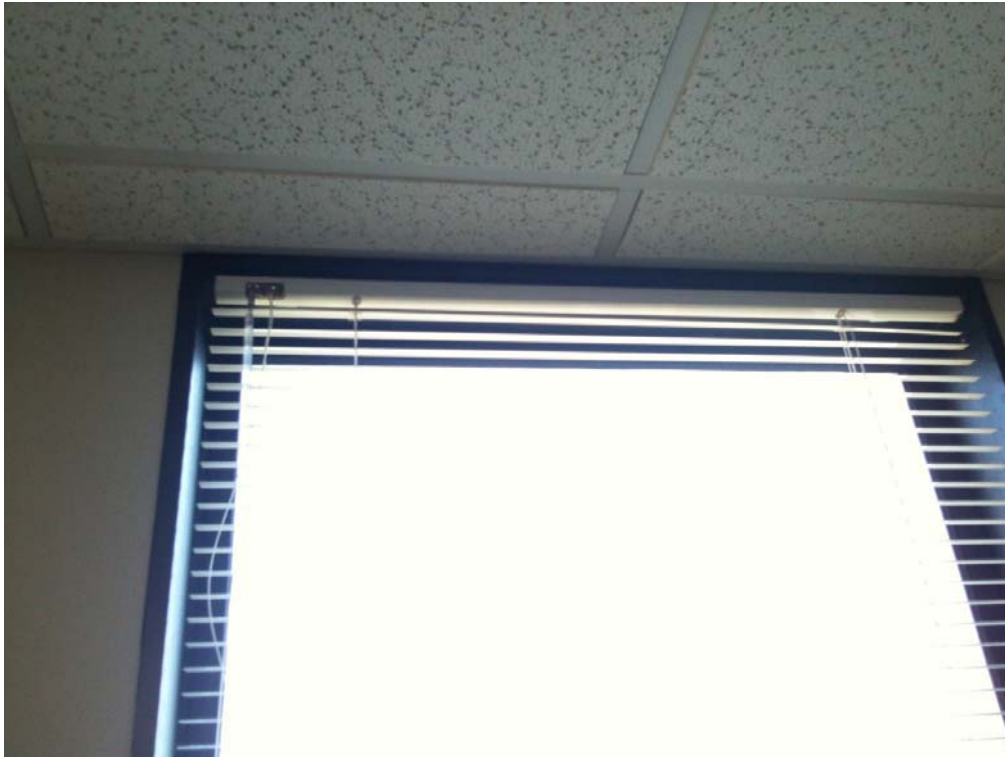
3rd Floor North – Property Appraiser – Head Detail: A.C.T.; Jamb: Painted G.W.B.

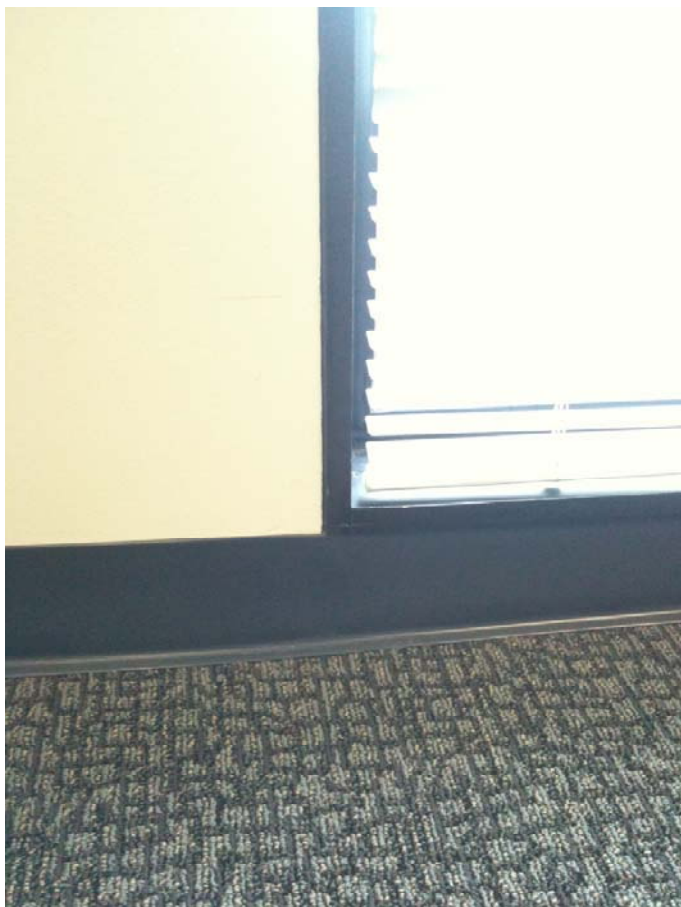
3rd Floor – Property Appraiser – Sill Detail: Carpet/Vinyl Base

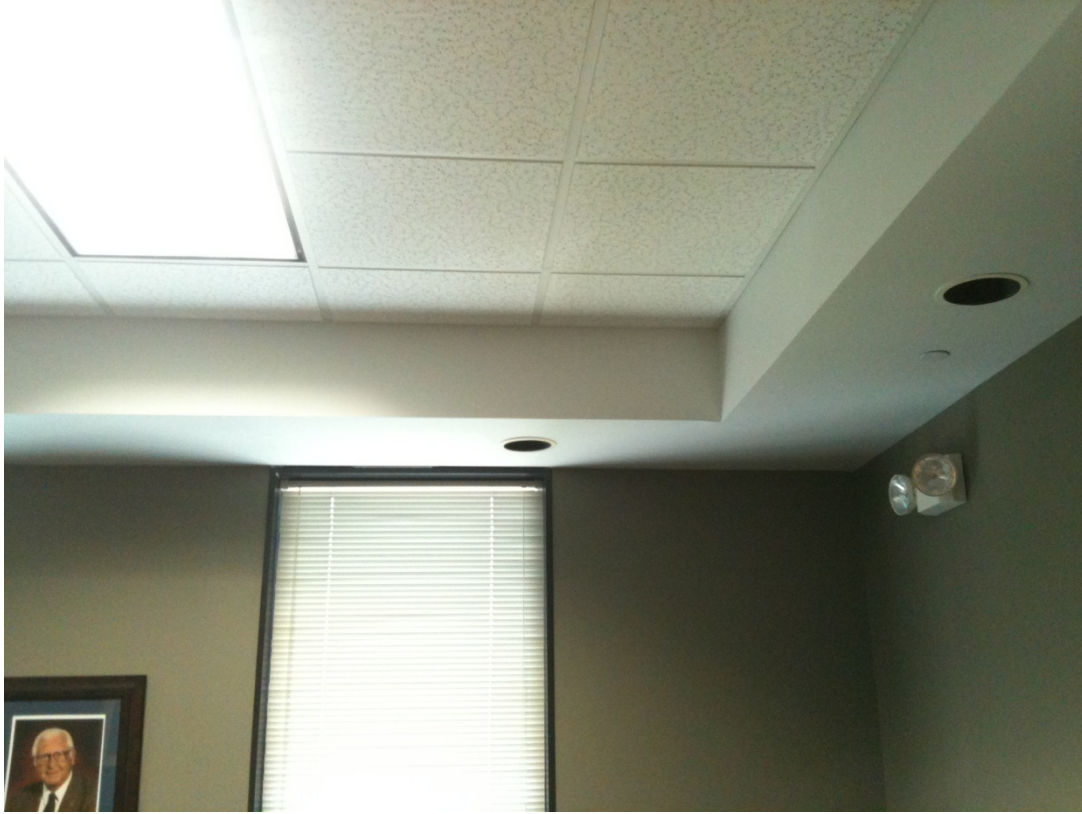
3rd Floor – Clerk of Courts – Head Detail: G.W.B Soffit/Painted

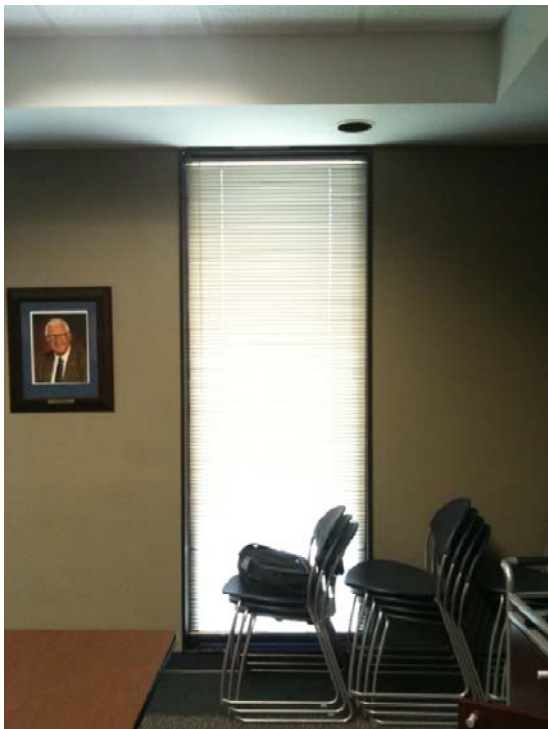
3rd Floor – Clerk of Courts – Sill Detail: Vinyl Base; Jamb Detail: G.W.B./Painted

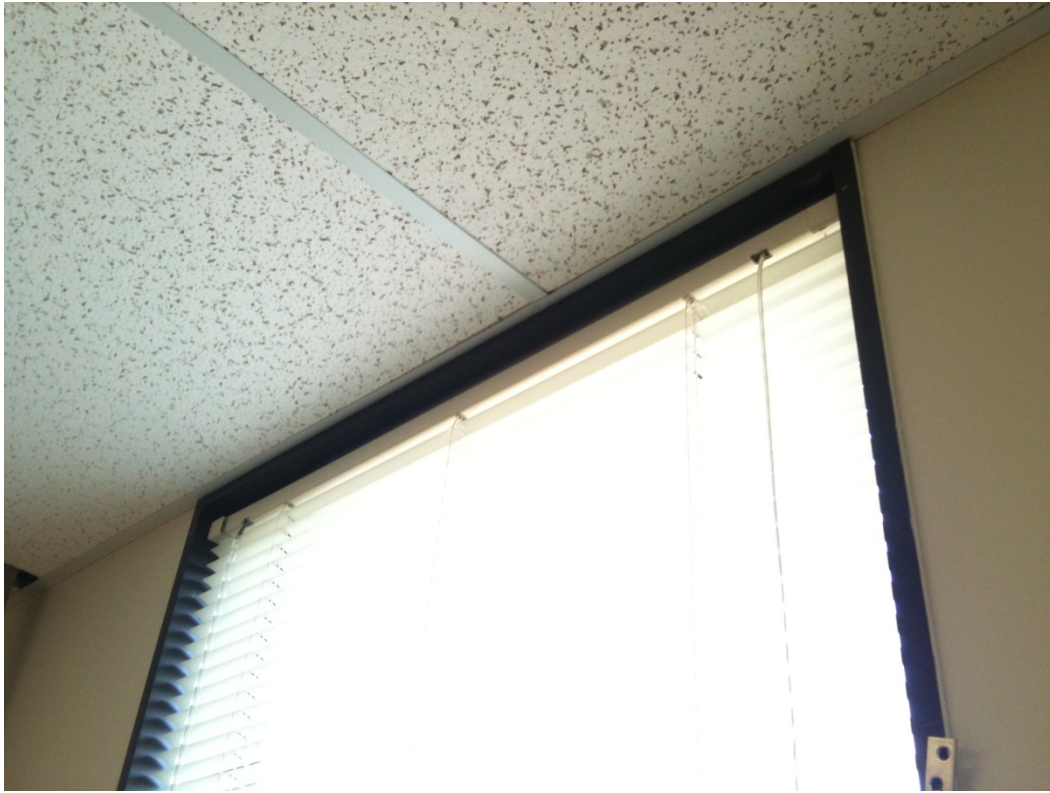
4th Floor-North-Clerk of Court Finance Head Detail: A.C.T.; Jamb: G.W.B./painted

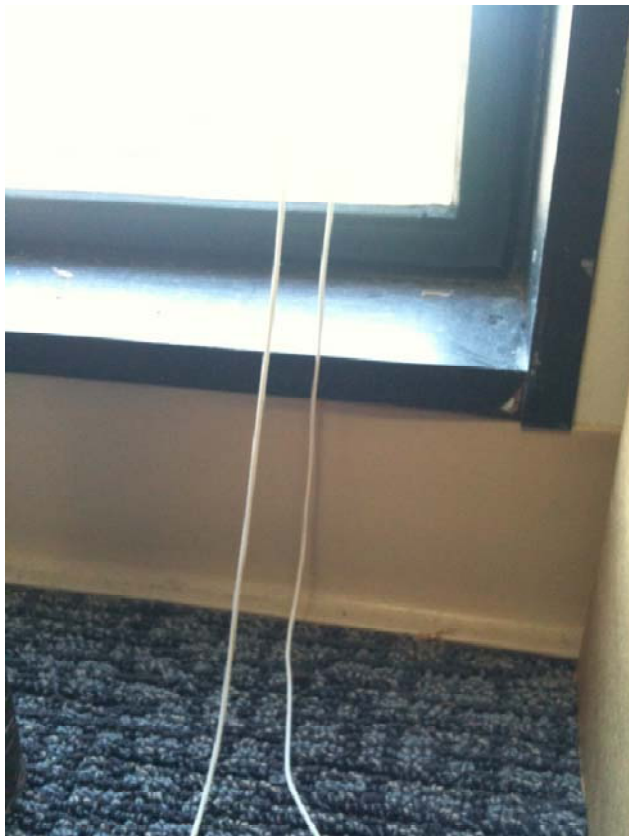
4th Floor-North-Clerk of Court Finance- Sill Detail: Carpet/Vinyl Base

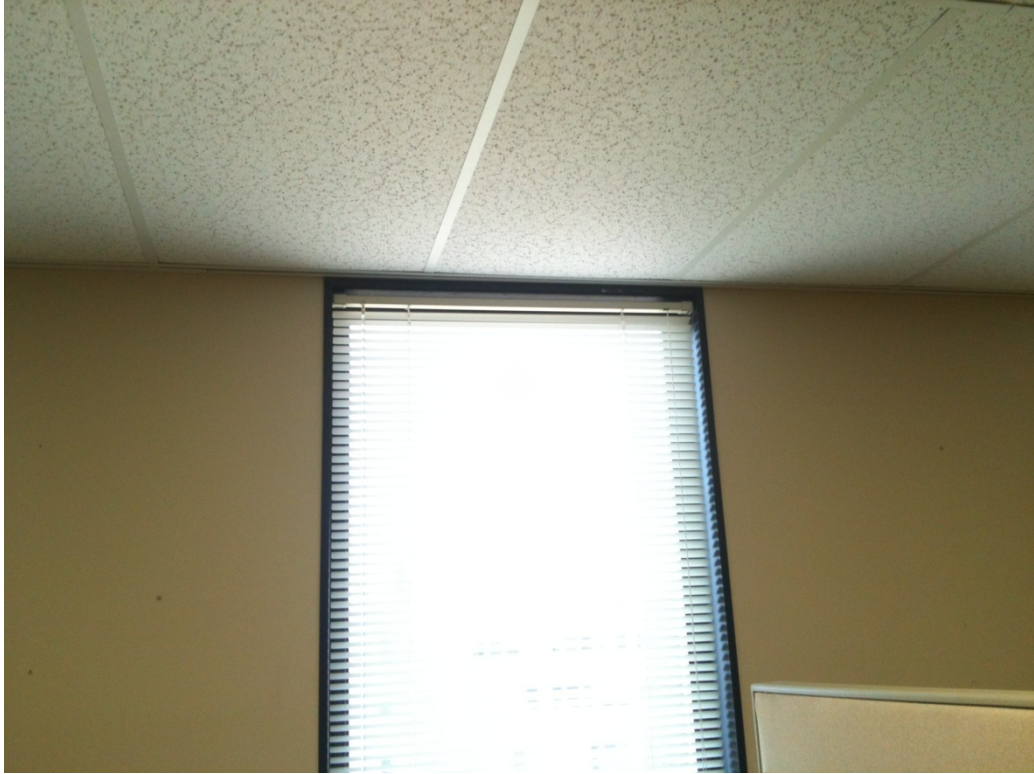
4th Floor-ATF- open office- Head Detail: A.C.T.; Jamb: G.W.B./painted

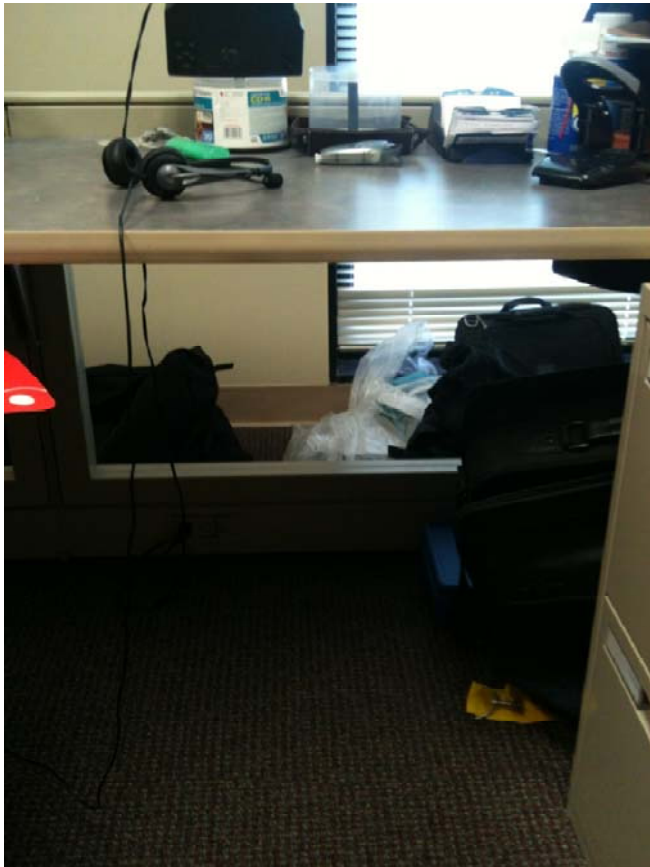
4th Floor-ATF- open office furnishings- Sill Detail: Carpet/Vinyl Base

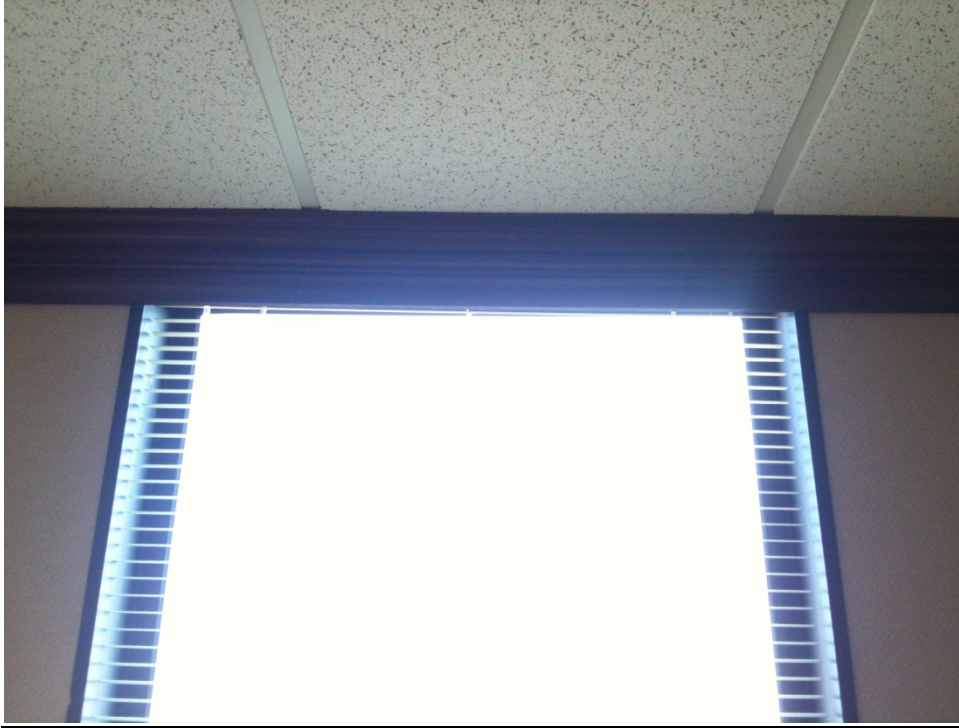
5th Floor-Century Link Head Detail: A.C.T./Wood Crown Molding – window frame extends above/behind crown mold, metal blinds

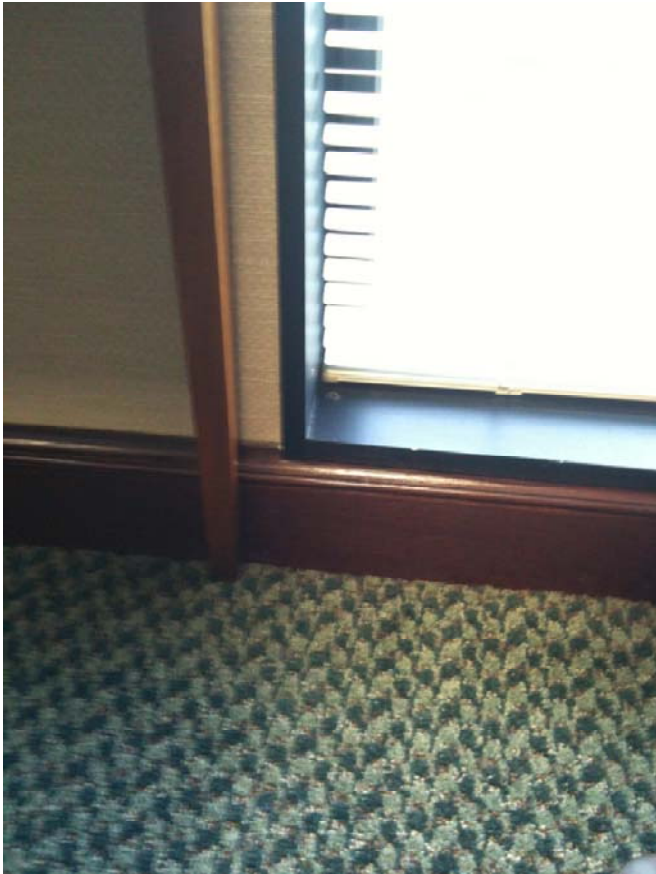
5th Floor – Century Link – Sill Detail: Carpet/Wood Base-stained

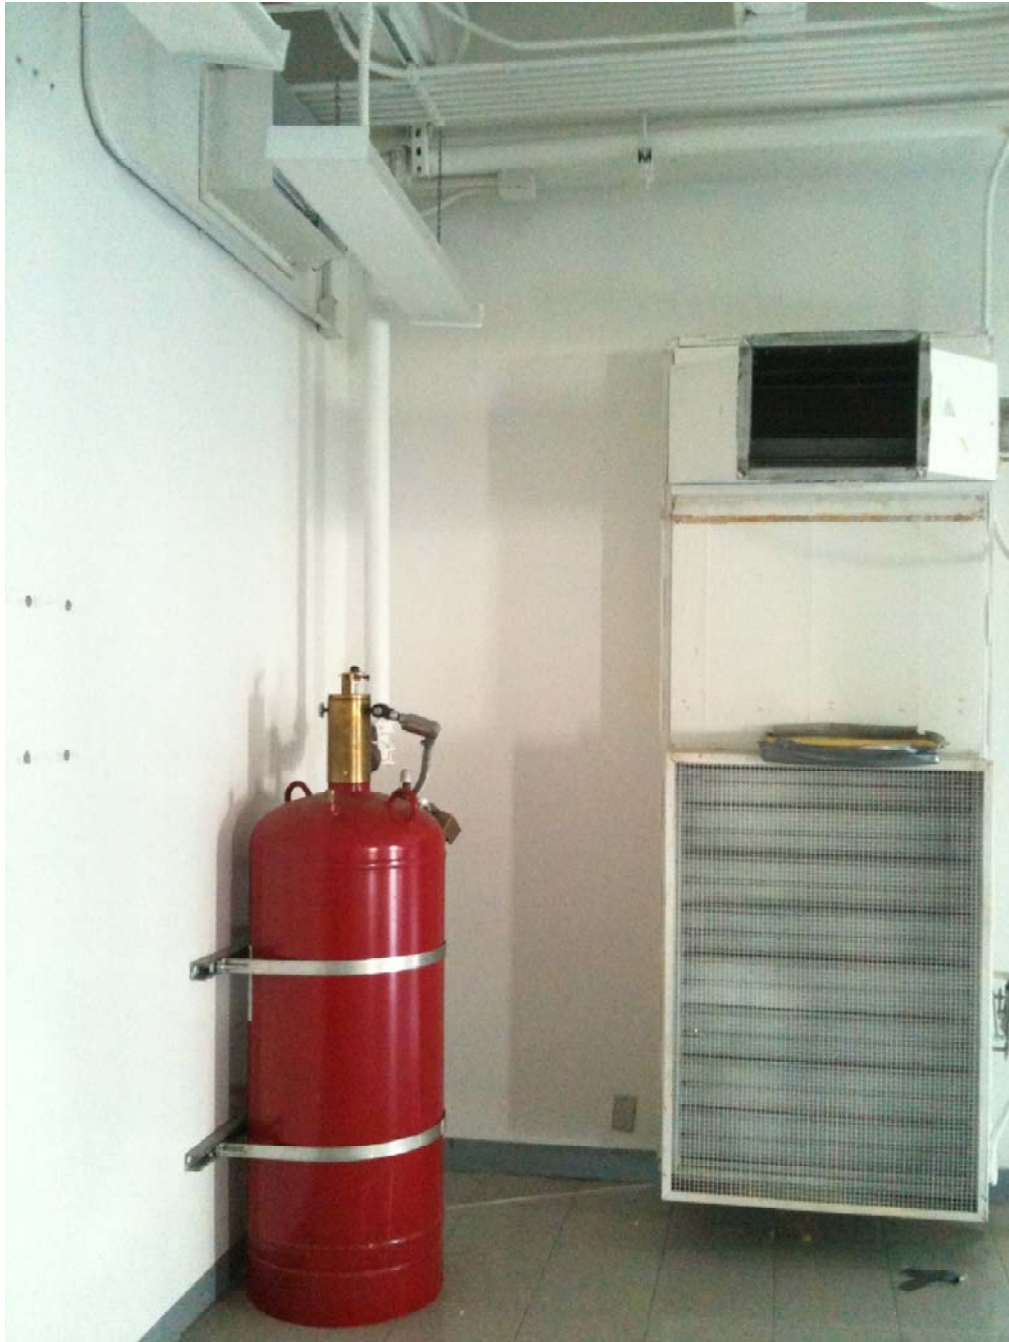
South – Vacant (Formerly T-Mobile Suit)

Equipment is shown where window will be replaced. Disengage equipment from exterior wall opening. Gypsum wall will also need to be removed to louver and natural window head height from finished floor. Louver will temporarily be visible from within tenant space.

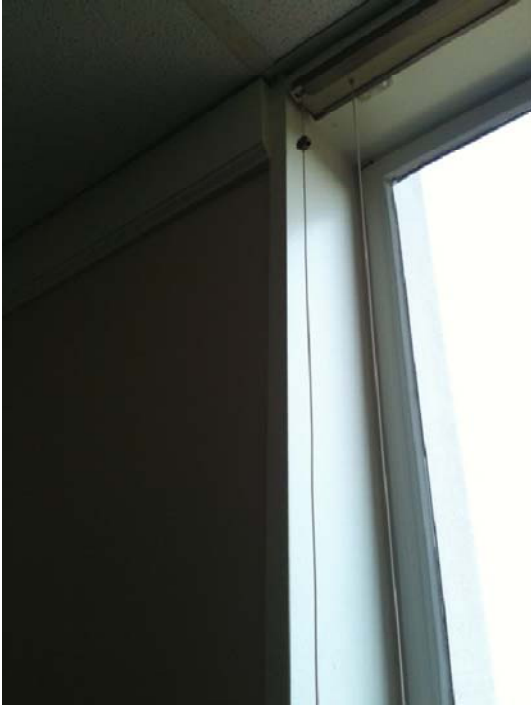
6th Floor- H&K Law Firm Head Detail: A.C.T./Wood Crown Molding – window frame-painted, fabric shades.

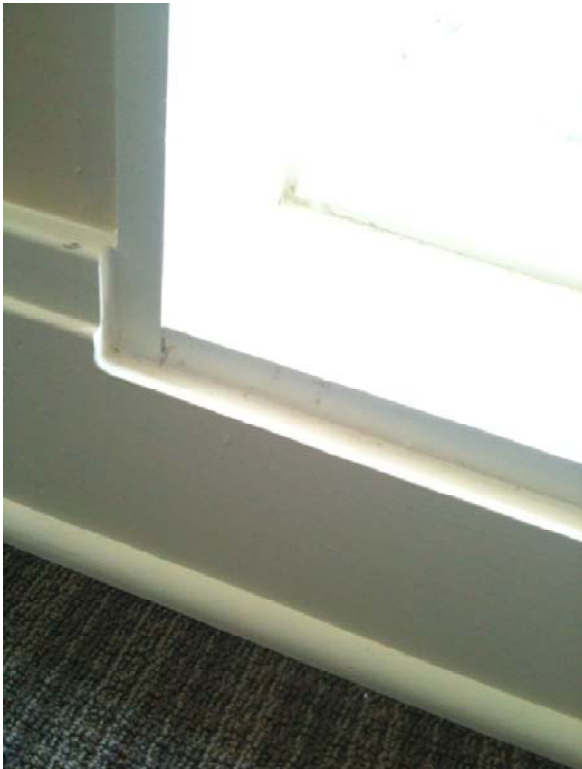
6th Floor – H & K Law Firm Sill Detail: Wood Base Painted – carpet.

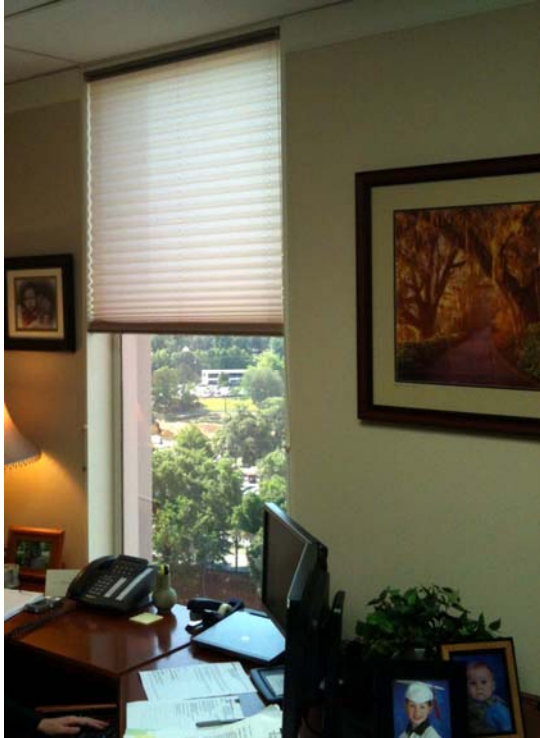
6th Floor H & K Law Firm - Head Detail: Window Frame/painted – Wood Trim; Fabric Shades

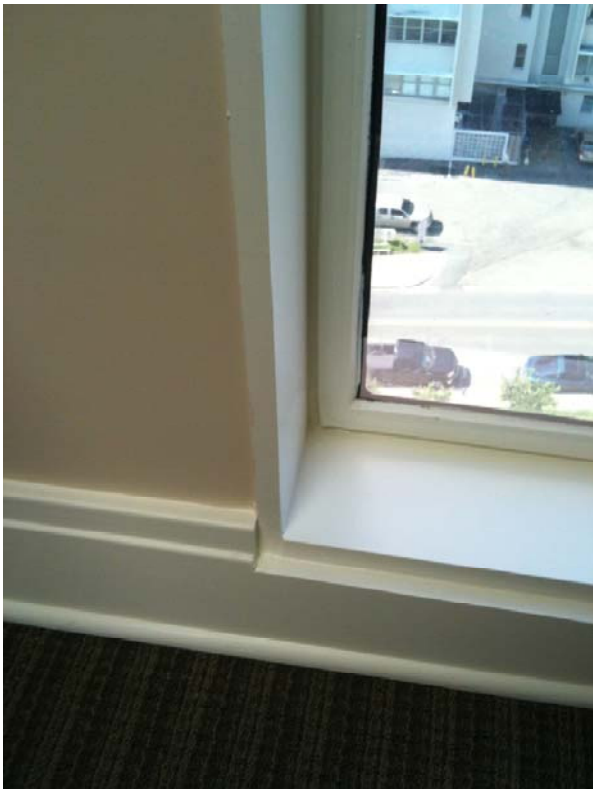
6th Floor H&K Law Firm – Sill Detail: Wood Trim/Painted, Window Frame Painted;

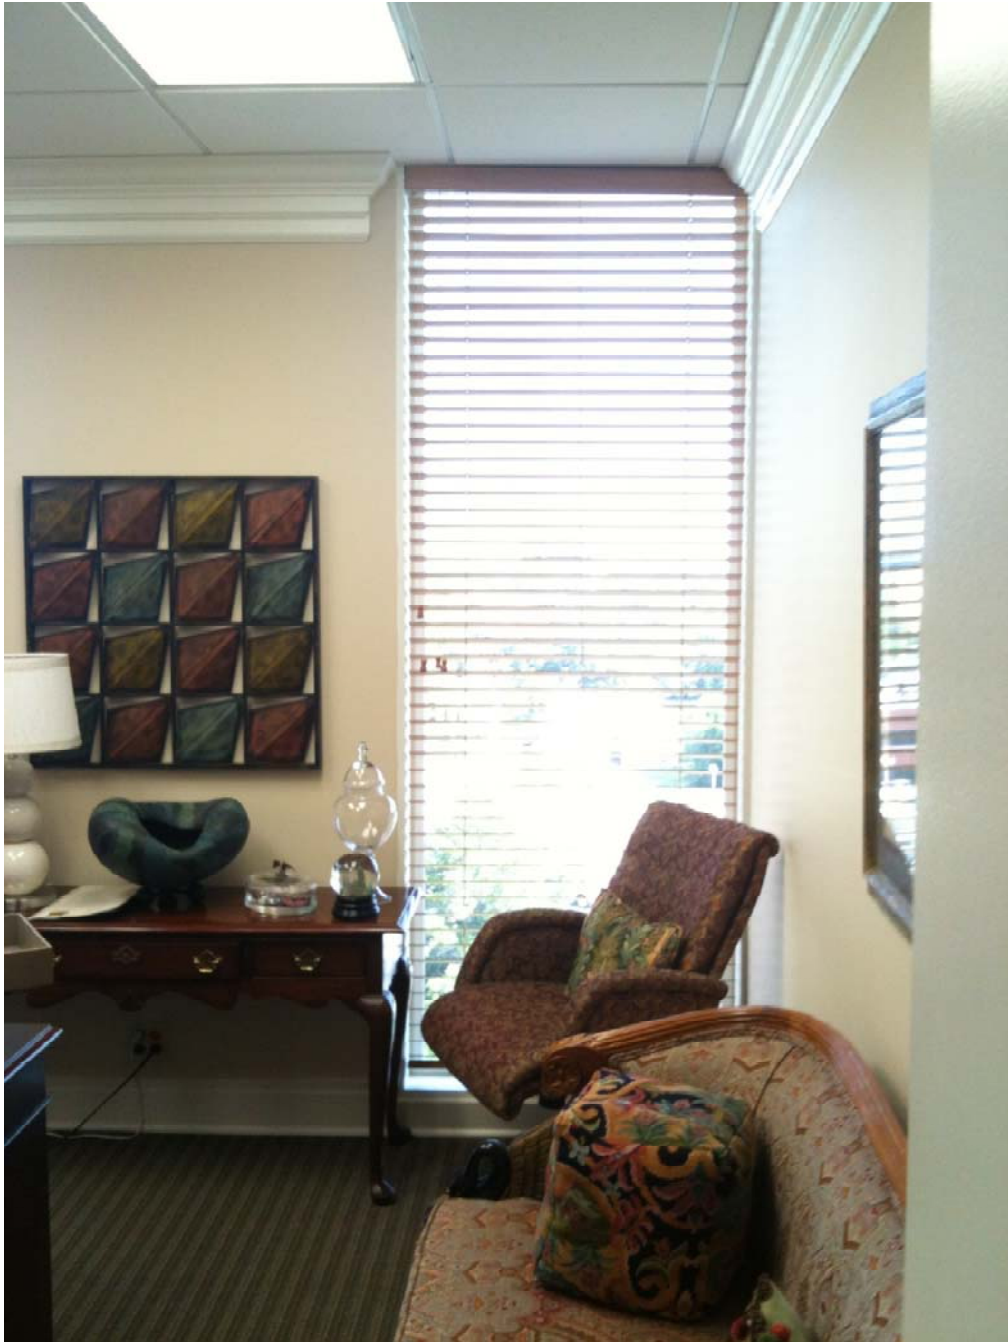
7th Floor Window – Same as H & K windows on 6th floor: Painted window frame, and painted wood trim.

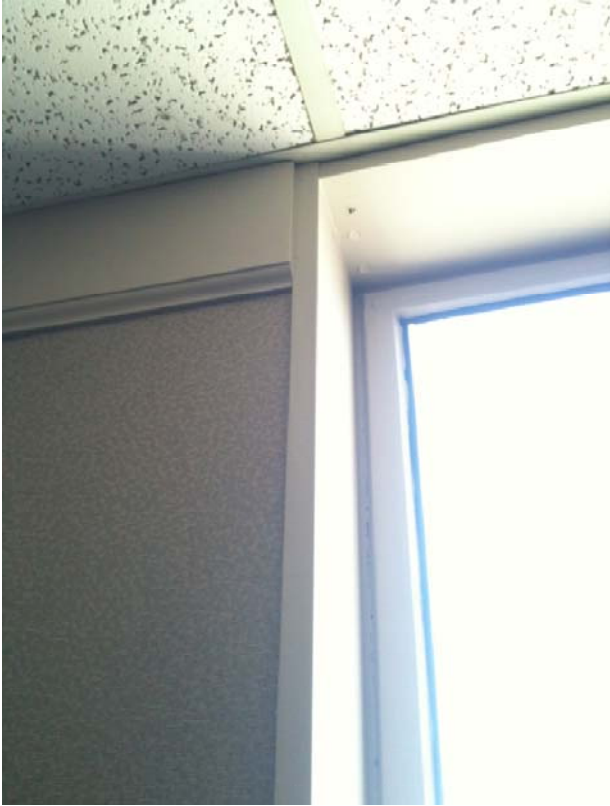
7th South – Vacant Head Detail: Window Frame -painted; Wood trim –painted; A.C.T. ceilings

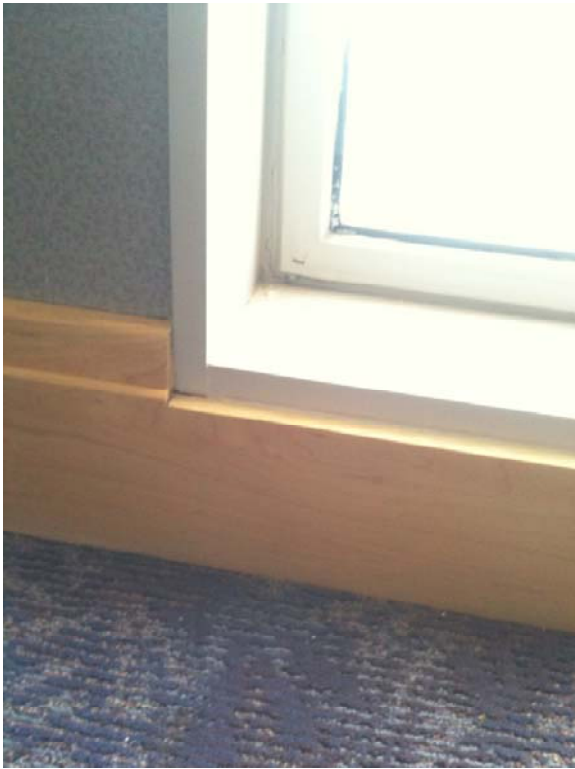
7th South – Vacant – Sill Detail: Wood Base –stained; Carpet; Walls: Wall Covering;

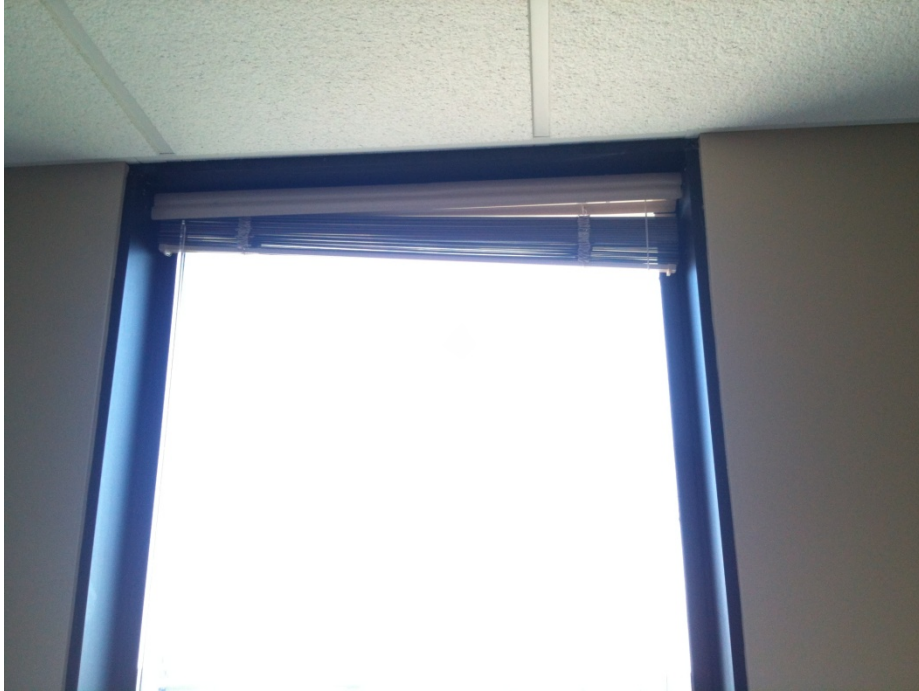
8th Floor Head Detail: A.C.T. ceiling; Walls - Painted

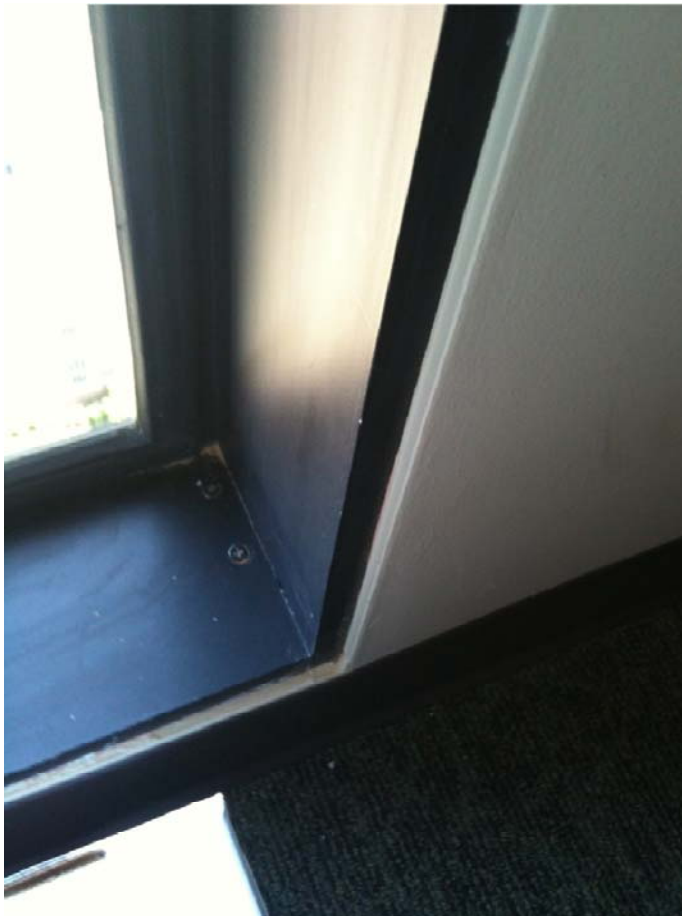
8th Floor Sill Detail: Vinyl Wall base; Wall Painted

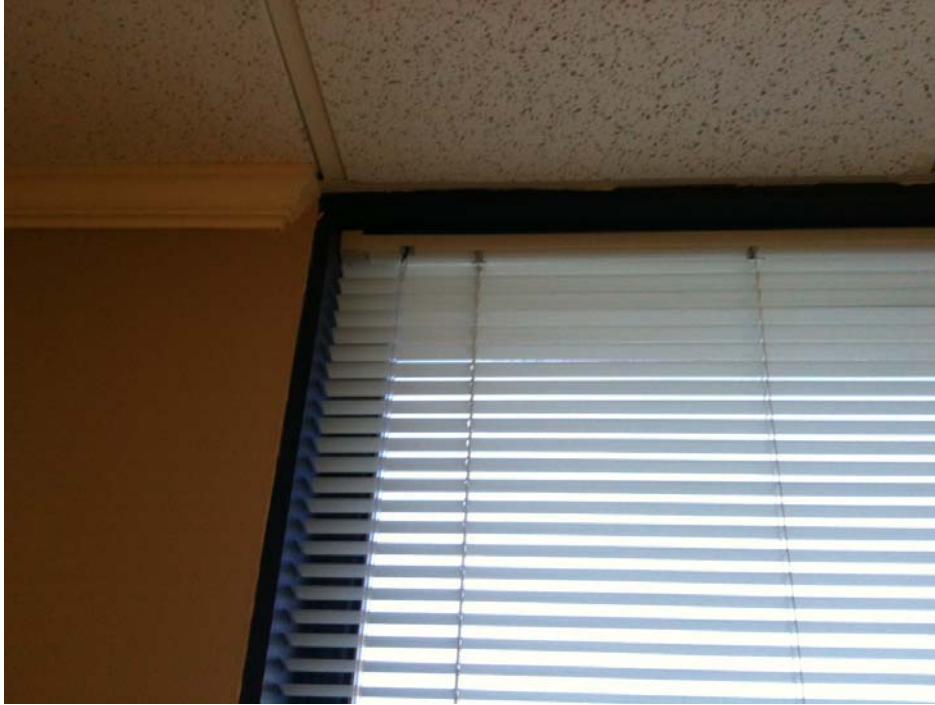
8th Floor South – Farm Bureau – Head Detail: A.C.T. & Wood Trim painted, Walls: Painted GWB.

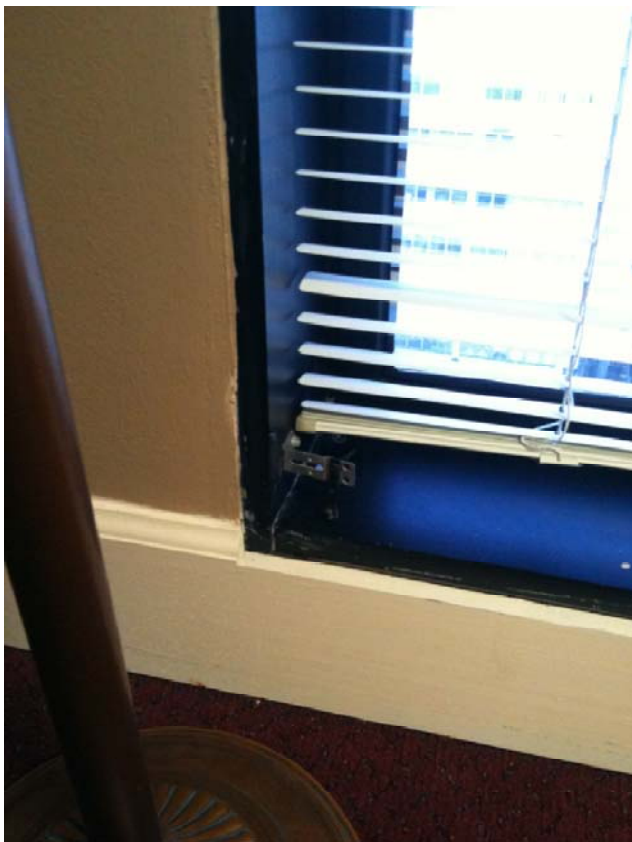
8th Floor – Farm Bureau- Base: wood trim, Walls: painted
