RE: Bid Title: Fred George Greenway Museum and Nature Center Renovation  
Bid No: BC-02-27-14-22

### ADDENDUM #1

**ASBESTOS SURVEY REPORT**

**3034 Capital Circle NW  
Tallahassee, Florida 32303**

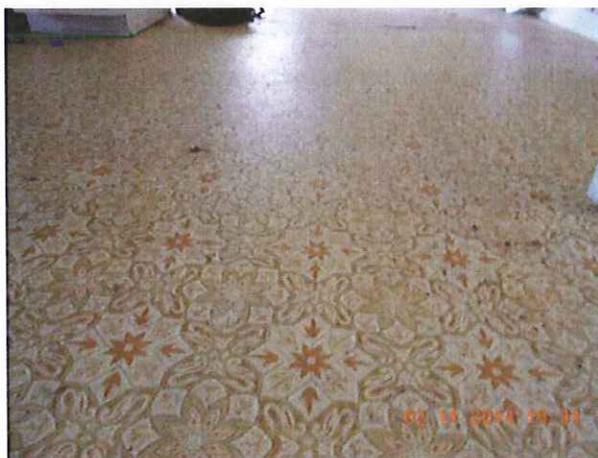
HA No:	HA Description	Friable	ACM Category
5	Sheet flooring Folral pattern	<input type="checkbox"/>	Category I Nonfriable

HA-5, Sheet Flooring Floral Pattern in Kitchen/Dining room is ACM. Asbestos containing flooring material should be removed as Regulated ACM (RACM) prior to any disturbance as this material is likely to become friable during renovation or demolition. Asbestos abatement

Sheet Flooring Floral Pattern in Kitchen/Dining room is ACM. Asbestos containing flooring material should be removed as Regulated ACM (RACM) prior to any disturbance as this material is likely to become friable during renovation or demolition. Asbestos abatement shall be performed by Florida Licensed asbestos abatement contractor.

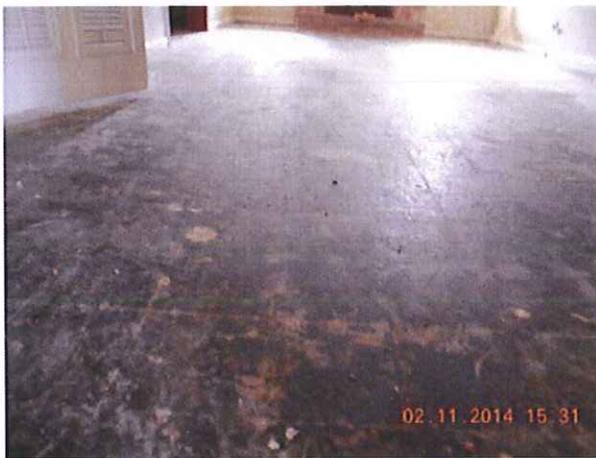
HA No:	HA Description	Friable	ACM Category
7	Floor Mastic Black	<input type="checkbox"/>	Category I Nonfriable

HA-7 Floor Mastic Black in Family room, foyer and hallway is ACM. Remove asbestos containing floor mastic as ACM prior to any disturbance as this material is likely to become friable during disturbance. If the building is scheduled for demolition, remove asbestos containing adhesive mastic as ACM if concrete substrate will be recycled. If concrete is not going to be recycled, mastic can be left in place during demolition, provided wet demolition is performed. Asbestos abatement shall be performed by Florida Licensed asbestos abatement contractor.

Floor Mastic Black in Family room, foyer and hallway is ACM. Remove asbestos containing floor mastic as ACM prior to any disturbance as this material is likely to become friable during disturbance. If the building is scheduled for demolition, remove asbestos containing adhesive mastic as ACM if concrete substrate will be recycled. If concrete is not going to be recycled, mastic can be left in place during demolition, provided wet demolition is performed. Asbestos abatement shall be performed by Florida Licensed asbestos abatement contractor.

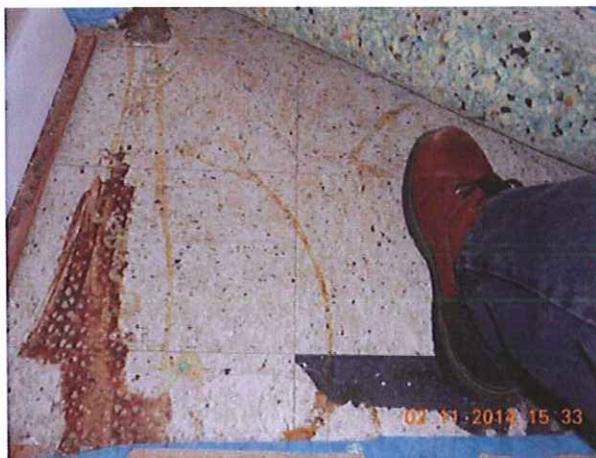
HA No:	HA Description	Friable	ACM Category
8	Floor tile 9x9 and mastic Black	<input type="checkbox"/>	Category I Nonfriable

HA-8, Floor Tile 9x9 White and Mastic Black in Bedroom 1, Bedroom 2 and Bath 1 is ACM. Asbestos containing flooring material and Mastic back should be removed as Regulated ACM (RACM) prior to any disturbance as this material is likely to become friable during disturbance. If the building is scheduled for demolition, remove asbestos containing adhesive mastic as ACM if concrete substrate will be recycled. If concrete is not going to be recycled, mastic can be left in place during demolition, provided wet demolition is performed. Asbestos abatement shall be performed by Florida Licensed asbestos abatement contractor.

Floor Tile 9x9 White and Mastic Black in Bedroom 1, Bedroom 2 and Bath 1 is ACM. Asbestos containing flooring material and Mastic back should be removed as Regulated ACM (RACM) prior to any disturbance as this material is likely to become friable during disturbance. If the building is scheduled for demolition, remove asbestos containing adhesive mastic as ACM if concrete substrate will be recycled. If concrete is not going to be recycled, mastic can be left in place during demolition, provided wet demolition is performed. Asbestos abatement shall be performed by Florida Licensed asbestos abatement contractor.

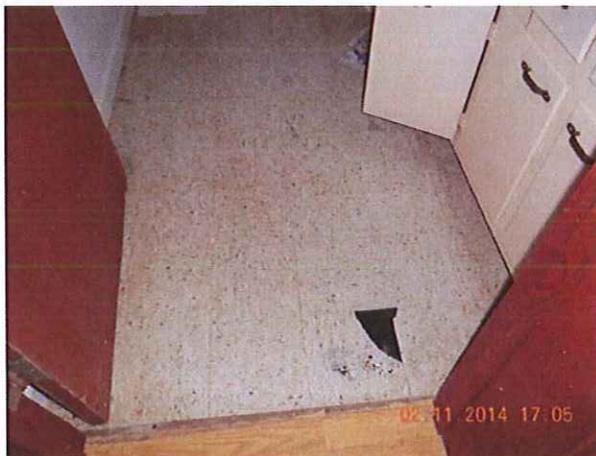
HA No:	HA Description	Friable	ACM Category
9	Floor tile 12x12 (Multi layer) and Mastic Black	<input type="checkbox"/>	Category I Nonfriable

HA-9, Floor tile 12x12 (Multi layer) and Mastic Black in Bath 2 is ACM. Asbestos containing flooring material and Mastic back should be removed as Regulated ACM (RACM) prior to any disturbance as this material is likely to become friable during disturbance. If the building is scheduled for demolition, remove asbestos containing adhesive mastic as ACM if concrete substrate will be recycled. If concrete is not going to be recycled, mastic can be left in place during demolition, provided wet demolition is performed. Asbestos abatement shall be performed by Florida Licensed asbestos abatement contractor.

Floor tile 12x12 (Multi layer) and Mastic Black in Bath 2 is ACM. Asbestos containing flooring material and Mastic back should be removed as Regulated ACM (RACM) prior to any disturbance as this material is likely to become friable during disturbance. If the building is scheduled for demolition, remove asbestos containing adhesive mastic as ACM if concrete substrate will be recycled. If concrete is not going to be recycled, mastic can be left in place during demolition, provided wet demolition is performed. Asbestos abatement shall be performed by Florida Licensed asbestos abatement contractor.

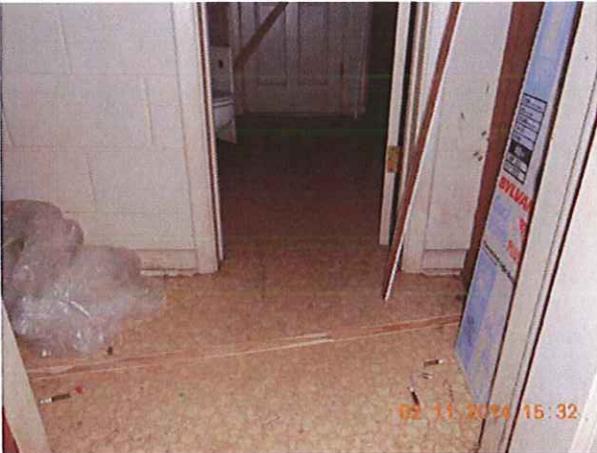
HA No:	HA Description	Friable	ACM Category
10	Sheet Flooring (Rock Pattern)	<input type="checkbox"/>	Category I Nonfriable

HA-10, Sheet Flooring Rock Pattern in Bath 4 is ACM. Asbestos containing flooring material should be removed as Regulated ACM (RACM) prior to any disturbance as this material is likely to become friable during renovation or demolition. Asbestos abatement shall be performed by Florida Licensed asbestos abatement contractor.

<p><b>Recommmendations / Comments</b></p> <p>Sheet Flooring Rock Pattern in Bath 4 is ACM. Asbestos containing flooring material should be removed as Regulated ACM (RACM) prior to any disturbance as this material is likely to become friable during renovation or demolition. Asbestos abatement shall be performed by Florida Licensed asbestos abatement contractor.</p>
