Alford Arm Creek EcoSummary

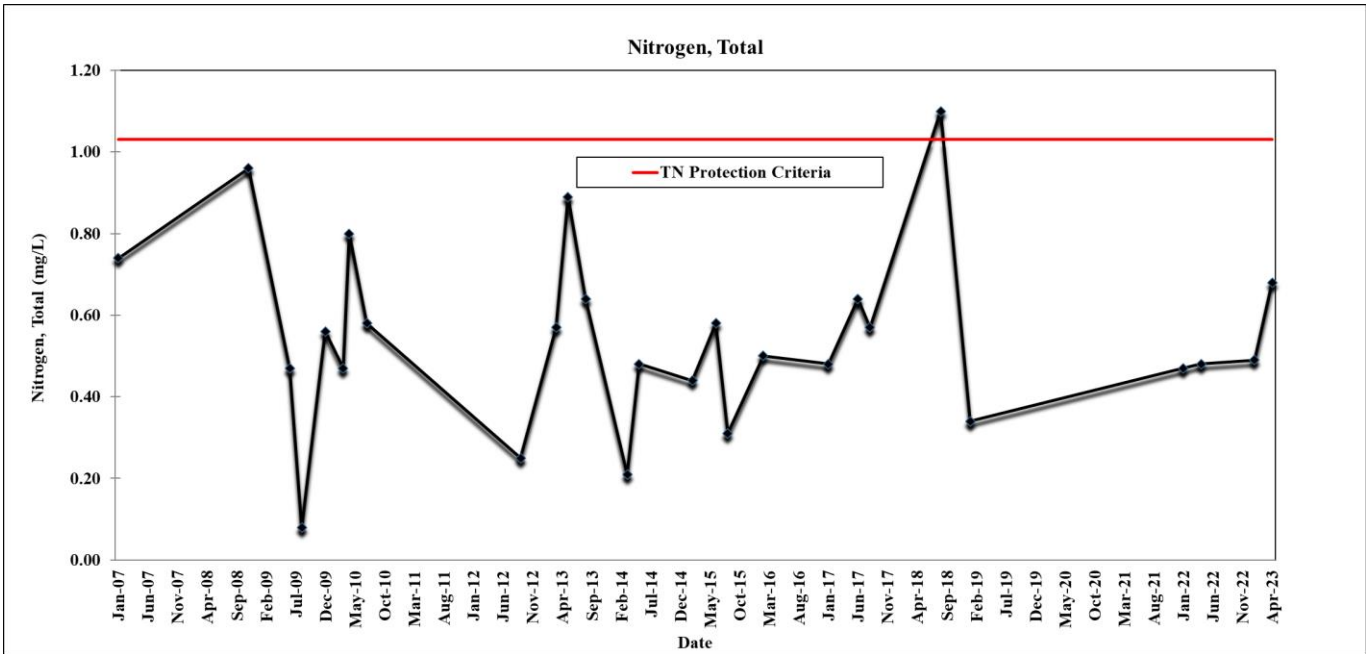
Figure 2. Total Nitrogen results for Alford Arm Creek.

Due to low water and back flow conditions, four temporally independent samples per year have never been collected from this station. For illustrative purposes, individual data points were plotted to determine any possible trends (**Figures 2 and 3**). With few exceptions, individual values did not exceed the instream criteria for Total Nitrogen or Total Phosphorus.

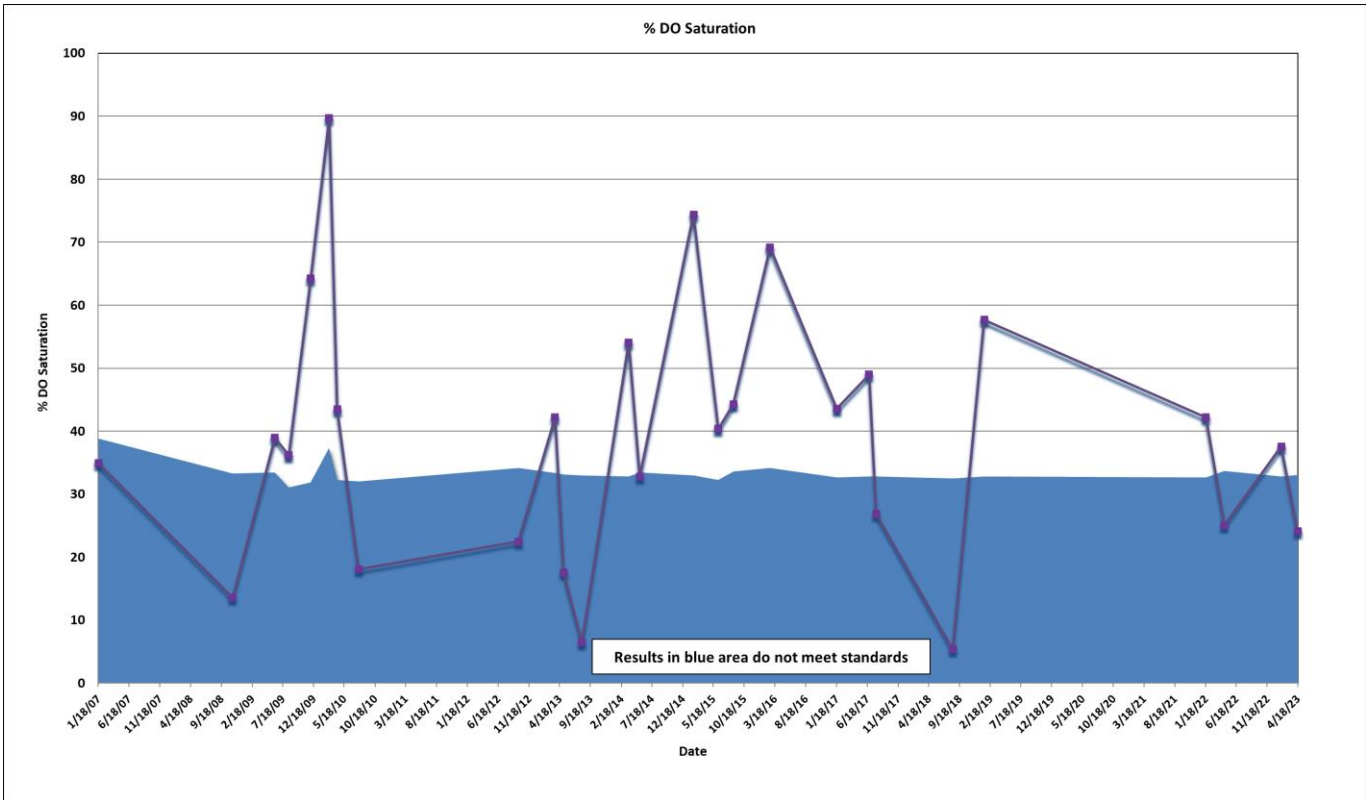
Figure 4. Dissolved Oxygen Percent Saturation results for Alford Arm Creek.

As **Figure 4** shows, Alford Arm Creek did not always meet the Class III criteria for % dissolved oxygen (DO) saturation. This is not surprising since low gradient, low flow streams often have low DO levels.
