# Lake Cascade EcoSummary

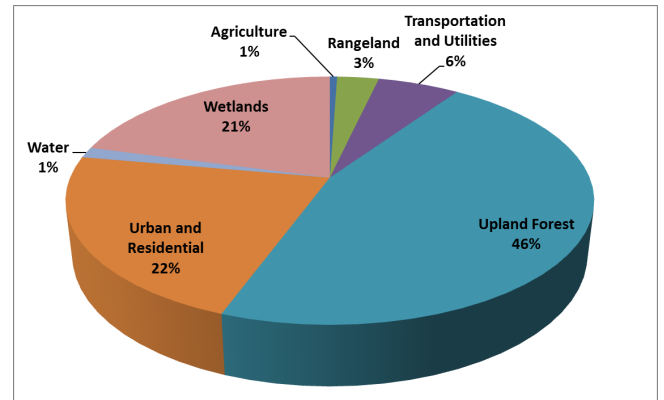
**Figure 1.** Lake Cascade watershed land use.

Approximately 32% of land uses in the 16,591-acre Lake Cascade watershed comes from agriculture, rangeland, transportation, utilities, urban and residential (as shown in **Figure 1**). These types of land uses are often attributed to increases in stormwater runoff and higher nutrient loads.

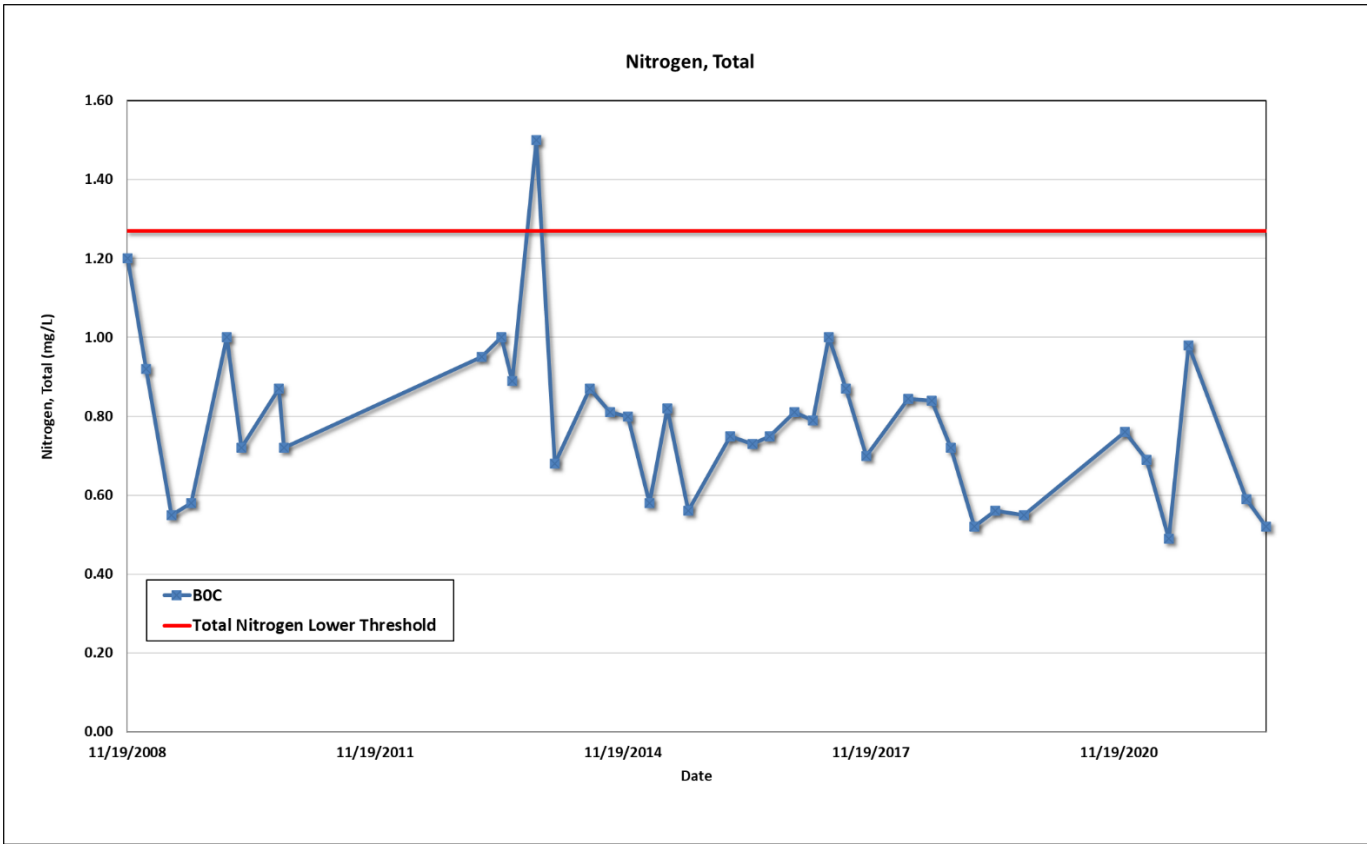
**Figure 1.** Total Nitrogen results for Lake Cascade.

For illustrative purposes, individual data points were plotted to determine any possible trends (**Figures 1-3**). With few exceptions, individual values did not exceed the in-lake criteria.

While the geometric means for the NNC parameters were never exceeded, individual values occasionally rose above the threshold values. There was a large increase in Total Nitrogen and Phosphorus in 2013 (4<sup>th</sup> and 1<sup>st</sup> quarters, respectively) and a smaller increase in phosphorus levels during the 1<sup>st</sup> quarter of 2018. Increased levels of nutrients could be attributed to the decay of terrestrial plants that grew in the lake bottom during drought conditions or possibly stormwater runoff associated with the southwest Capital Circle widening. Post nutrient levels have decreased. The chlorophyll-a value for the 1<sup>st</sup> quarter of 2019 (55.2 µg/L) is by far the highest chlorophyll-a value recorded on Lake Cascade. Other water quality parameters taken during that time frame did not suggest an algal bloom or nutrient problem, so it is unknown why the chlorophyll-a value was so elevated.
