RE: Bid Title: Meridian Rd and Rhoden Cove Rd Intersection Improvements
Bid No: BC-04-25-13-26
Opening Date: Thursday, May 25, 2013 at 2:00 PM

ADDENDUM #1

REPORT OF
GEOTECHNICAL INVESTIGATION
INTERSECTION IMPROVEMENTS
MERIDIAN ROAD AND RHODEN COVE ROAD
LEON COUNTY, FLORIDA

SUBJECT: Report of Geotechnical Investigation
Intersection Improvements
Meridian Road and Rhoden Cove Road
Leon County, Florida

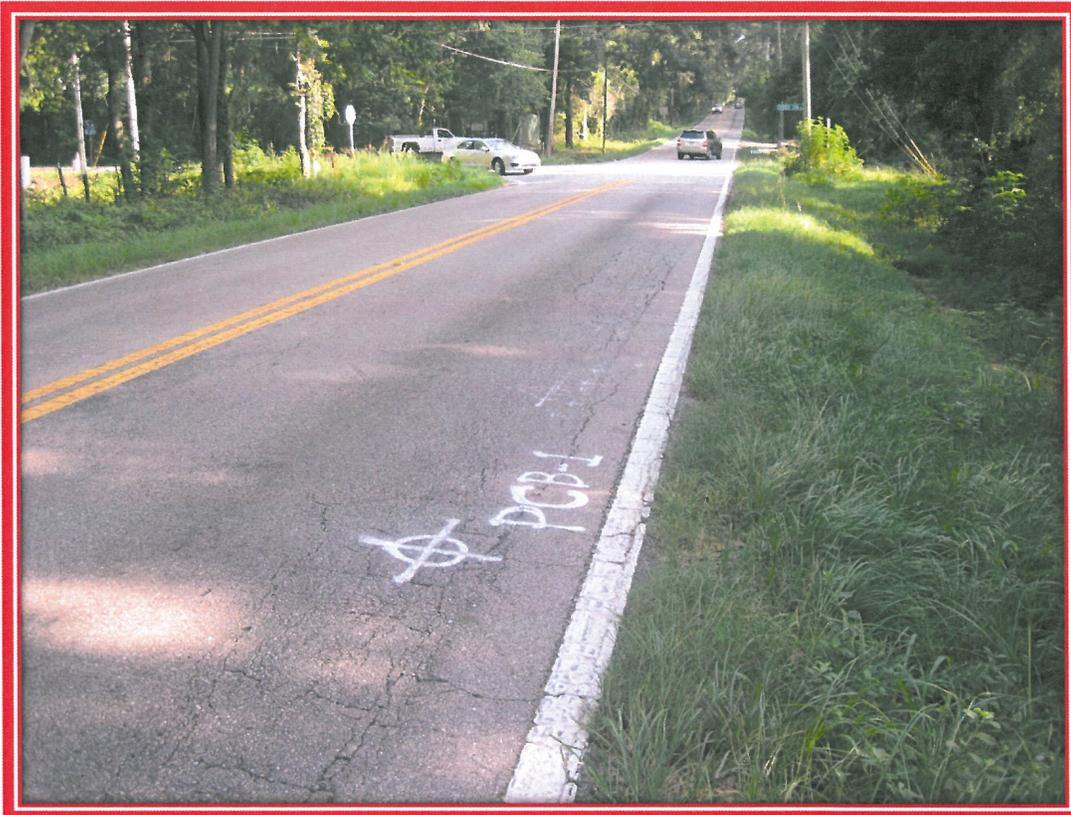
Photographs taken during a site visit in July 2012 have been provided as **Figures 3A** through **3D**. As can be seen in **Figures 3A** and **3B**, Meridian Road is a two-lane paved road with grass shoulders and drainage swales surrounded by woodlands. Rhoden Cove Road is a two-lane road and expands to three-lanes at the intersection of Meridian Road. Photographs displaying the site condition of Rhoden Cove Road have been provided as **Figures 3C** and **3D**.

FIGURE 3A: PHOTOGRAPH OF EXISTING PAVEMENT CONDITIONS NEAR PAVEMENT CORE RC-PC-1 ALONG MERIDIAN ROAD (FACING NORTH)

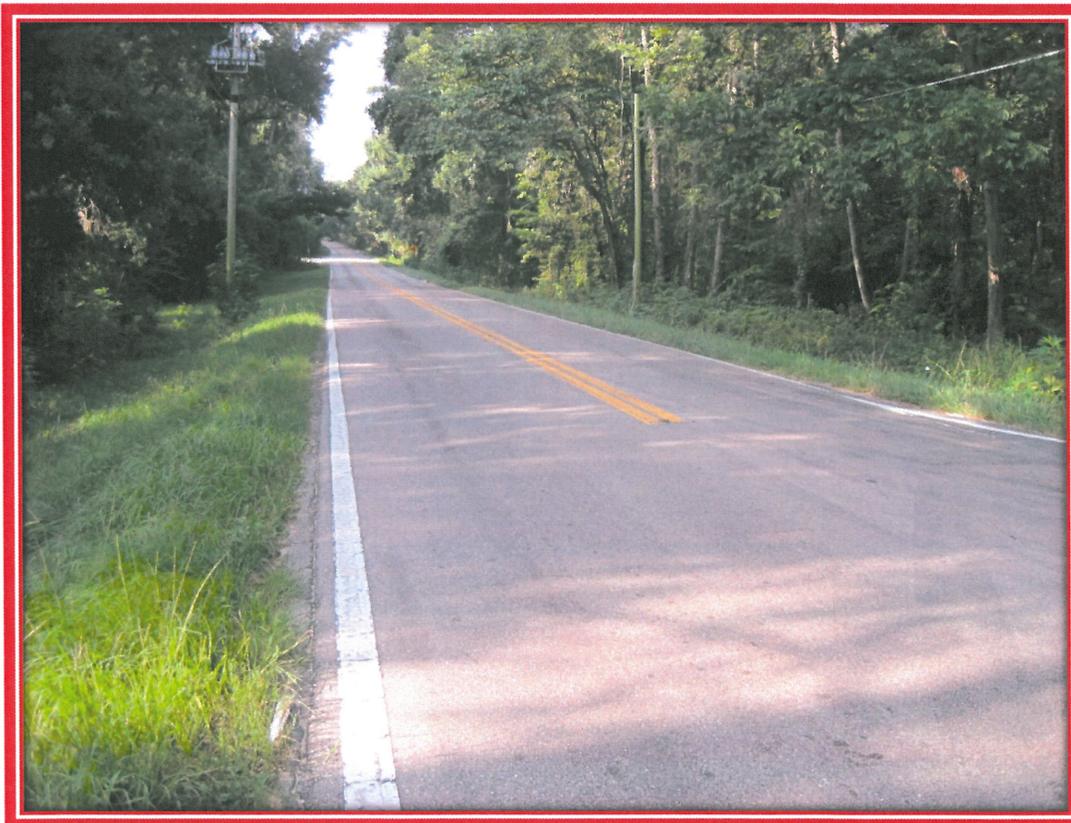
FIGURE 3B: PHOTOGRAPH OF EXISTING PAVEMENT CONDITIONS NEAR PAVEMENT CORE RC-PC-1 ALONG MERIDIAN ROAD (FACING SOUTH)

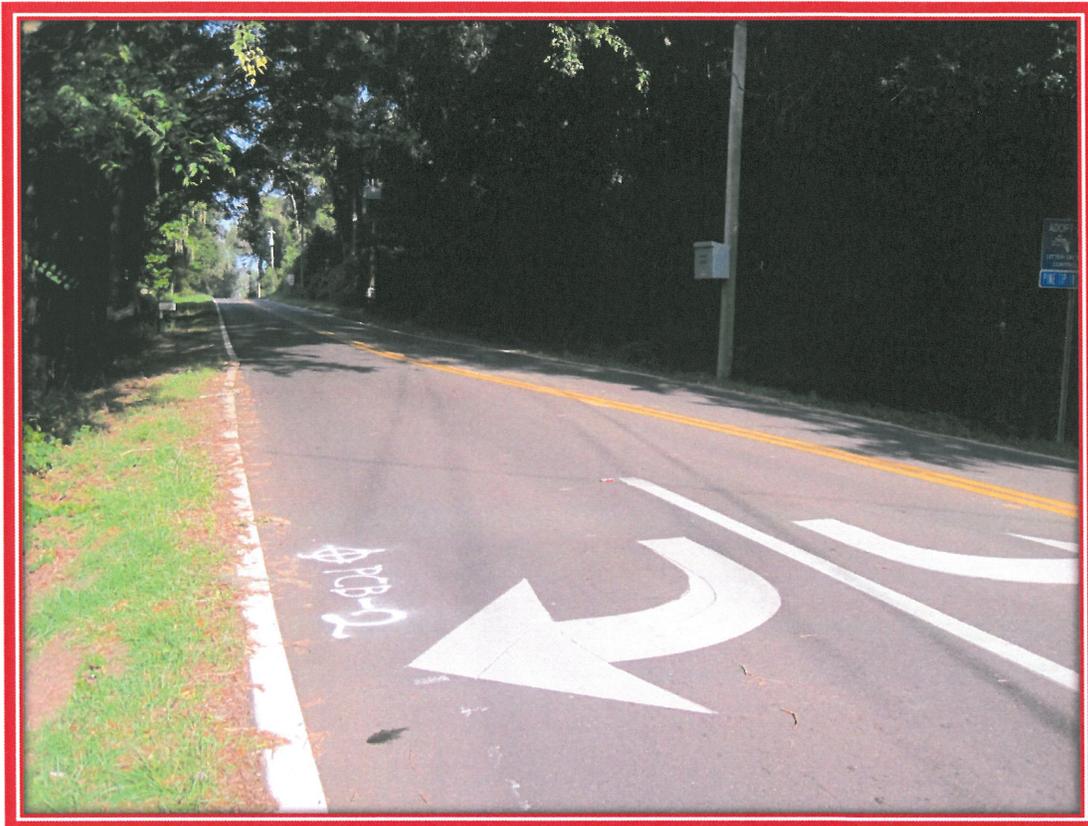
FIGURE 3C: PHOTOGRAPH OF EXISTING PAVEMENT CONDITIONS NEAR PAVEMENT CORE RC-PC-2 ALONG RHODEN COVE (FACING WEST)

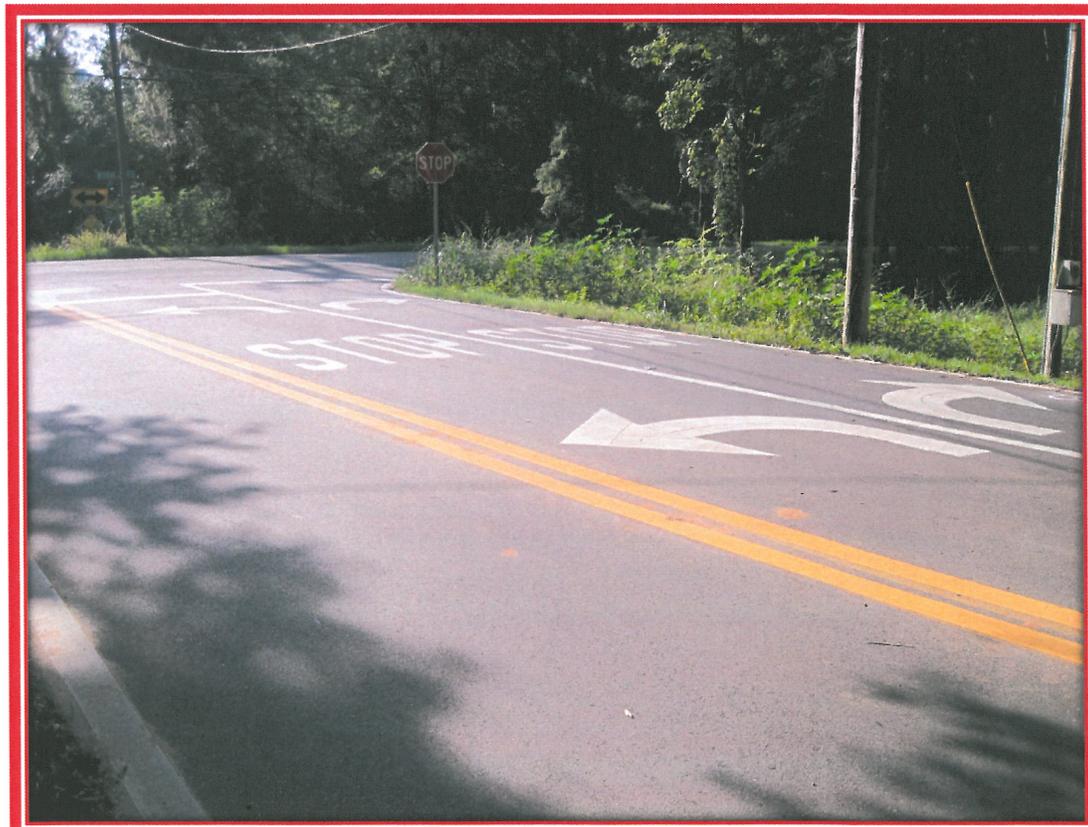
FIGURE 3D: PHOTOGRAPH OF EXISTING PAVEMENT CONDITIONS NEAR PAVEMENT CORE RC-PC-2 ALONG RHODEN COVE (FACING EAST)

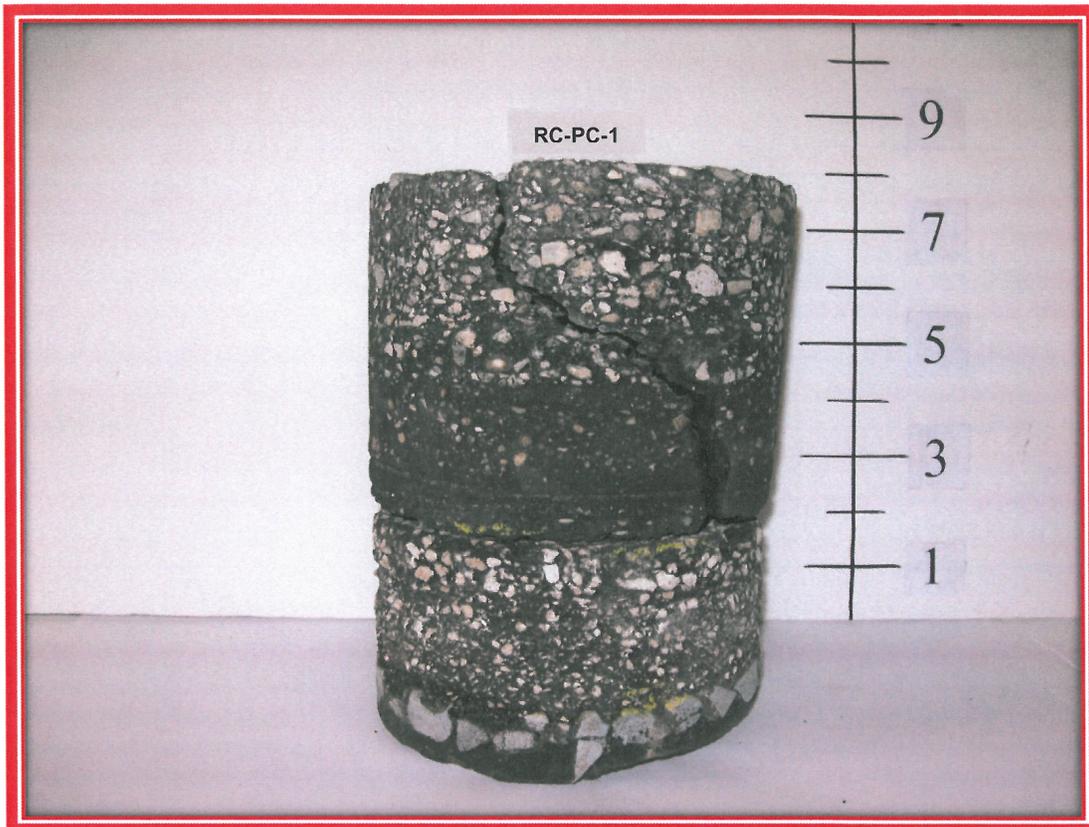
Pavement Core Data – Two (2) pavement cores were authorized for this investigation. The pavement core numbers, lengths, locations, and pavement conditions are summarized in the Pavement Core and Condition Survey provided as **TABLE 5**. Photographs of each pavement core are included as **Figures 6A** through **6B**. A detailed Pavement Core Data Sheet for each core location has also been provided in **APPENDIX B**.

FIGURE 6A: PHOTOGRAPH OF PAVEMENT CORE RC-PC-1

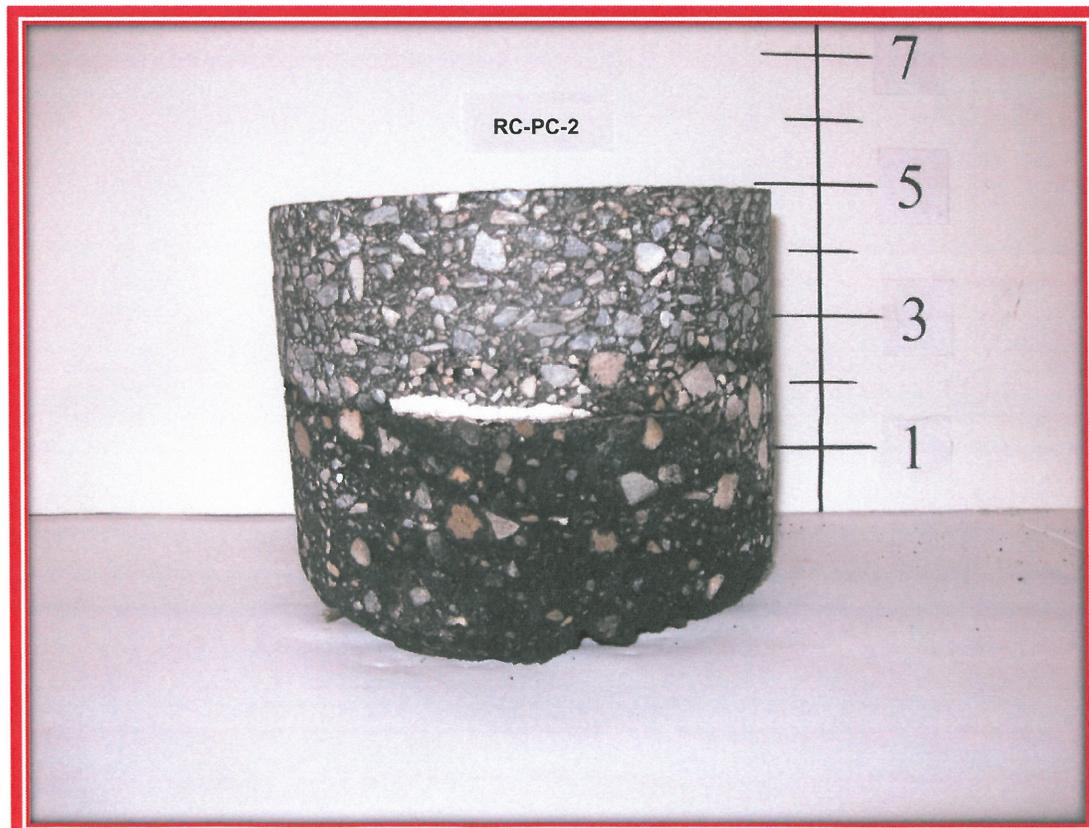
FIGURE 6B: PHOTOGRAPH OF PAVEMENT CORE RC-PC-2

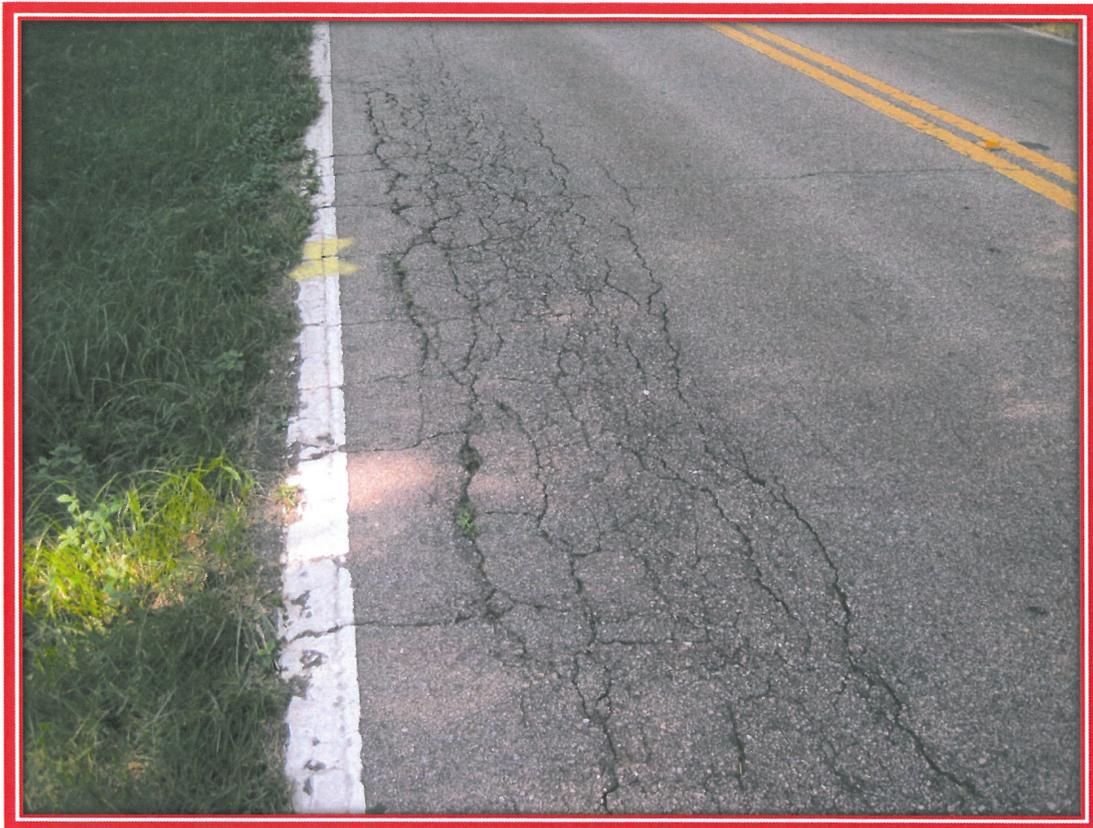
Pavement Conditions – In general, the travel lanes of Meridian Road were found to be in poor condition with severe fatigue cracking, moderate longitudinal cracking, and light edge cracking. In general, the turn lanes and travel lanes of Rhoden Cove Road have been recently resurfaced and were found to be in fair condition with light fatigue cracking. Photographs of the existing pavement conditions have been provided as **Figures 7A** and **7B**.

**FIGURE 7A: PHOTOGRAPH OF PAVEMENT CONDITIONS
ALONG MERIDIAN ROAD**

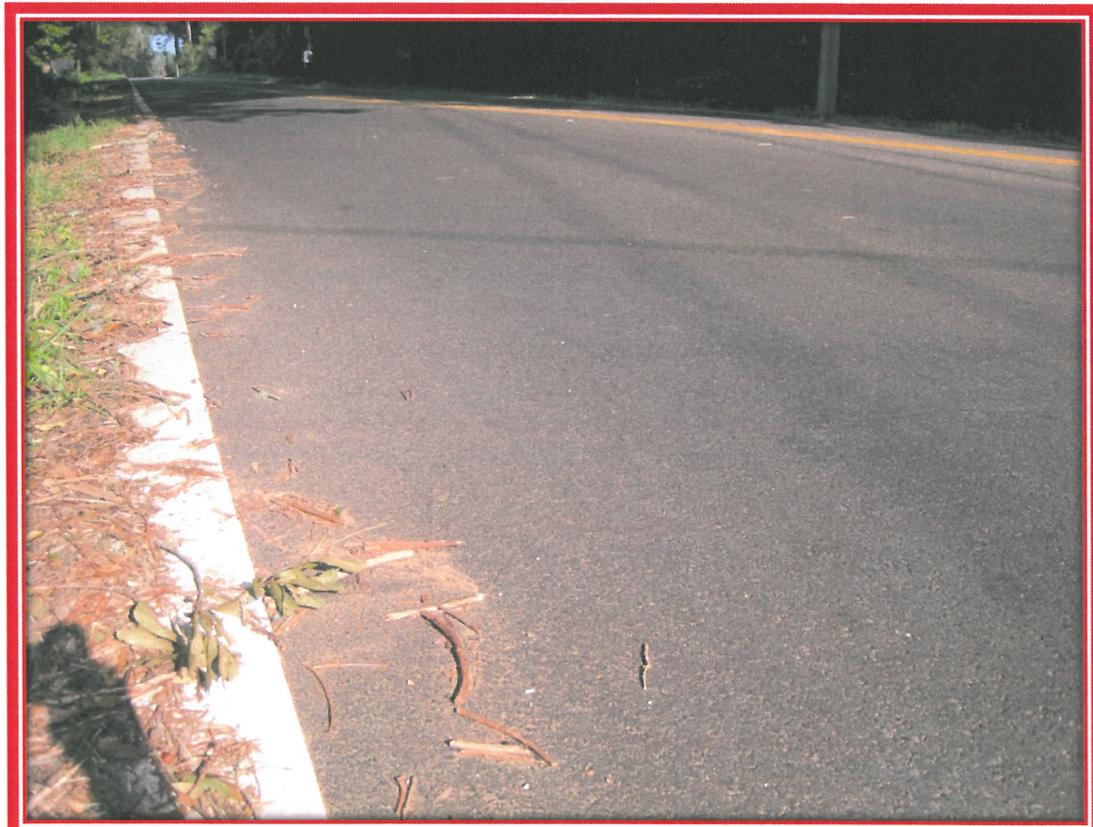
**FIGURE 7B: PHOTOGRAPH OF PAVEMENT CONDITIONS
ALONG RHODEN COVE ROAD**

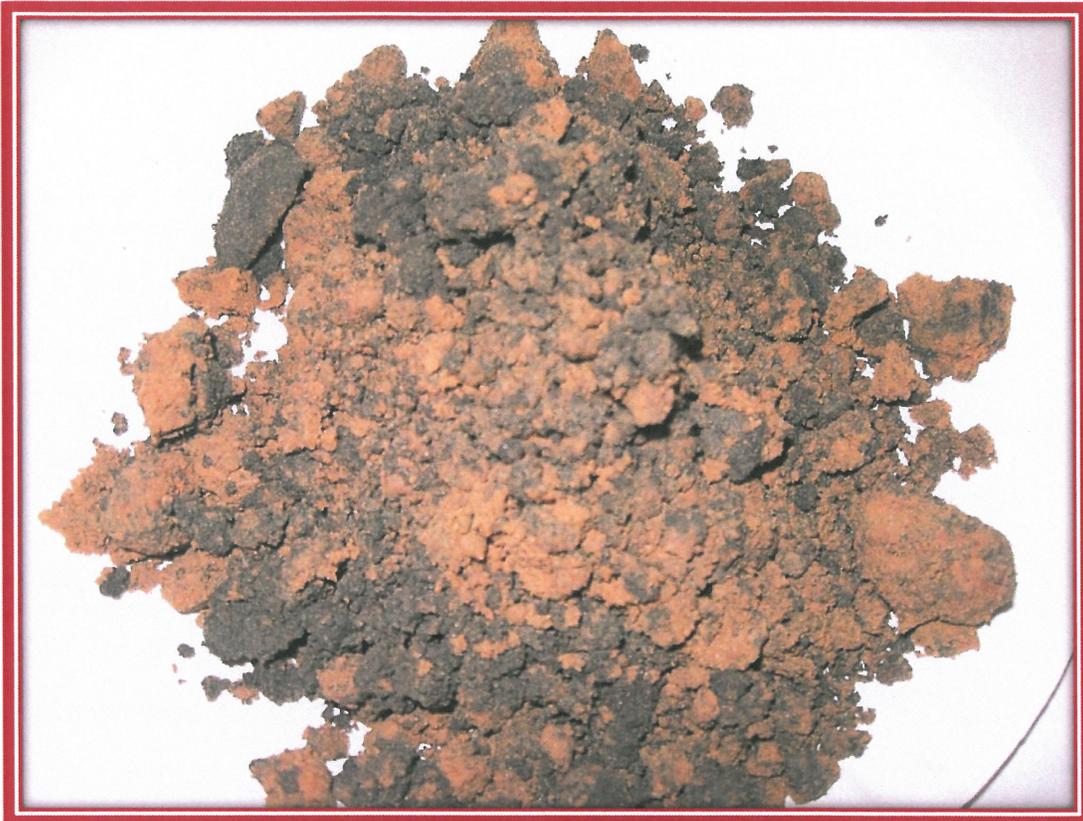
Base and Subgrade Conditions – As previously state herein, **DCP** tests were conducted on the base and subgrade materials at each pavement core location. Type-B Stabilization Base Material was encountered at each pavement core location. **EGS** recommends that the following classifications be used for the roadway base and subgrade:

**FIGURE 8A: PHOTOGRAPH OF BASE MATERIAL
AT PAVEMENT CORE RC-PC-1**

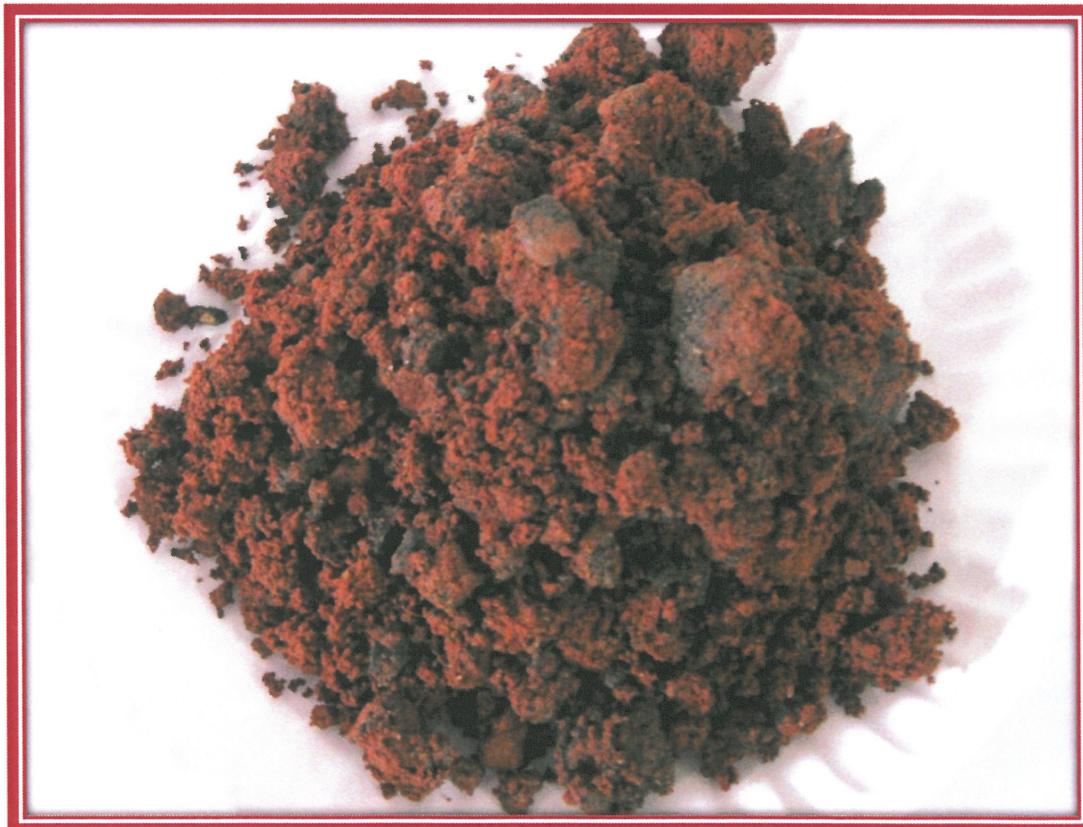
**FIGURE 8B: PHOTOGRAPH OF BASE MATERIAL
AT PAVEMENT CORE RC-PC-2**
