# **Water Quality Report For Selected Lakes and Streams**

**Leon County Public Works  
Division of Engineering Services**

**October 2010**

(Water Quality Data collected through December of 2009)

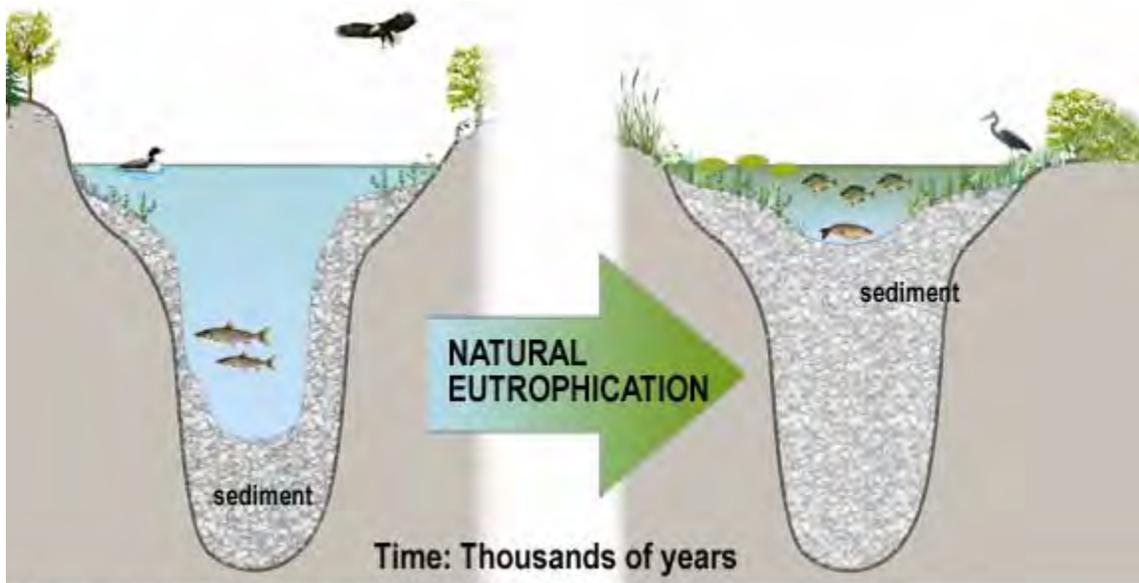
Cultural (or anthropogenic) eutrophication is caused by human activities accelerating eutrophication by increasing the rate at which nutrients enter the water (**Figure 3-2**). Increased levels of nutrients cause vascular plants (macrophytes) and algae to speed up their growth. The increased plants and algae increase oxygen output during the day, but utilize oxygen at night. If there are enough plants and algae in the lake, oxygen levels can be decreased to levels that will kill fish and other aquatic animals. As algae and plants die, they are decomposed by bacteria which release a portion of nutrients into the water. These bacteria also utilize oxygen in the water, which depresses oxygen levels in or directly above the sediment. The nocturnal use of oxygen by plants and algae in addition to excessive bacterial decomposition contributes to aquatic animal kills. As part of the decomposition process, plants and algae sink to the bottom of the lake and become part of the sediment. Eventually the lake starts to fill with sediment and in extreme cases will completely disappear (**Figure 3-2**).

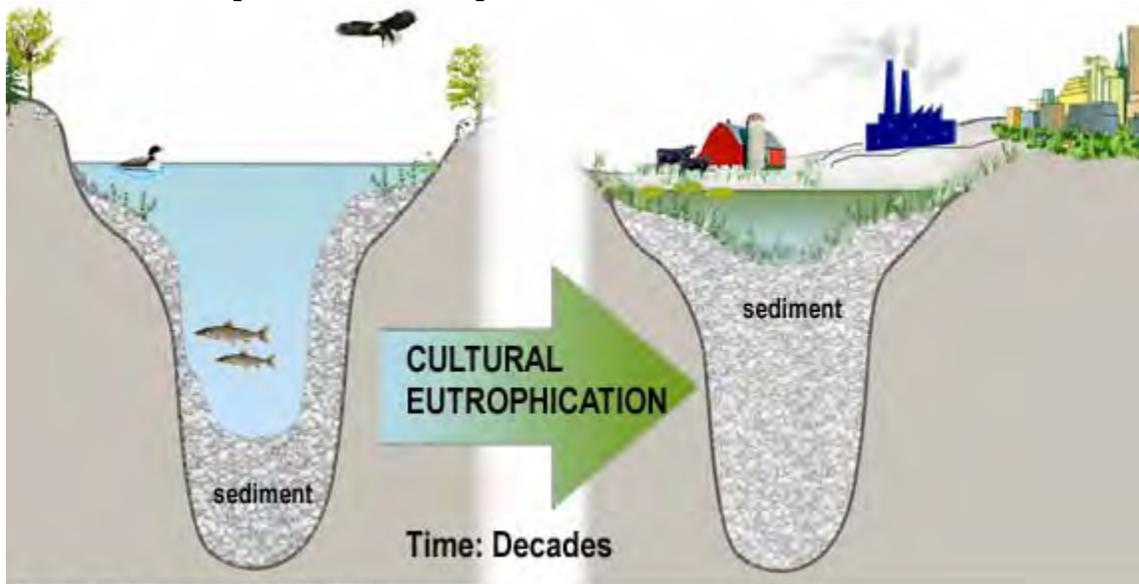
**FIG. 3-1. An example of natural eutrophication.**

Natural eutrophication is a gradual process by which lakes age and become more productive as the lake builds up concentrations of plant nutrients. This occurs when production and consumption within the lake become unbalanced and the lake slowly becomes overladen with nutrients. While not rare in nature, natural eutrophication normally takes thousands of years to progress (**Figure 3-1**).

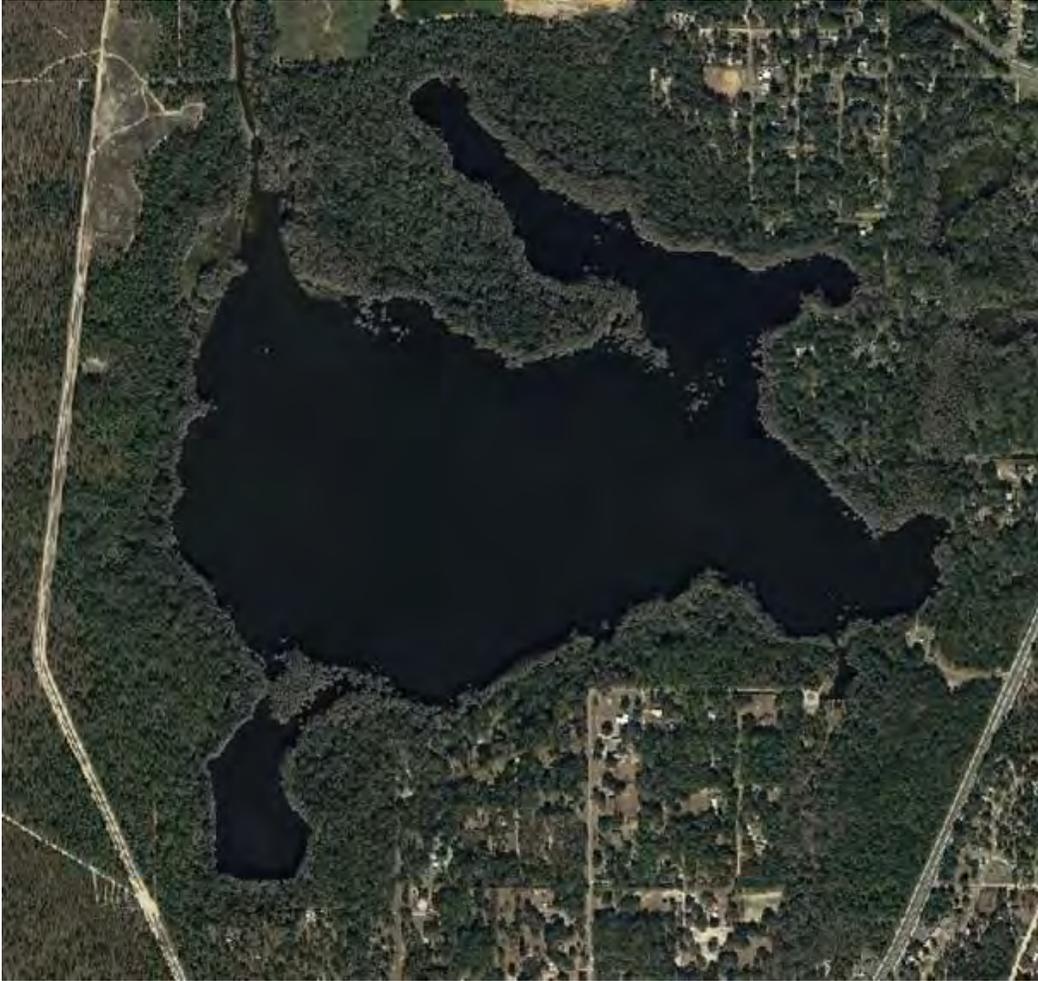
**FIG. 6-1. Lake Munson in a non algal bloom condition.**

Warm and calm waters with high levels of nutrients and low levels of turbidity and color are prime candidates for a bloom. These blooms can last weeks or months and turn the water bright green and can sometimes cause water to take on the appearance of green antifreeze. In most cases, blooms are most prevalent during the summer months and die back during the cold winter months.

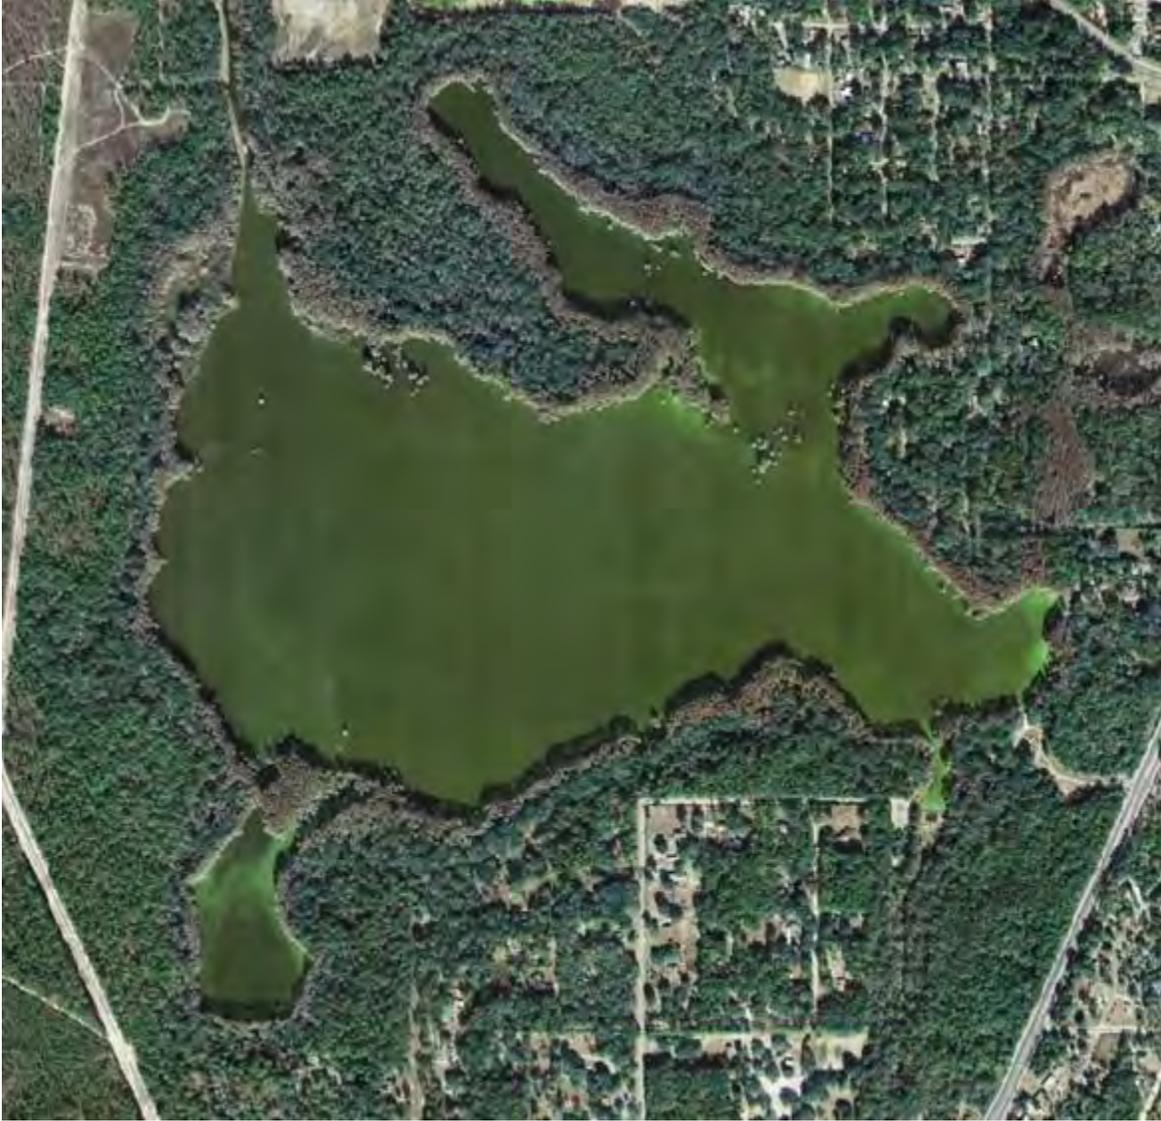
**FIG. 6-2 Lake Munson algal bloom.**

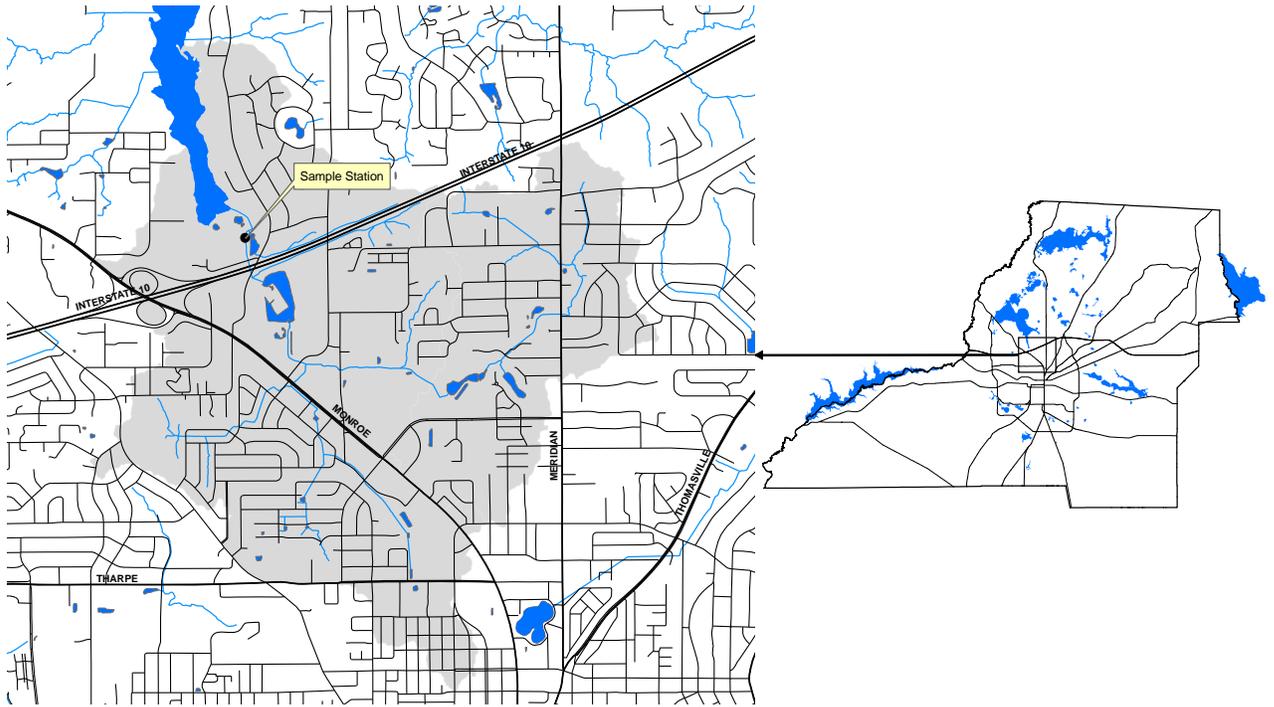
**FIG. 8.4-30. Overview Map of the Meginnis Creek Stream watershed.**

Meginnis Creek is a substantially altered, nitrogen limited stream located in the northern part of Tallahassee and drains into Lake Jackson (**Figure 8.4-30**).

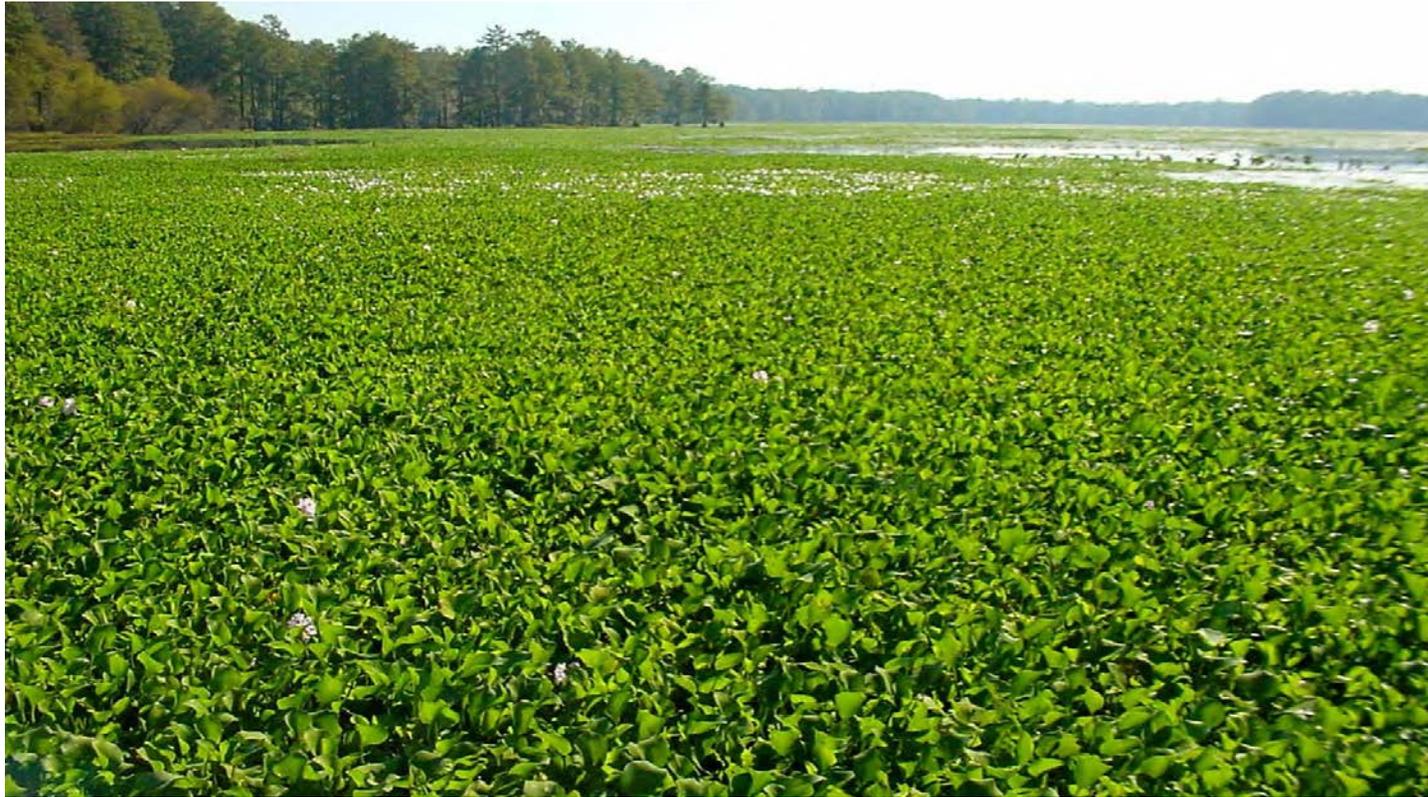
**FIG. 8.7-36. Lake Munson in October 2003. The water surface is dominated by water hyacinth (*Eichnorhiza crassipes*) a Category I Invasive Exotic.**

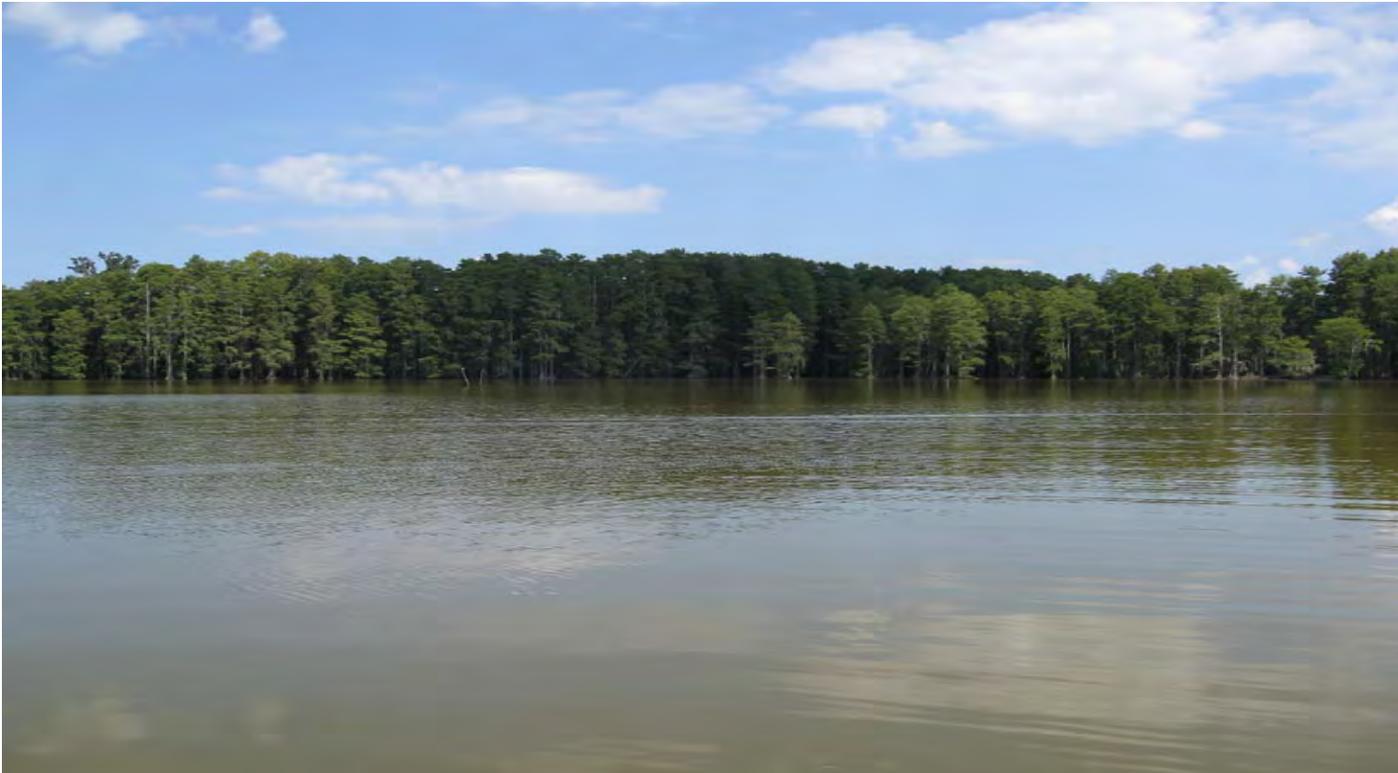
**FIG. 8.7-37. Lake Munson in August 2009. The water surface is completely devoid of aquatic plants.**
