Waterbody: Lake Cascade

Basin: Lake Munson

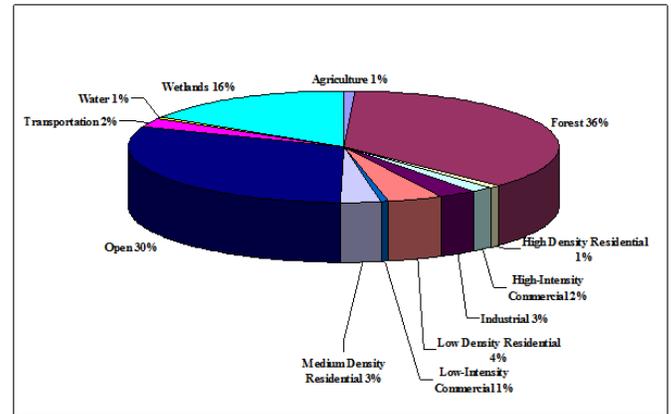
As shown in the following pie chart, approximately 17% of land uses in the 11,148 acre Bradford Brook watershed are agricultural, residential, industrial, commercial or transportation. Increases in stormwater runoff, and waterbody nutrient loads can often be attributed to these types of land uses.
