## Waterbody: Lake Miccosukee

## Basin: Lake Miccosukee

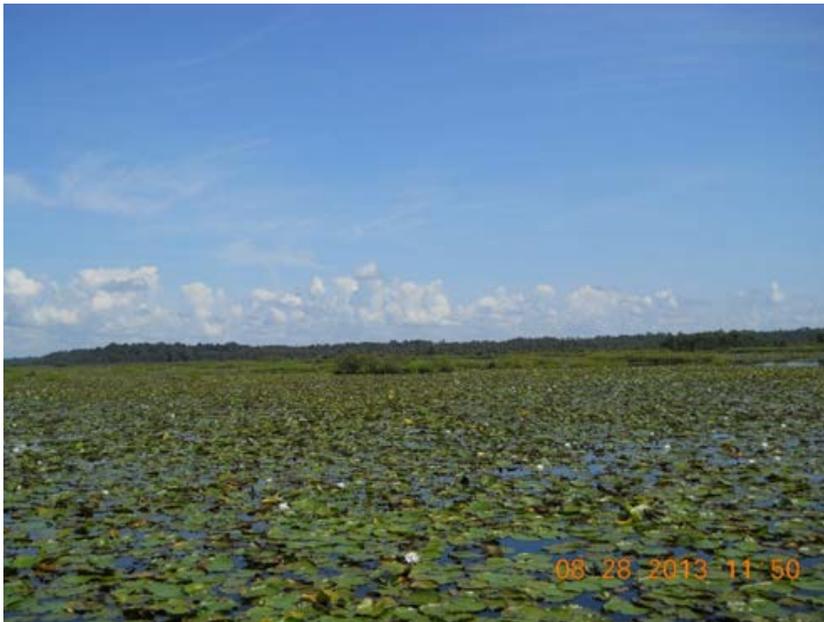
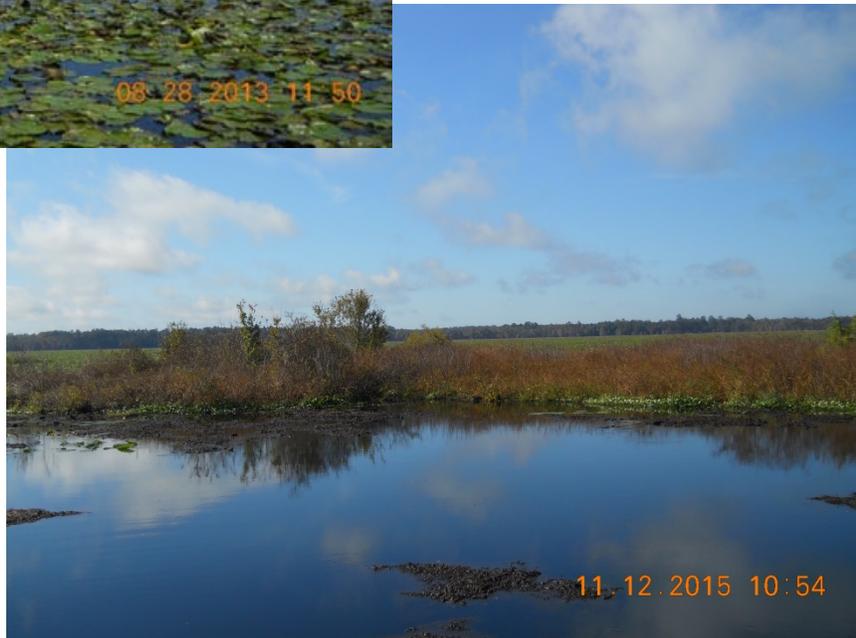
**Figure 1.** Station MI2. Note the open water that now surrounds the station.

No exceedances were noted, but chlorophyll-*a* values and total nitrogen values were elevated in 2013, possibly as a result of nutrient fluxes associated with the most recent lake refilling. Values in 2014 were slightly lower, but chlorophyll-*a* and total phosphorus values increased in 2015. Changes in the area around the station may have contributed to the change. Previously, the area in the vicinity of station MI2 was dominated by *Nymphaea odorata*, the fragrant water lily. Florida Fish and Wildlife contractors recently enlarged an open water area adjacent to the station that has now encompassed the station area (Figure 1). In this case, open water has allowed the algal population to increase causing higher

concentrations of chlorophyll-*a* and total phosphorus. Orthophosphate levels remain low.

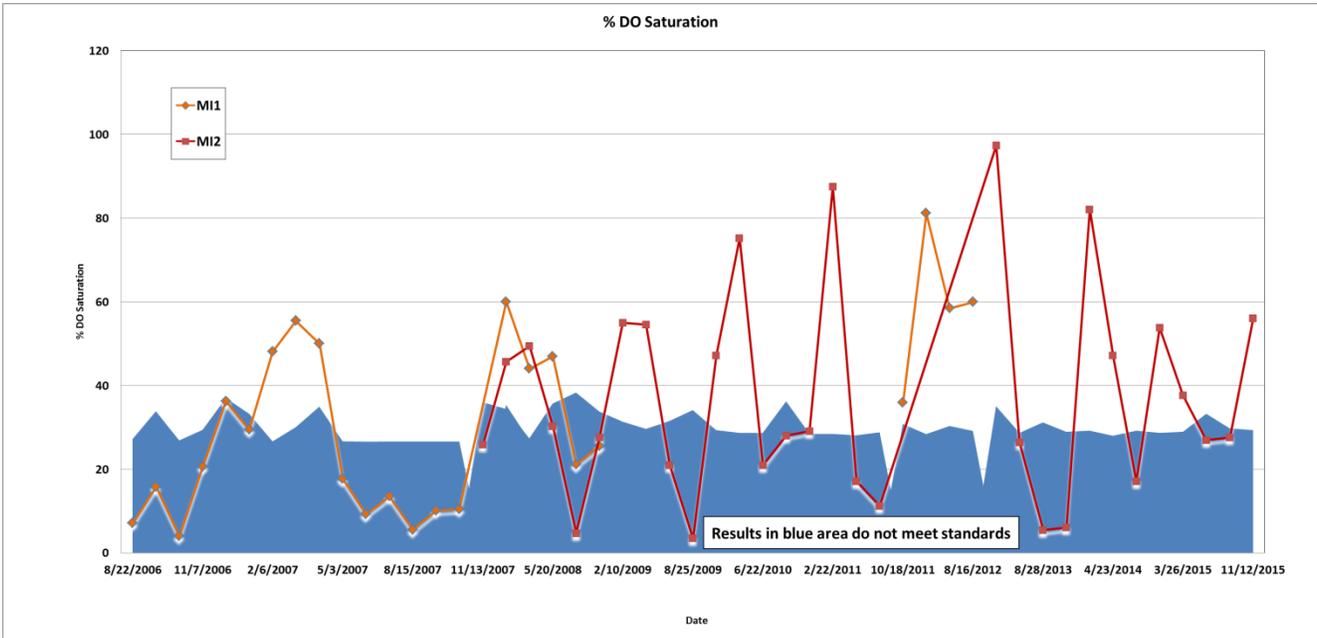
As Figure 2 shows, the Lake Miccosukee stations showed percent DO saturation values that did not meet Class III water quality criteria. Staff considers the low DO normal for this lake because the stations are shallow and normally covered with vegetation, preventing rapid water exchange with the larger area of the lake. Plant respiration (samples were often taken in the morning hours) and organic sediments also contributed to the low DO saturation values.

Figure 2. Dissolved Oxygen Percent Saturation results for Lake Miccosukee.
