Waterbody: Soapstone Creek

Basin: Ochlockonee River

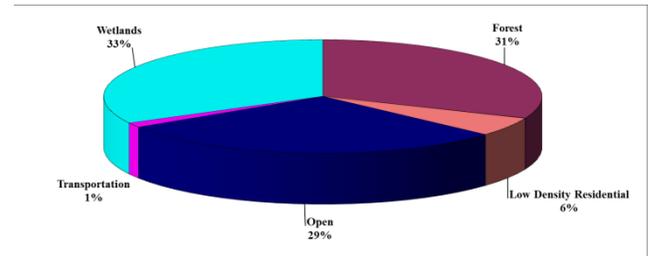
While the following pie chart shows the majority of the 5,301 acre watershed is relatively undeveloped, residential and transportation uses make up approximately 7% of the watershed. Increases in

stormwater runoff and waterbody nutrient loads can often be attributed to these types of land uses.

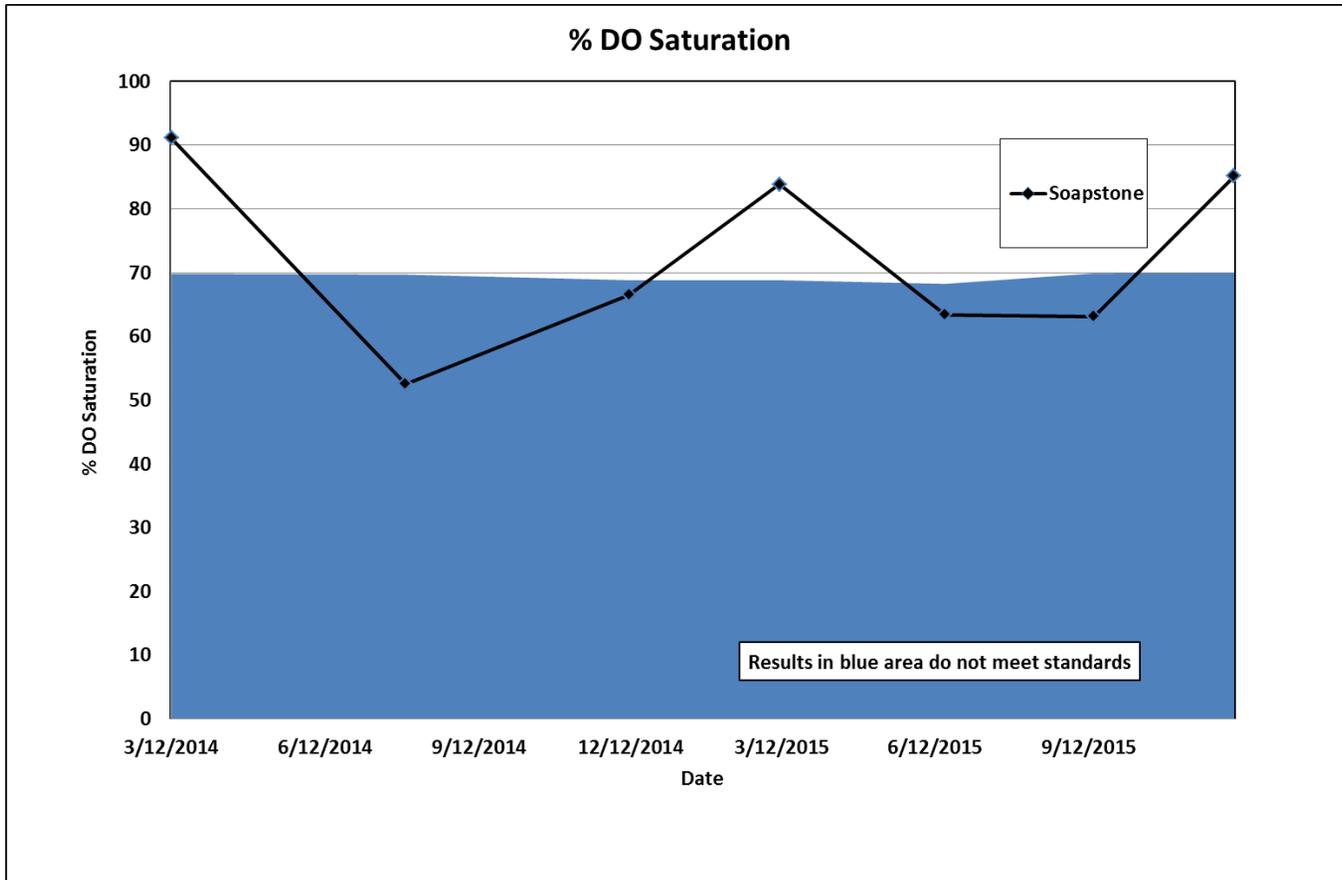
As Figure 1 shows, Soapstone Creek occasionally did not meet the Class III criteria for dissolved oxygen (DO). Staff believes that this is a natural condition for this location, since the creek is a low gradient blackwater stream that drains wetlands.

Figure 1. Dissolved Oxygen Percent Saturation results for Northeast Black Creek.

Based on ongoing sampling, Soapstone Creek met the nutrient thresholds for the East Panhandle Region. As a result of low flow, the Class III criterion for dissolved oxygen was not met during the sampling period. Other water quality parameters appear to be normal for the area and no impairments were noted.
