## Waterbody: Lake Lafayette

## Basin: Lake Lafayette

Lake Lafayette was historically a meandering, wetland/prairie lake system located in eastern Leon County, but land alterations in the mid-1900s separated the lake into four distinct sections, known as Upper Lake Lafayette, Lake Piney Z, Alford Arm, and Lower Lake Lafayette. Limited hydraulic connectivity occurs between the various sections, much of which is present only during high water elevations. Because of the compartmentalization of the four sections, each section is treated as a separate “lake” with its own watershed.

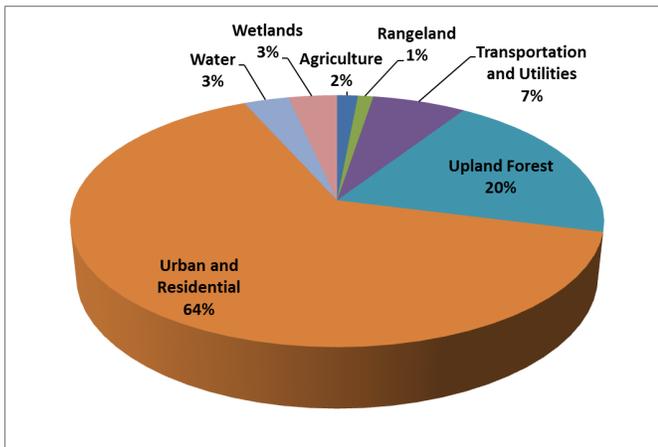
As shown in the following pie chart, agriculture, rangeland, transportation, utilities, urban and residential uses make up approximately 74% of the 14,792-acre Upper Lake Lafayette watershed. Increases in stormwater runoff and waterbody nutrient loads can often be attributed to these types of land uses.

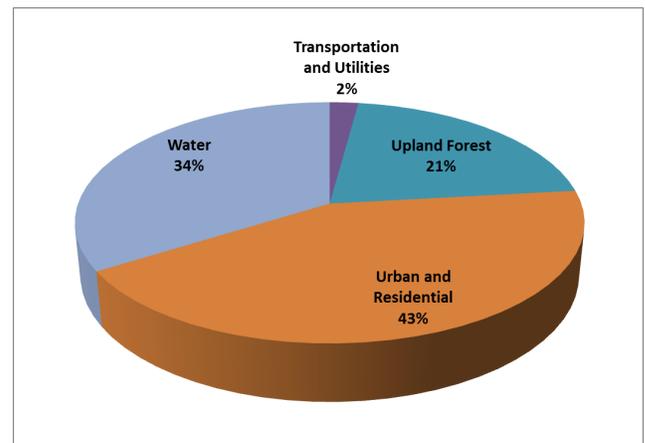
As shown in the following pie chart, transportation, utilities, urban and residential land uses make up approximately 45% of the 691-acre Piney Z watershed. Increases in stormwater runoff and waterbody nutrient loads can often be attributed to these types of land uses.

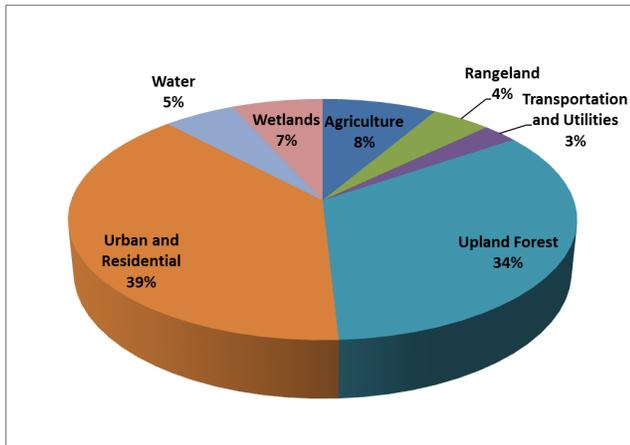
As shown in the following pie chart, agriculture, rangeland, transportation, utilities, urban and residential uses make up approximately 54% of the 36,966-acre Lower Lake Lafayette watershed. Increases in stormwater runoff and waterbody nutrient loads can often be attributed to these types of land uses.

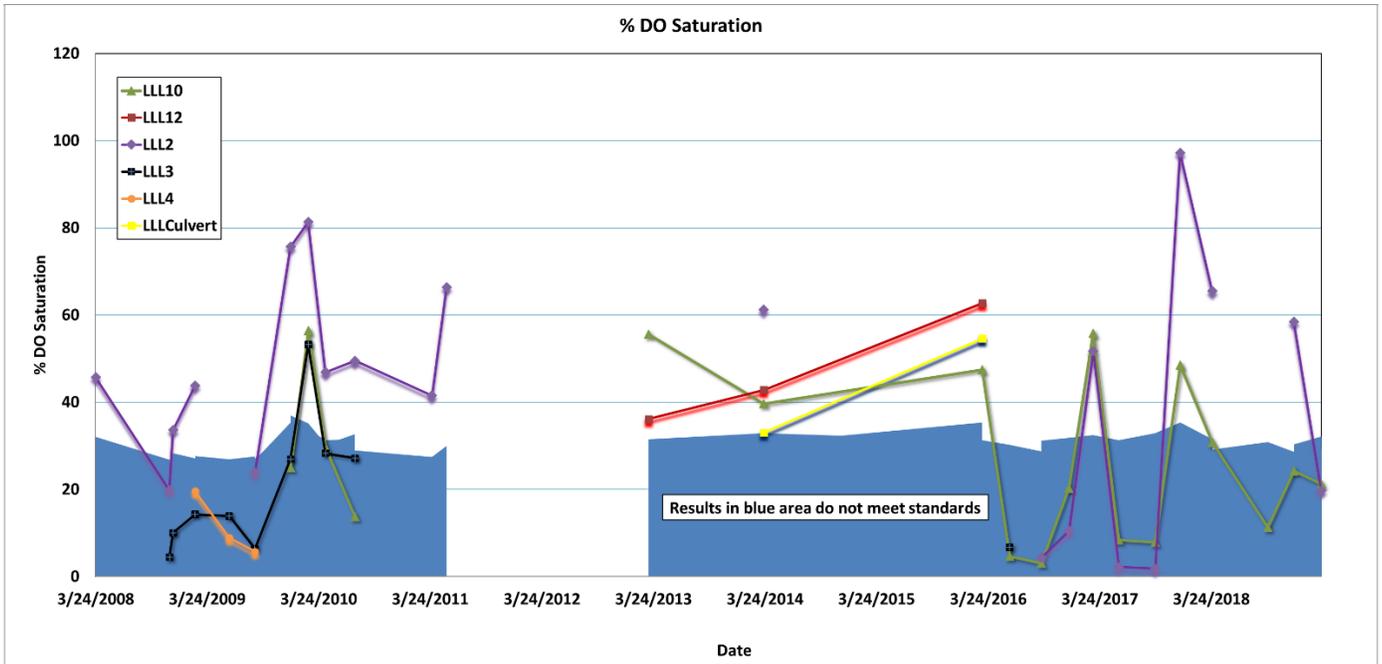
Figure 1. Dissolved Oxygen Percent Saturation results for Lower Lake Lafayette. The data gap reflects low (or no) water in the lake at that time.

Due to the wetland like nature of Lower Lake Lafayette, dissolved oxygen (DO) levels can be very low. Staff considers the low DO levels normal for this type of system (Figure 1).

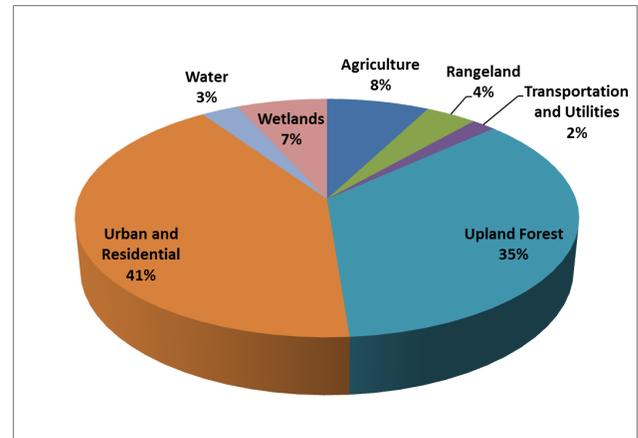
Alford Arm is a 371-acre waterbody which was separated from Lower Lake Lafayette by construction of the CSX Railroad. As shown in the following pie chart, agriculture, rangeland, transportation, utilities, urban and residential uses make up approximately 55% of the 30,116-acre Alford Arm watershed. Increases in stormwater runoff and waterbody nutrient loads can often be attributed to these types of land uses.
