Waterbody: Lake Miccosukee

Basin: Lake Miccosukee

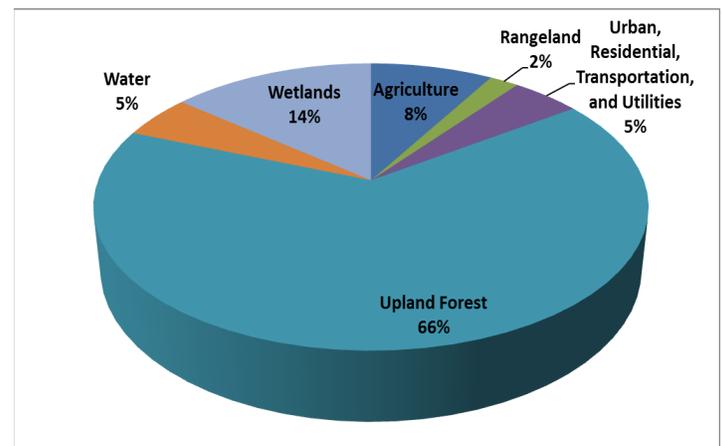
As shown in the following pie chart, approximately 15% of land use in the 147,861-acre Lake Miccosukee basin is agriculture, rangeland, transportation, utilities, urban and residential. Increases in stormwater runoff and waterbody nutrient loads can often be attributed to these types of land uses.

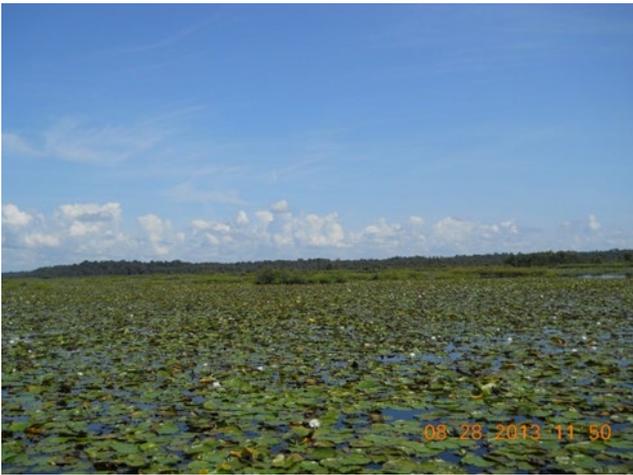
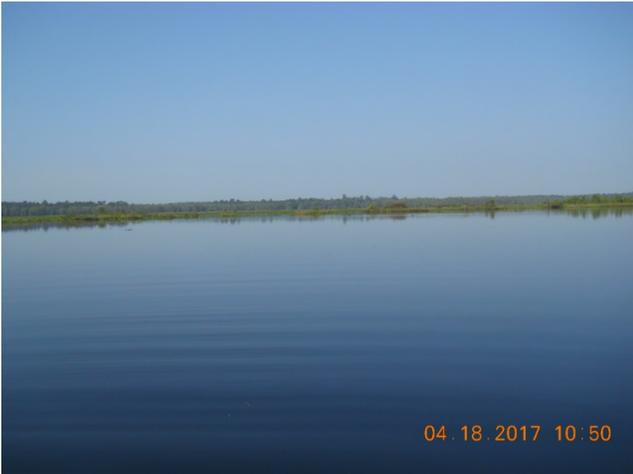
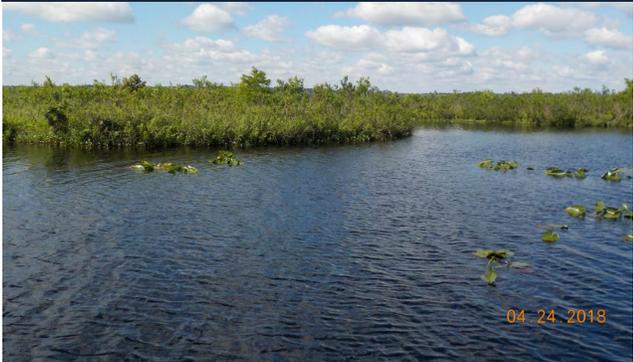
Figure 1. Station MI2. Note the open water surrounding the station in the second photo and the floating tussock islands in the third photo.

No exceedances were noted, but chlorophyll-*a* values and total nitrogen values were elevated in 2013, possibly as a result of nutrient fluxes associated with the most recent lake refilling. Values in 2014 were slightly lower, but chlorophyll-*a* and total phosphorus values increased in 2015. Sampling conditions prevented sampling during the 2nd quarter of 2016, but based on three samples, chlorophyll-*a* (13.0 µg/L) and total nitrogen (0.79 mg/L) levels were similar to what was seen in 2015. Total phosphorus levels (0.03 mg/L) had decreased to 2014 levels. Nutrient and chlorophyll-*a* levels in 2017 were similar to what was found in 2014 with lower or similar levels in 2018 and 2019. Changes in the area around the station may have contributed to changes in nutrient concentrations. Previously, the area in the vicinity of station MI2 was dominated by *Nymphaea odorata*, the fragrant water lily. Florida Fish and Wildlife (FWC) contractors enlarged an open water area adjacent to the station that has now encompassed the station area (Figure 1, photo two). More recently, floating tussock islands have formed, or floated into the sampling area (Figure 1, photo three). Because of the anthropogenic

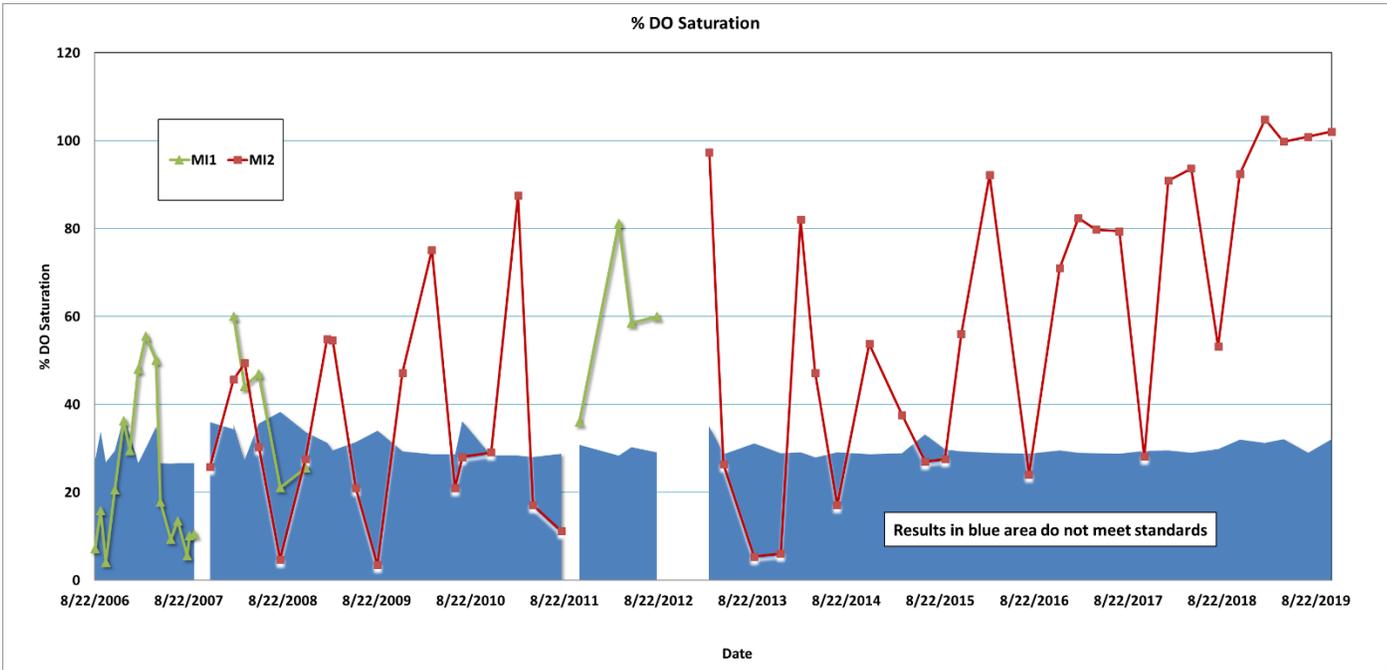
As Figure 2 shows, the Lake Miccosukee stations showed percent DO saturation values that did not

meet Class III water quality criteria. Staff considers the low DO normal for this lake because the stations are shallow and normally covered with vegetation, preventing rapid water exchange with the larger area of the lake. Plant respiration (samples were often taken in the morning hours) and organic sediments also contributed to the low DO saturation values. Because station MI2 has become less vegetated, more water circulation is occurring along with less plant respiration, thus allowing DO saturation values to increase.

Figure 2. Dissolved Oxygen Percent Saturation results for Lake Miccosukee. Gaps in the data are due to low water, preventing sampling.
