Waterbody: Lake McBride

Basin: Lake Lafayette

Lake McBride is a 183 acre lake located in northern Leon County.

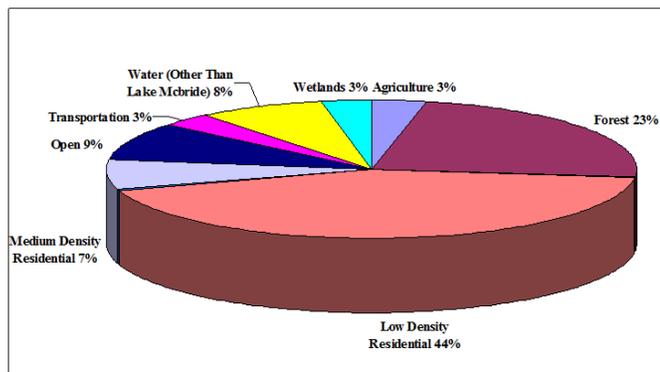
As shown in the following pie chart, approximately 57% of land use in the 1,210 acre Lake McBride watershed is agricultural, residential, or transportation. Increases in stormwater runoff and waterbody nutrient loads can often be attributed to these types of land uses.

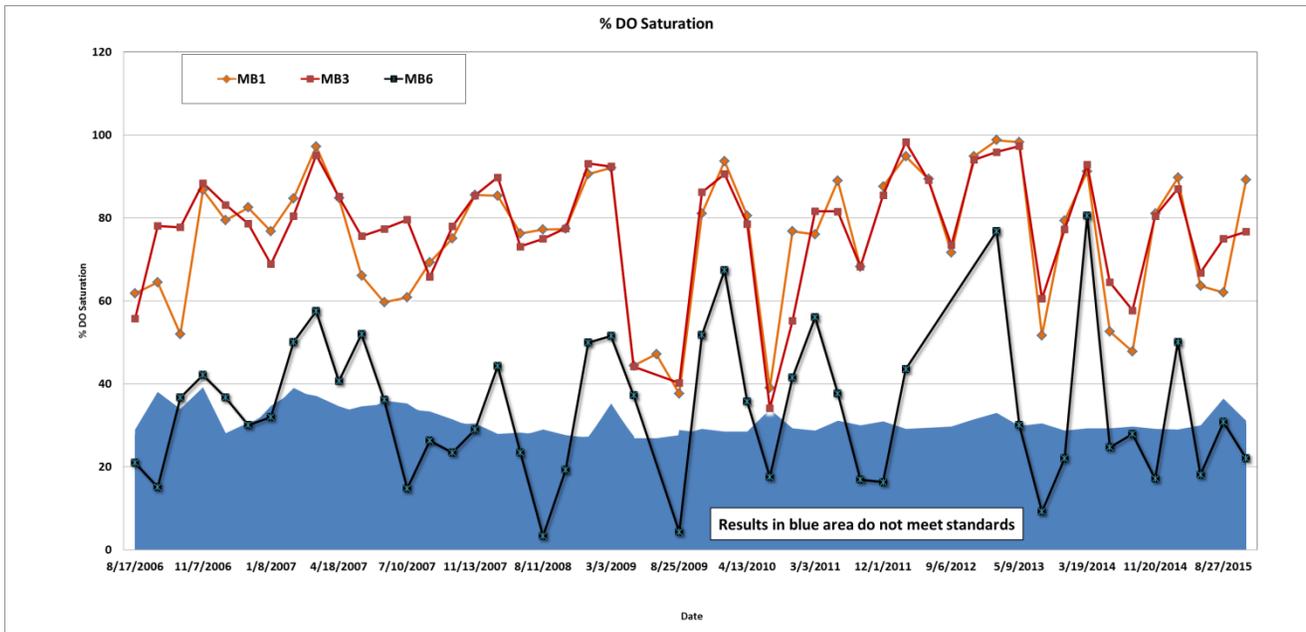
Figure 1. Dissolved Oxygen Percent Saturation results for Lake McBride.

Station MB6 percent dissolved oxygen (DO) saturation values were below Class III criteria during certain events. This was not unexpected, since this station, located in the southwest quadrant of the lake, is shallow and covered with vegetation, which prevents rapid water exchange with the larger area of the lake. Plant respiration (samples were often taken in the morning hours) also contributed to the low DO saturation values. Staff believes that this is a natural condition for this location.

Based on ongoing sampling, Lake McBride met the nutrient thresholds for the East Panhandle Region; and the floral community is considered “healthy” by the LVI. Staff considers the low DO results at Station MB6 a natural condition. Other water quality parameters appear to be normal for the area and no impairments were noted.
