Waterbody: Lake Munson

Basin: Lake Munson

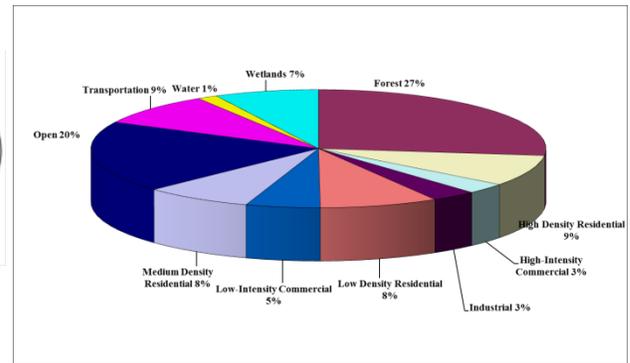
As shown in the following pie chart, approximately 45% of land use in the 42,526 acre Lake Munson basin is industrial, commercial, residential, or transportation. Increases in stormwater runoff and waterbody nutrient loads can often be attributed to these types of land uses.

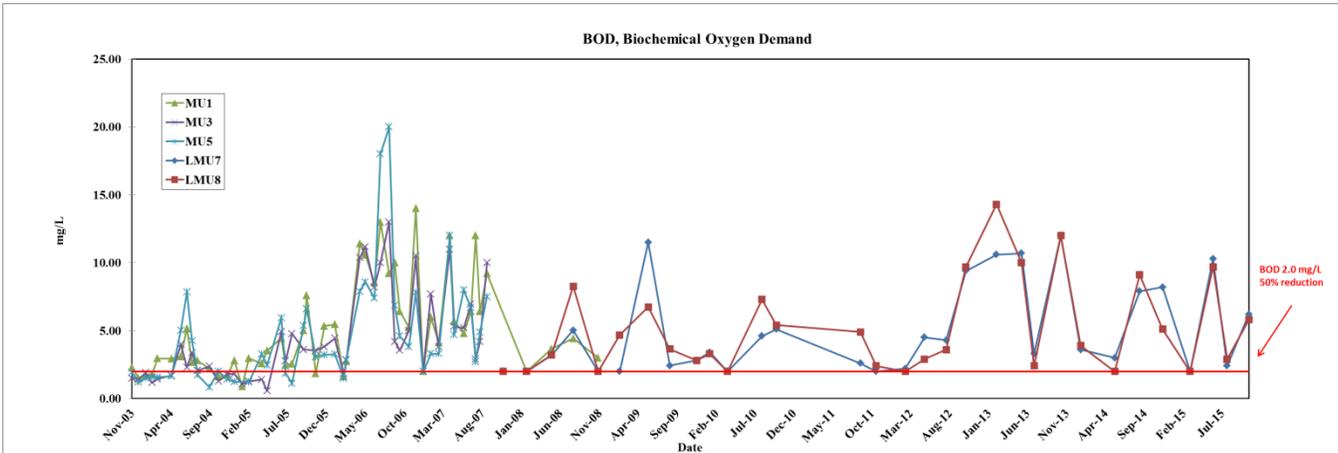
Figure 1. BOD results for Lake Munson.

While the lake drawdown appeared to consolidate the sediment, there seems to have been little to no effect regarding nutrient reduction in the water column. As shown in Figures 1 through 4, BOD, total nitrogen, total phosphorus and turbidity levels are consistently above the TMDL limits. Algal blooms, represented by chlorophyll-*a* (Figure 5), also

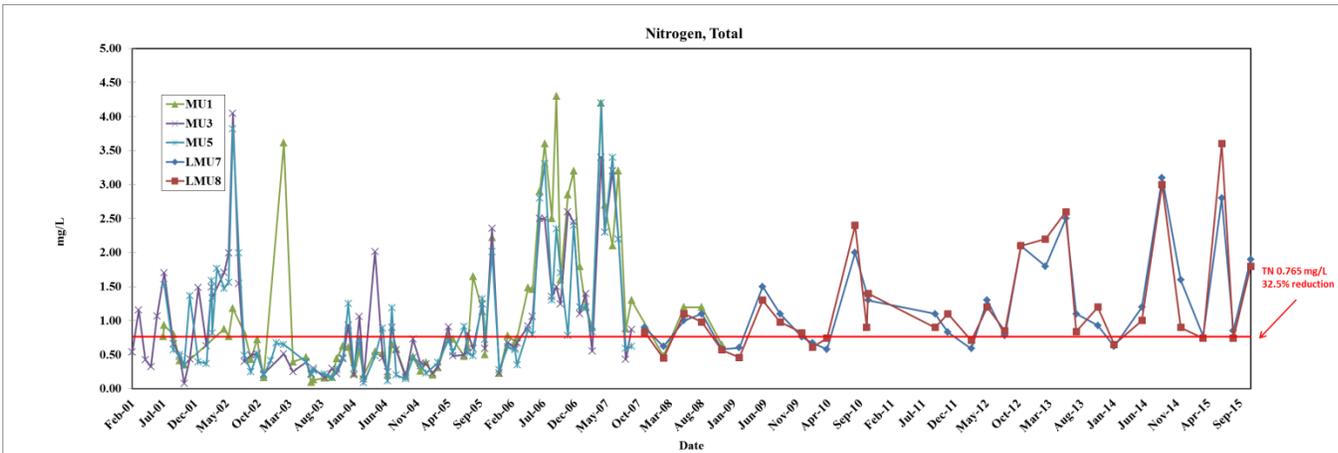
Figure 2. Total Nitrogen results for Lake Munson.

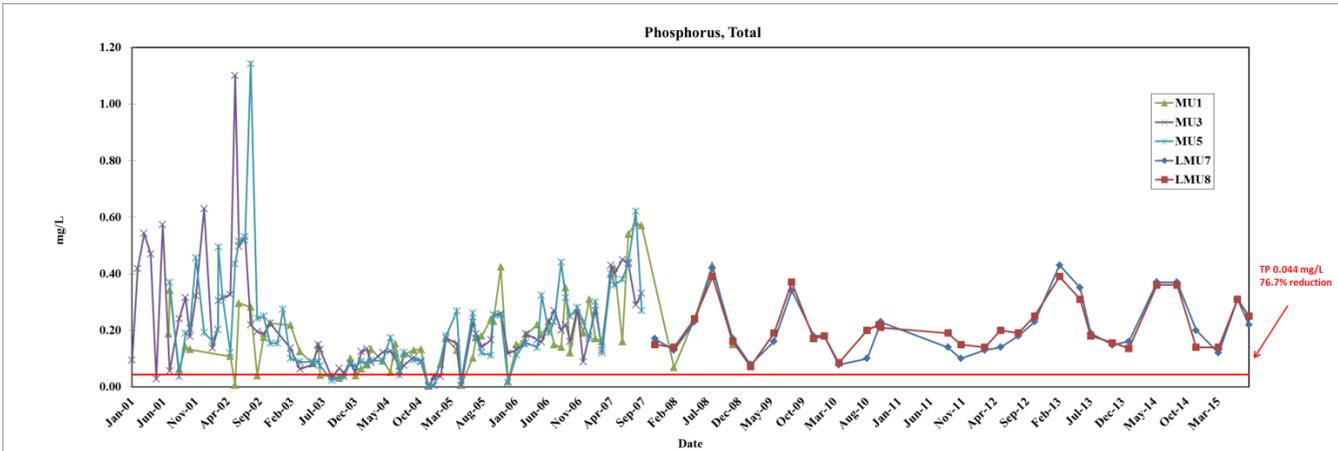
Figure 3. Total phosphorus results for Lake Munson.

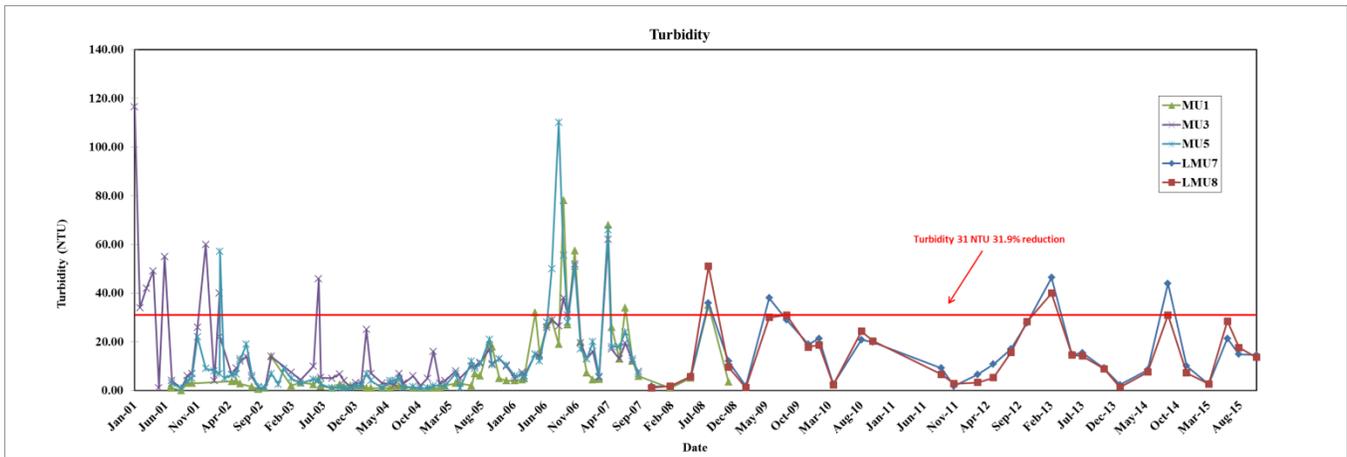
Figure 4. Turbidity results for Lake Munson.

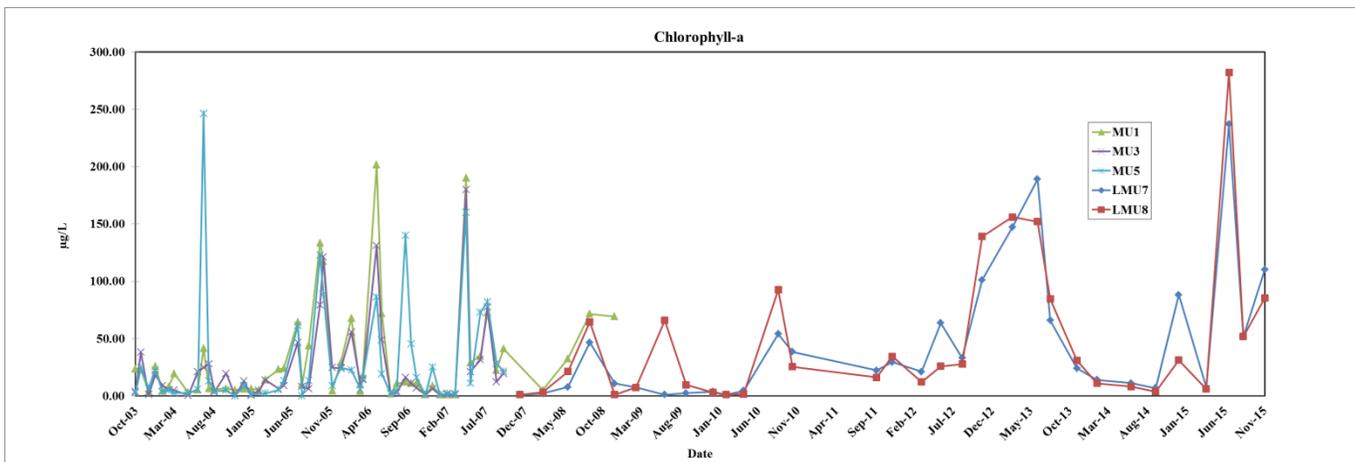
Figure 5. Chlorophyll-a results for Lake Munson.

continue to be a problem in Lake Munson. FDEP analysis determined that samples taken from the algal blooms that occurred in February and June of 2013 were dominated by *Microcystis* sp., a known toxin producer. FDEP confirmed that microcystin toxin was being released at the time of the algal blooms.
