Waterbody: Panther Creek

Basin: Lake Miccosukee

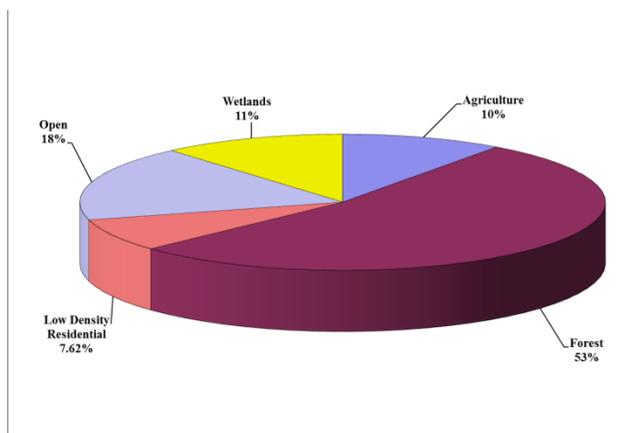
As shown in the following pie chart, approximately 18% of land use in the 2,580 acre watershed is agricultural or residential. Increases in stormwater runoff and waterbody nutrient loads can often be attributed to these types of land uses.
