Waterbody: Lake Miccosukee

Basin: Lake Miccosukee

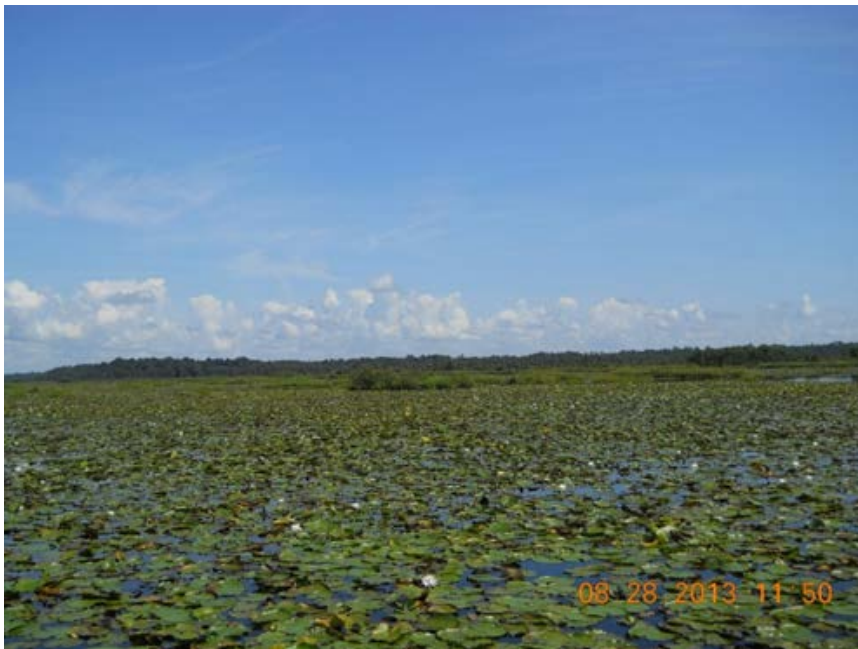
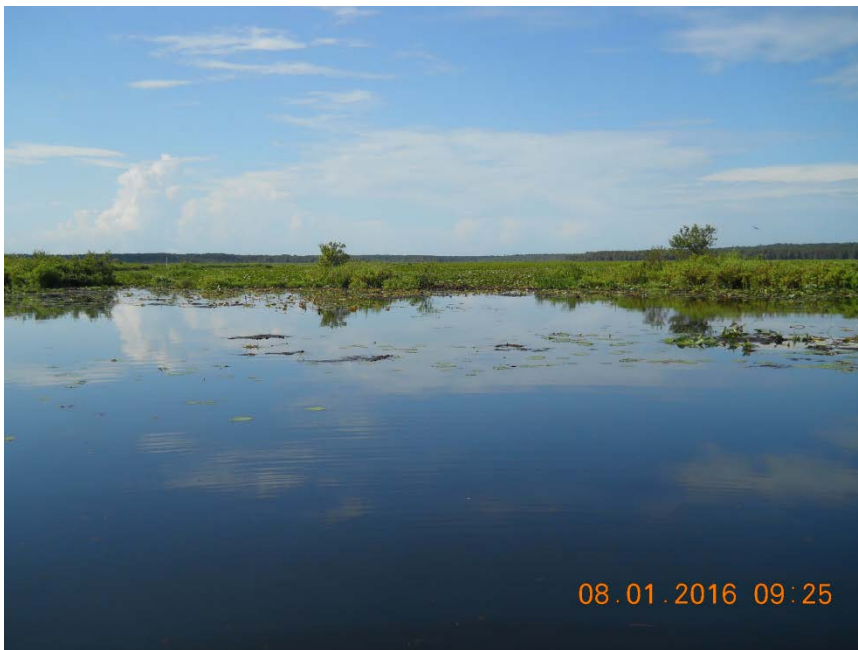
Figure 1. Station MI2. Note the open water that now surrounds the station.

Based on ongoing sampling, Lake Miccosukee met the nutrient thresholds for the East Panhandle Region. Changes in the plant community may be influencing nutrient and chlorophyll-*a* levels at station MI2. Percent DO saturation values did not always meet Class III water quality criteria. This was not unexpected and staff considers this normal for this lake. Other water quality parameters appear to be normal for the area and no other impairments were noted.

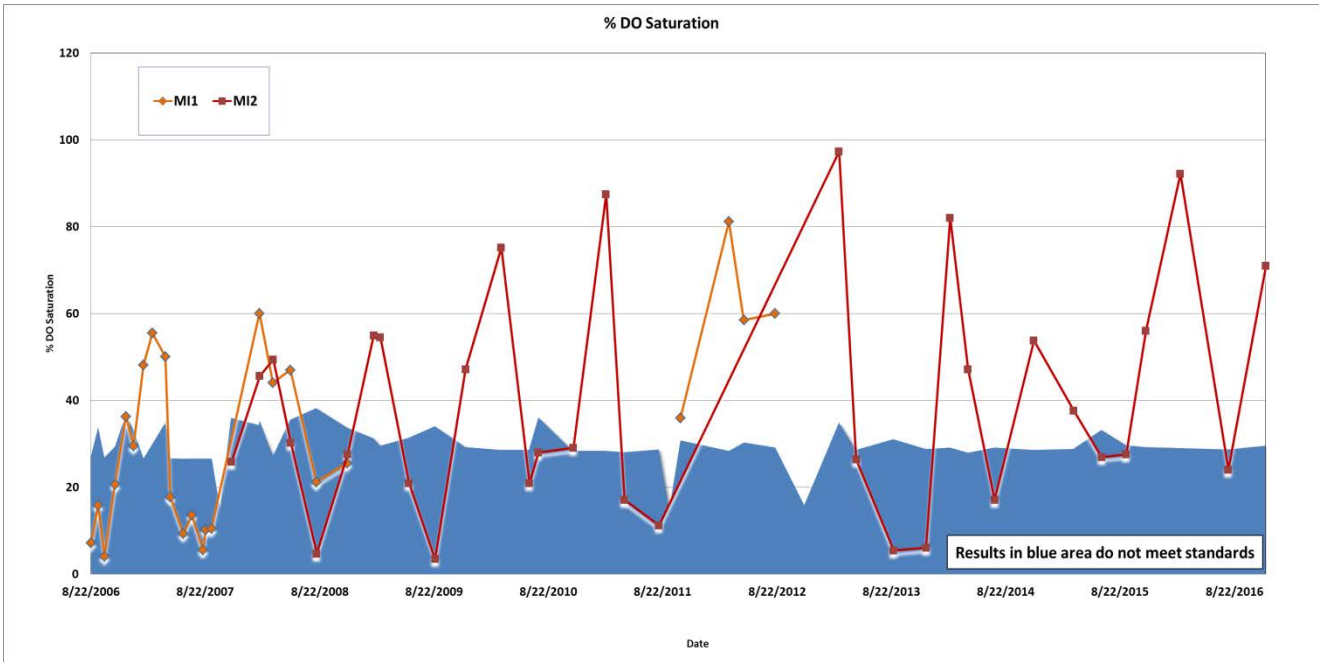
As Figure 2 shows, the Lake Miccosukee stations showed percent DO saturation values that did not meet Class III water quality criteria. Staff considers the low DO normal for this lake because the stations are shallow and normally covered with vegetation, preventing rapid water exchange with the larger area of the lake. Plant respiration (samples were often taken in the morning hours) and organic sediments also contributed to the low DO saturation values.

Figure 2. Dissolved Oxygen Percent Saturation results for Lake Miccosukee.
