Waterbody: Lake Bradford

Basin: Lake Munson

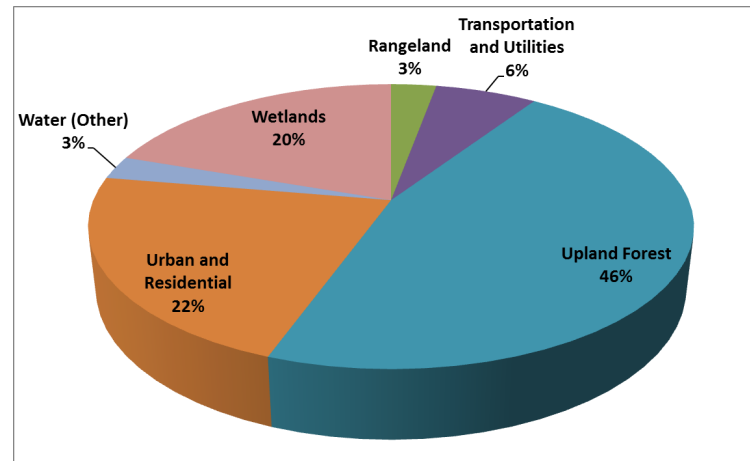
As shown in the pie chart, approximately 31% of land uses in the 17,637-acre Bradford Brook watershed are rangeland, transportation, utilities, urban and residential. Increases in stormwater runoff and waterbody nutrient loads can often be attributed to these types of land uses.
