Fisher Creek EcoSummary

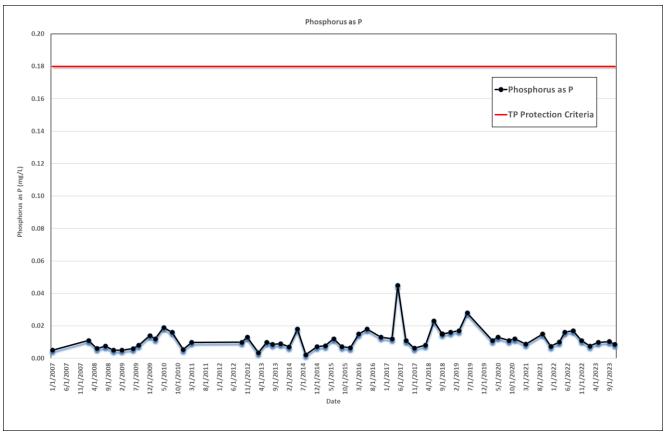
Figure 2. Total phosphorus results for Fisher Creek.

When data requirements were met (e.g., four samples collected in a calendar year), nutrient values were shown to not exceed the state criteria. For illustrative purposes, individual data points were plotted to determine any possible trends (**Figures 2 and 3**). Individual values did not exceed the instream criteria for total phosphorus and rarely exceeded total nitrogen criteria.

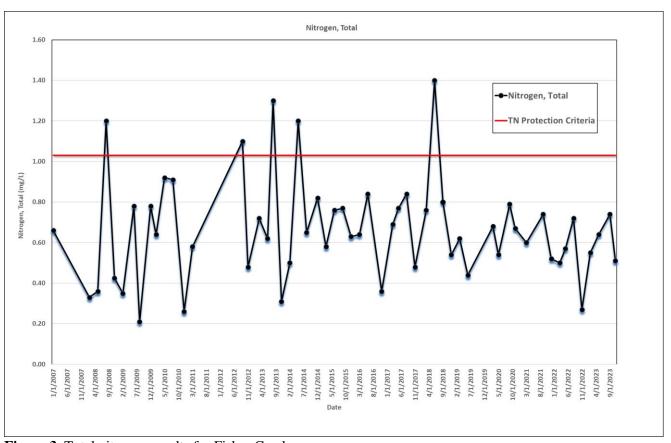
Figure 3. Total nitrogen results for Fisher Creek.
