Lexington Creek EcoSummary

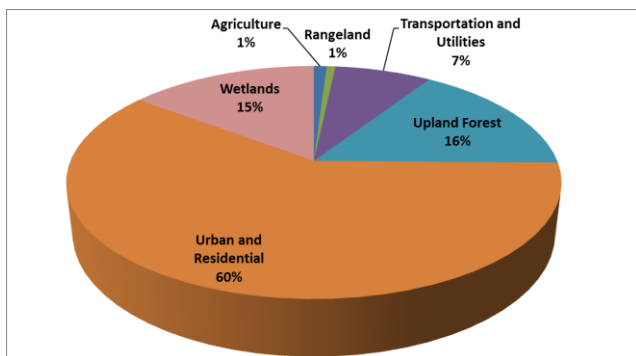
Figure 1. Lexington Creek watershed land use.

As shown in **Figure 1**, agriculture, rangeland, transportation, utilities, urban and residential uses make up approximately 69% of the 1,786-acre watershed. Increases in stormwater runoff and waterbody nutrient loads can often be attributed to these types of land uses.

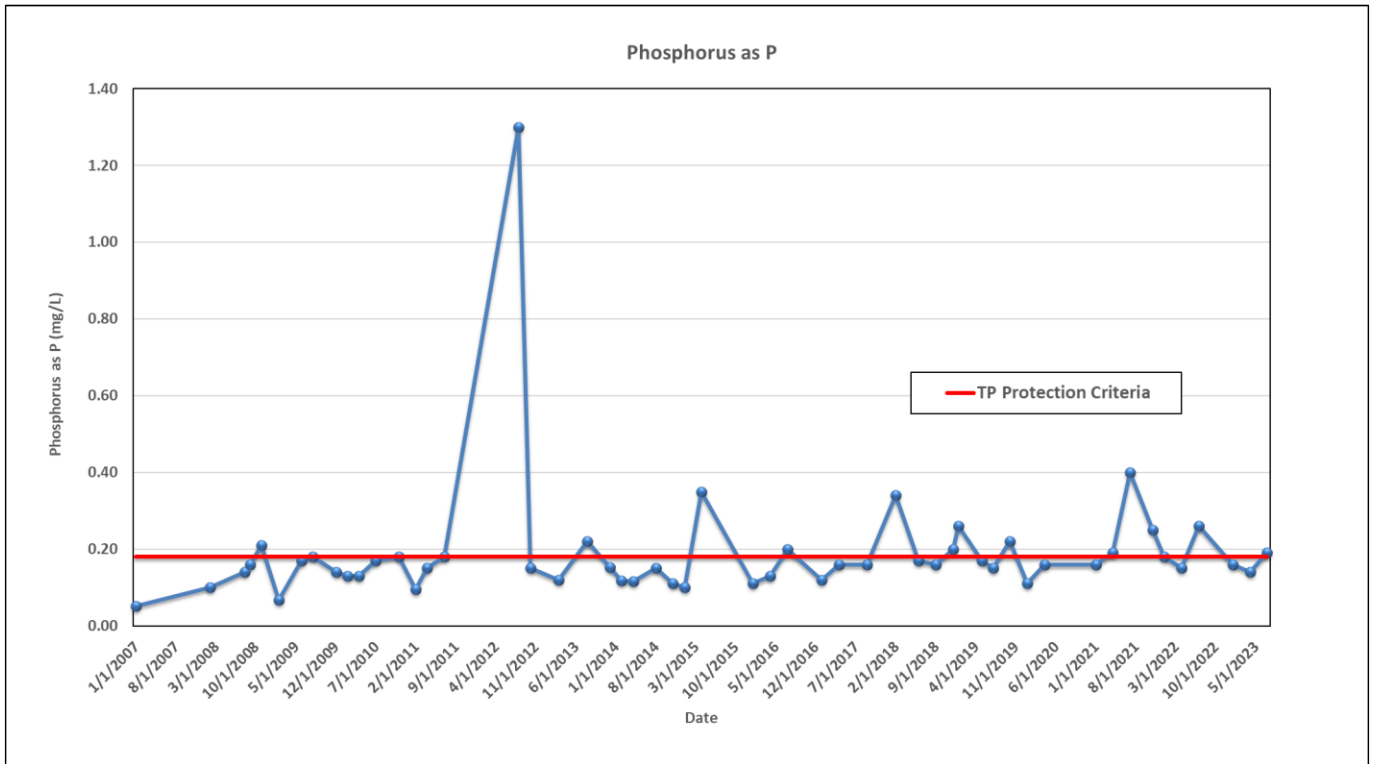
Figure 2. Total Phosphorus values in Lexington Creek.

This is not completely unexpected. Individual values were sometimes elevated during the sampling period (**Figure 2**). For example, due to a rainfall event that flushed phosphorus-laden sediment into the creek, the August 2012 Total Phosphorus value (1.3 mg/L) was substantially higher than all other phosphorus values recorded at this site.

The unusually high nitrogen and phosphorus levels during the August 2012 event can be attributed to stormwater runoff associated with the heavy rainfall in the area prior to the sampling event. The effects were probably more acute due to the previously dry streambed conditions and the associated floodplain being inundated within a short time from runoff.

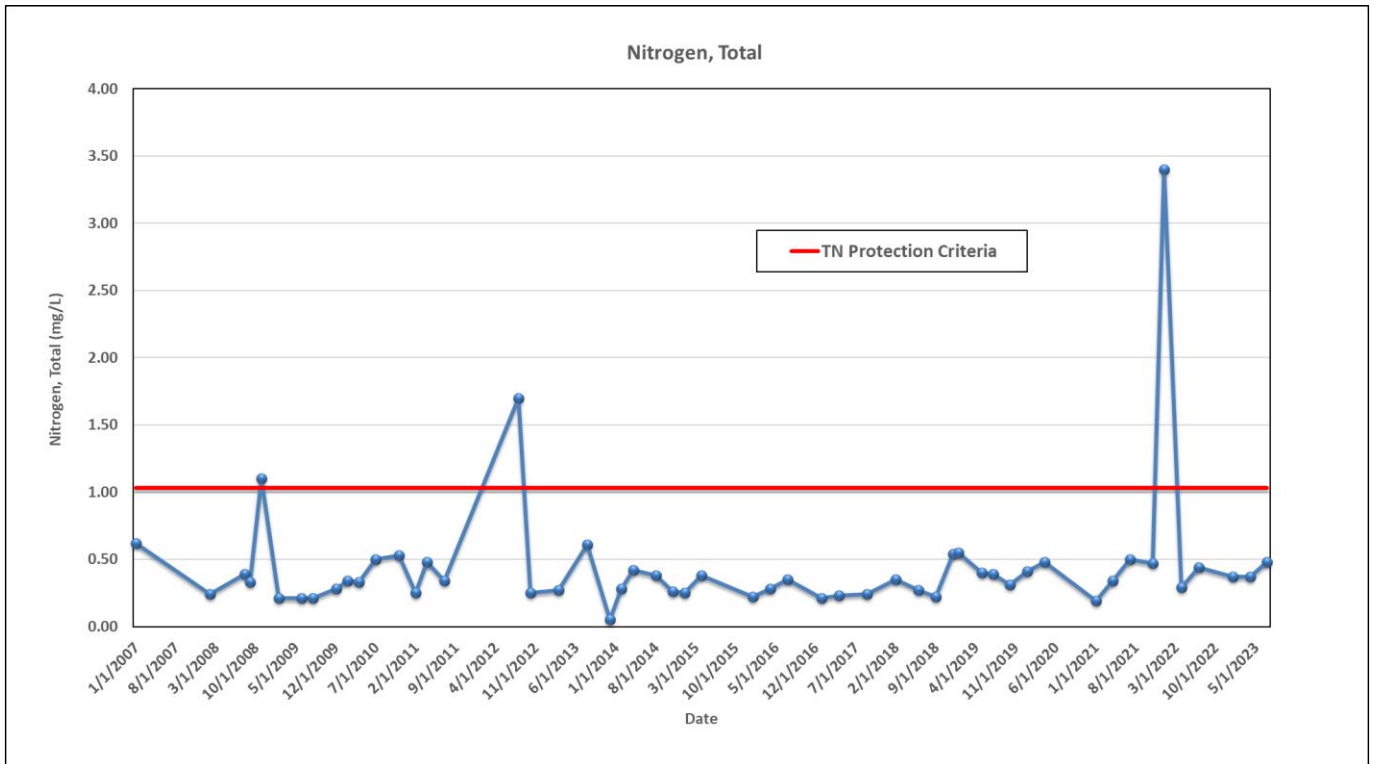
Figure 3. Total Nitrogen values in Lexington Creek.

The Total Nitrogen results over the entire sampling period did not exceed FDEP’s 1.03 mg/L threshold value. But individual nitrogen levels have occasionally been exceeded since sampling began (**Figure 3**). One exceedance occurred during the same previously mentioned August 2012 sampling event (1.7 mg/L); others include the November 2008 sampling event (1.1 mg/L), and the January 2022 sampling event (3.40 mg/L).

Interestingly enough, with the exception of nitrogen, water quality parameter results during the January 2022 event appeared normal; the excessive nitrogen amount could be attributed to organic detritus (e.g., leaf particles) being inadvertently collected in the sampling bottle.

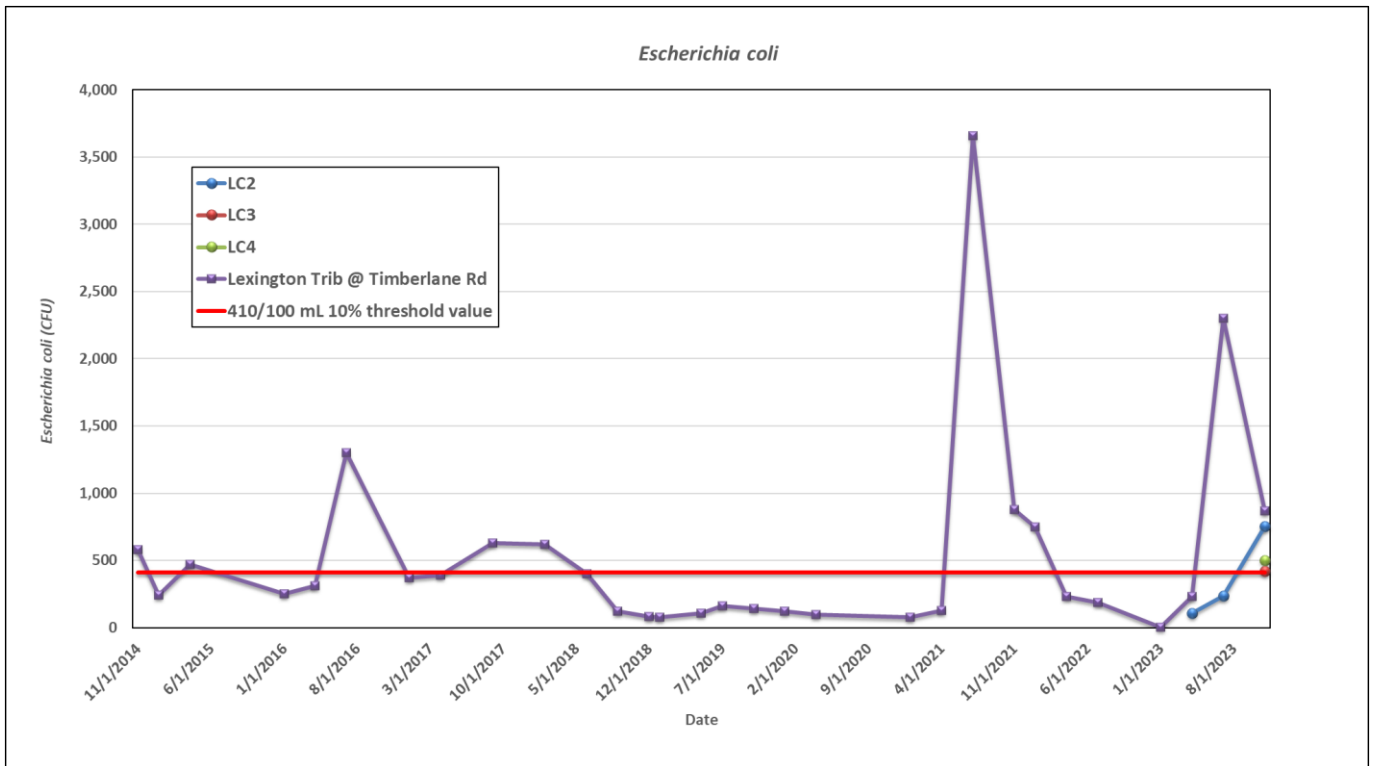
Figure 4. *Escherichia coli* values in Lexington Creek.

The *E. coli* water quality limit of > 410 in 10% of samples during a 30-day period have been exceeded several times during the sampling period (**Figure 4**). Leon County and FDEP have been in cooperation in the investigation of the source(s) of the bacteria. The results of the Microbial Source Tracking (MST) analyses and other analyses that track probable wastewater indicators (e.g., sucralose, acetaminophen) suggest that the sources of *E. coli* are human in origin. As part of their normal inspection, the City of Tallahassee (COT) undertook the rehabilitation of the sewer lines in the immediate area of the creek. Unfortunately, at least one leak has

occurred since the rehabilitation. A sewer line leak, located within ten meters of the creek, was discovered by Leon County staff on October 23, 2023. The leak was addressed later that same day by COT staff. But *E. coli* levels are still elevated with exceedances still occurring. To better track potential sources of *E. coli*, Leon County added additional water quality stations to the watershed in 2023 (**Figure 5**). Few conclusions can be made so far, but *E. coli* levels exceeded water quality standards at three of the four stations during the November 2023 sampling event. The high levels were probably associated with the approximately 2.8 inches of rain that fell two days prior to the sampling event. Whether this was related to a malfunctioning septic tank, sewer line leakage, or some other source is currently unknown. Leon County staff continues to investigate the source(s) of the bacteria.

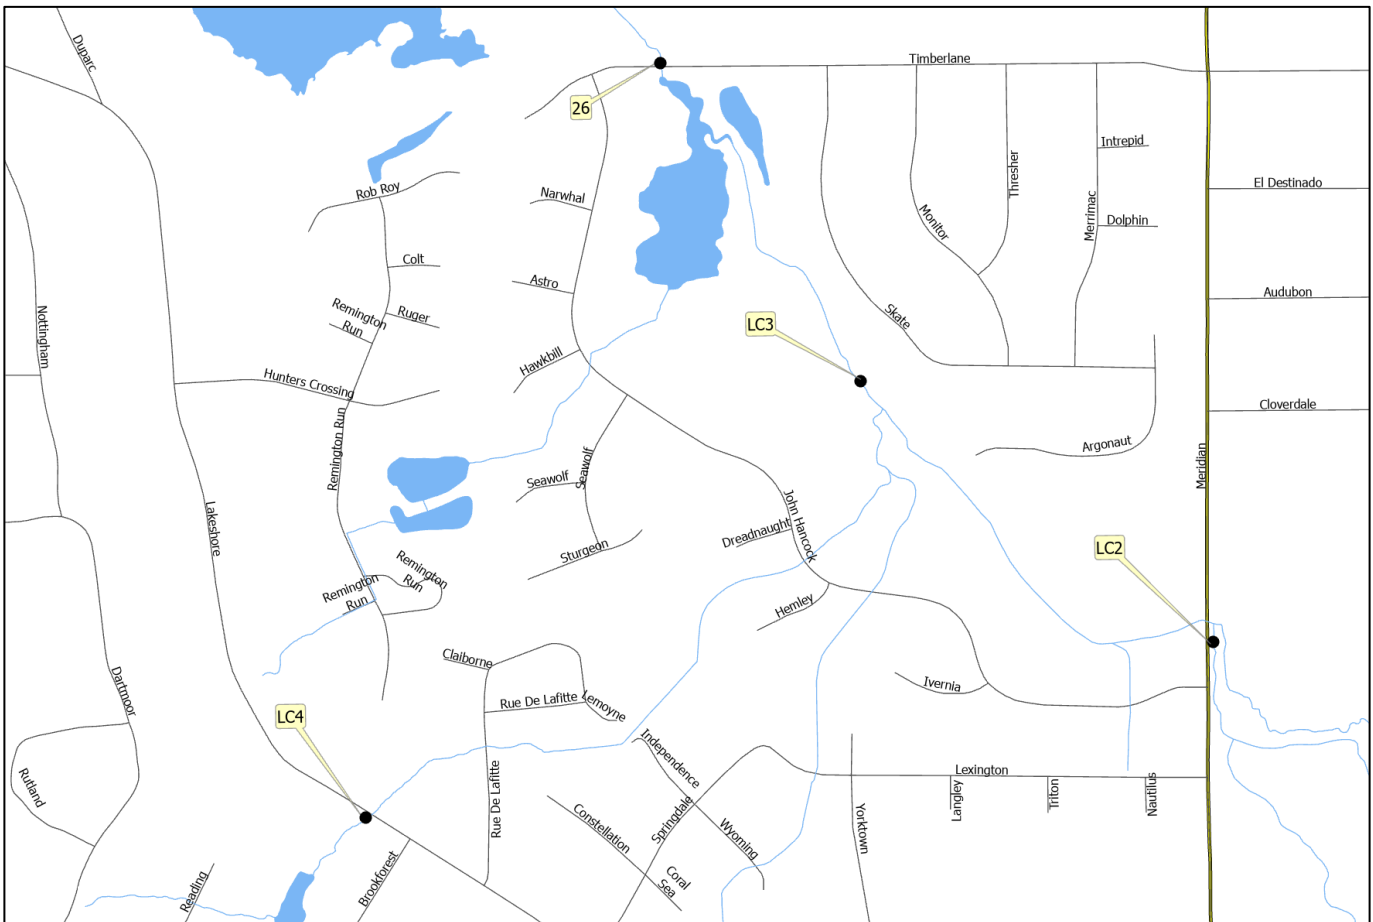
Figure 5. Locations of Water Quality Station 26 and the newly established *E. coli* stations LC2, LC3, and LC4.

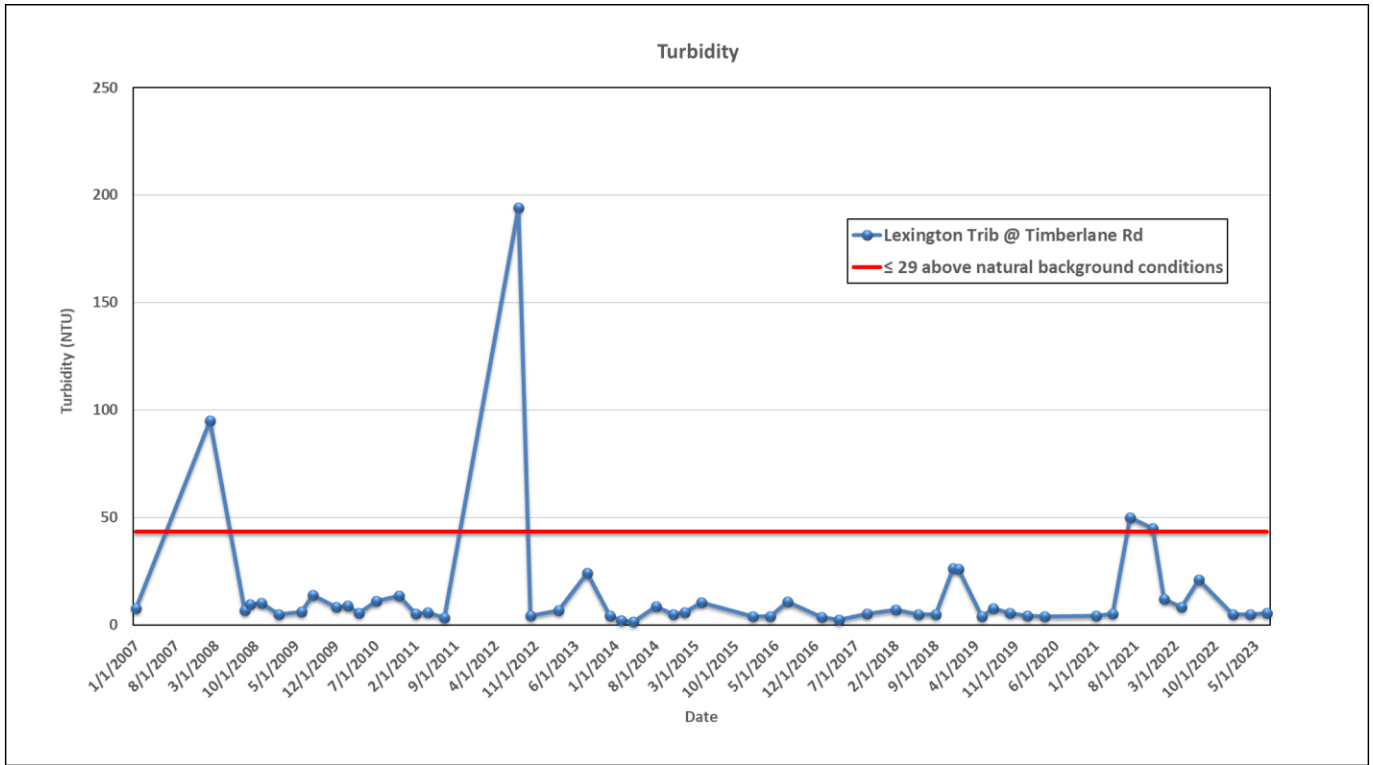
Figure 5. Turbidity values in Lexington Creek.

Turbidity levels have occasionally exceeded water quality standards (**Figure 6**). Sedimentation continues to be an ongoing problem in the stream.
