Lake Lafayette EcoSummary

Lake Lafayette was historically a meandering, wetland/prairie lake system located in eastern Leon County, but land alterations in the mid-1900s separated the lake into four distinct sections, known as Upper Lake Lafayette (ULL), Lake Piney Z, Alford Arm, and Lower Lake Lafayette (LLL). Limited hydraulic connectivity occurs between the various sections, much of which is present only during high water elevations. Because of the compartmentalization of the four sections, each section is treated as a separate “lake” with its own watershed.

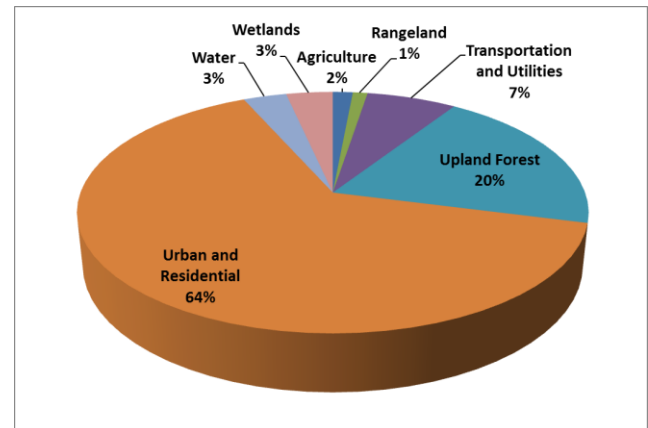
Figure 1. Upper Lake Lafayette watershed land use.

Approximately 74% of the 14,792-acre Upper Lake Lafayette watershed is agriculture, rangeland, transportation, utilities, urban and residential (as shown in **Figure 1**). These types of land uses are often attributed to increases in stormwater runoff and higher nutrient loads.

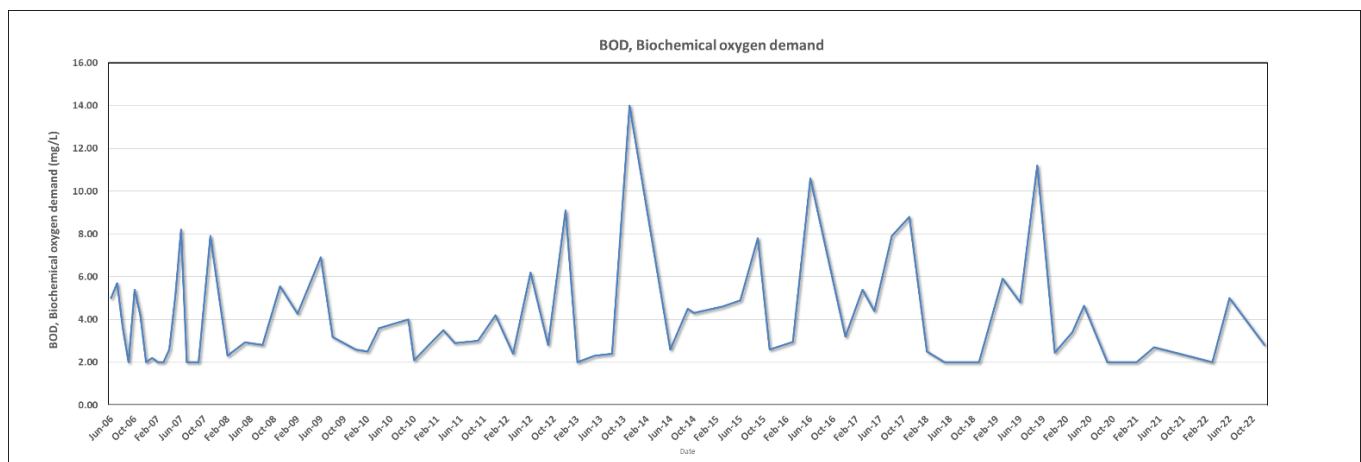
Figure 2. BOD results for Upper Lake Lafayette.

Historically, elevated Biological Oxygen Demand (BOD) results (average is 4.1 mg/L) have been an issue since Leon County sampling began in 2006 (**Figure 2**). Like the elevated nutrients and chlorophyll-a levels, urbanized inflow streams and a fluctuating lake volume

appear to be detrimentally affecting water quality.

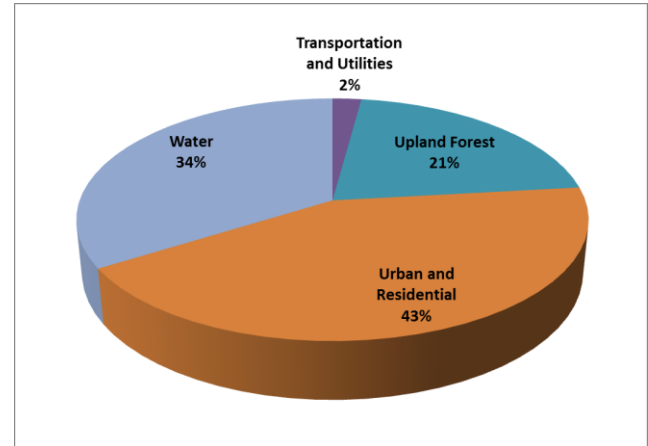
Figure 3. Lake Piney Z watershed land use.

Approximately 45% of the 691-acre Piney Z watershed is agriculture, rangeland, transportation, utilities, urban and residential (as shown in **Figure 3**). Increases in stormwater runoff and waterbody nutrient loads can often be attributed to these types of land uses.

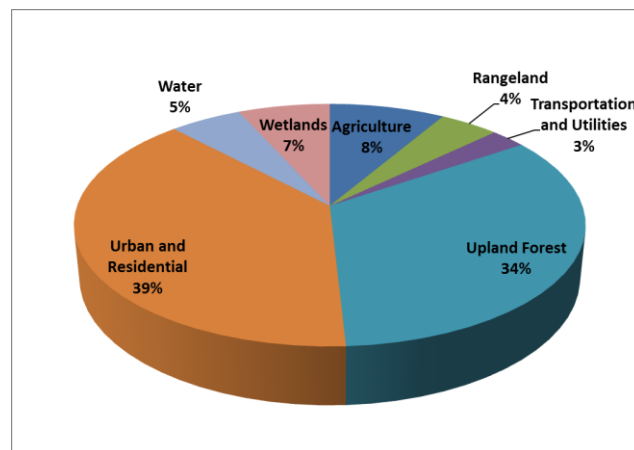
Figure 4. Lower Lake Lafayette watershed land use.

Approximately 54% of the 36,966-acre Lower Lake Lafayette watershed is agriculture, rangeland, transportation, utilities, urban and residential (as shown in **Figure 4**). Increases in stormwater runoff and waterbody nutrient loads can often be attributed to these types of land uses.

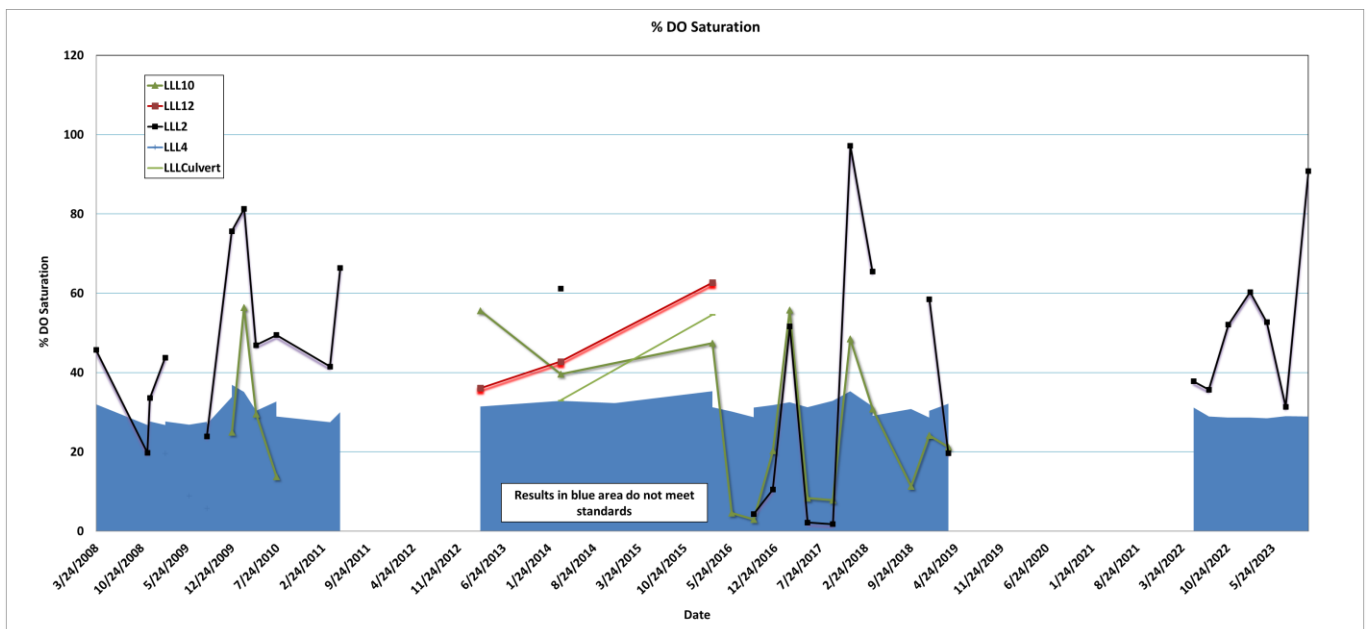
Due to the wetland like nature of Lower Lake Lafayette, dissolved oxygen (DO) levels can be very low. Staff considers the low DO levels normal for this type of system (**Figure 6**).

Figure 6. Dissolved Oxygen Percent Saturation results for Lower Lake Lafayette. The data gaps reflect low (or no) water in the system at that time.

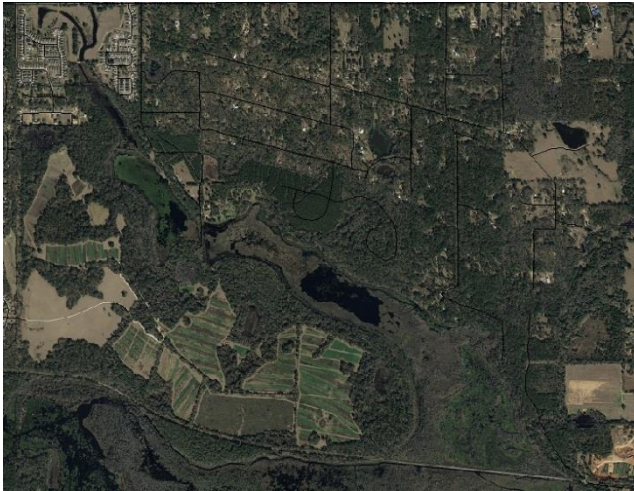
Figure 7. Alford Arm watershed land use.

Alford Arm is a 371-acre waterbody which was separated from Lower Lake Lafayette by construction of the FGA Railroad. Approximately 55% of the 30,116-acre Alford Arm watershed is agriculture, rangeland, transportation, utilities, urban and residential (as shown in **Figure 7**). Low water crossings constructed in the 1950's affected water flow through the system. Increases in stormwater runoff and waterbody nutrient loads can often be attributed to these types of land uses.
