# Lake Miccosukee EcoSummary

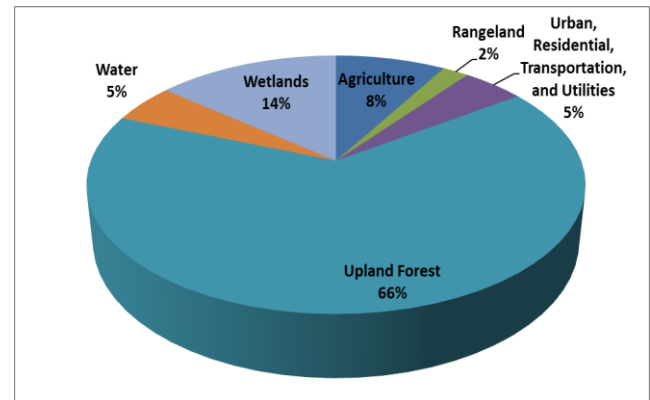
**Figure 1.** Lake Miccosukee watershed land use.

Approximately 15% of land use in the 147,861-acre Lake Miccosukee basin is agriculture, rangeland, transportation, utilities, urban and residential (as shown in **Figure 1**). These types of land uses are often attributed to increases in stormwater runoff and higher nutrient loads.

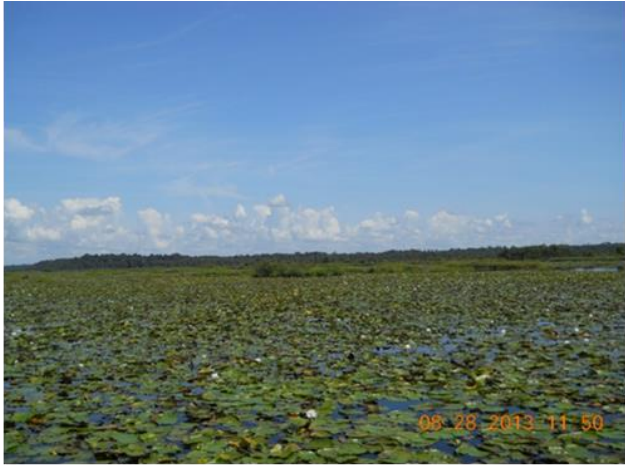
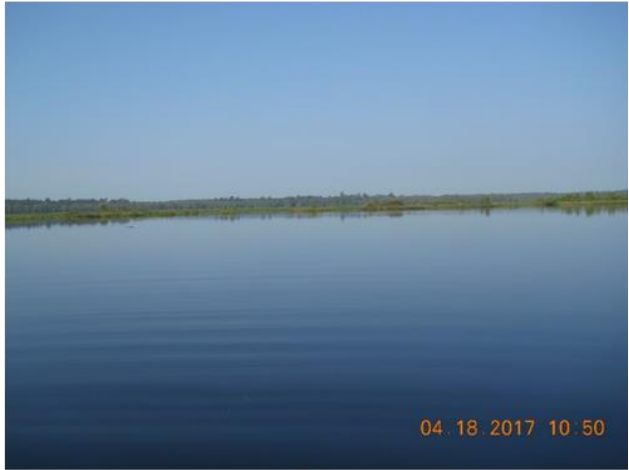
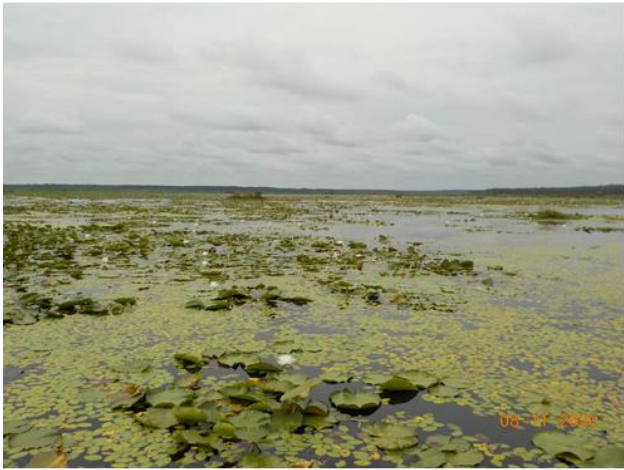
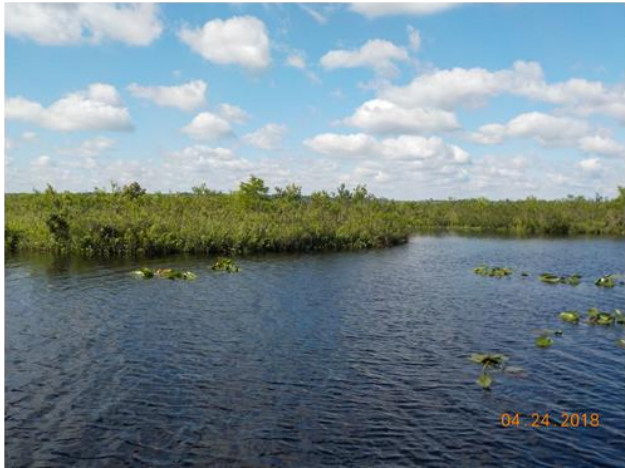
No exceedances were noted, but nutrient levels have fluctuated over time. Changes in the area around the station may have contributed to changes in nutrient concentrations (**Figure 2**). Previously, the area in the vicinity of station MI2 was dominated by *Nymphaea odorata*, the fragrant water lily. Florida Fish and Wildlife (FWC) contractors enlarged an open water area adjacent to the station that had encompassed the station area. More recently, emergent vegetation has again become more dominant, with the

addition of floating tussock islands that have either formed or floated into the sampling area. Because of the anthropogenic disturbances to the vegetative community, fluctuating water chemistry results continue to occur.

**Figure 2.** Station MI2 showing the variability of the plant community over time. Photos were taken in: 2013, 2017, 2018, and 2020.

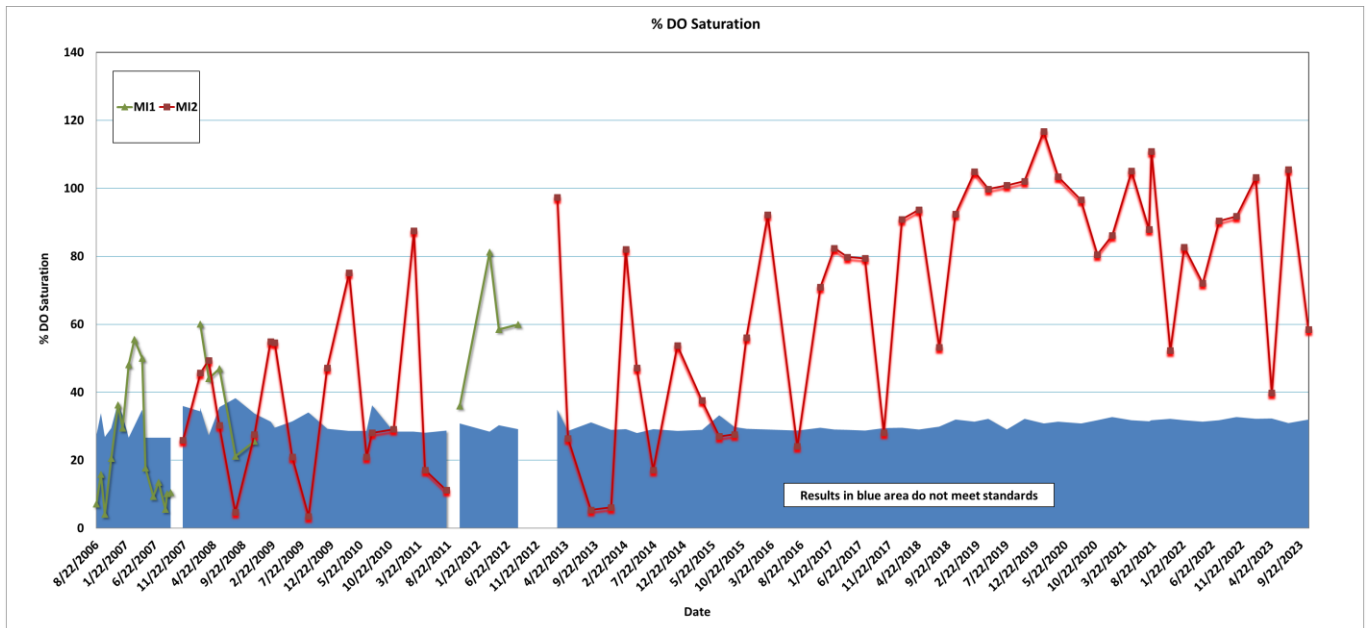
As **Figure 3** shows, the Lake Miccosukee stations exhibited percent DO saturation values that did not meet Class III water quality criteria. Staff considers the low DO normal for this lake because the stations are shallow and normally covered with vegetation, preventing rapid water exchange with the larger area of the lake. Plant respiration (samples were often taken in the morning hours) and organic sediments also contributed to the low DO saturation values. Because station MI2 has become less vegetated, more water circulation is occurring along with

less plant respiration, thus allowing DO saturation values to increase.

**Figure 3.** Dissolved Oxygen Percent Saturation results for Lake Miccosukee. Gaps in the data are due to low water, preventing sampling.
