# Lafayette Creek EcoSummary

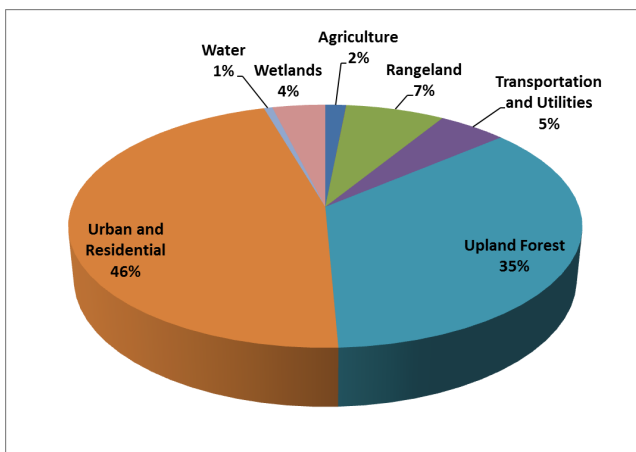
Approximately 60% of land use acreage in the 1,860-acre watershed is agriculture, rangeland, transportation, utilities, urban and residential (as shown in **Figure 1**). These types of land uses are often attributed to increases in stormwater runoff and higher nutrient loads.

**Figure 1.** Lafayette Creek watershed land use.

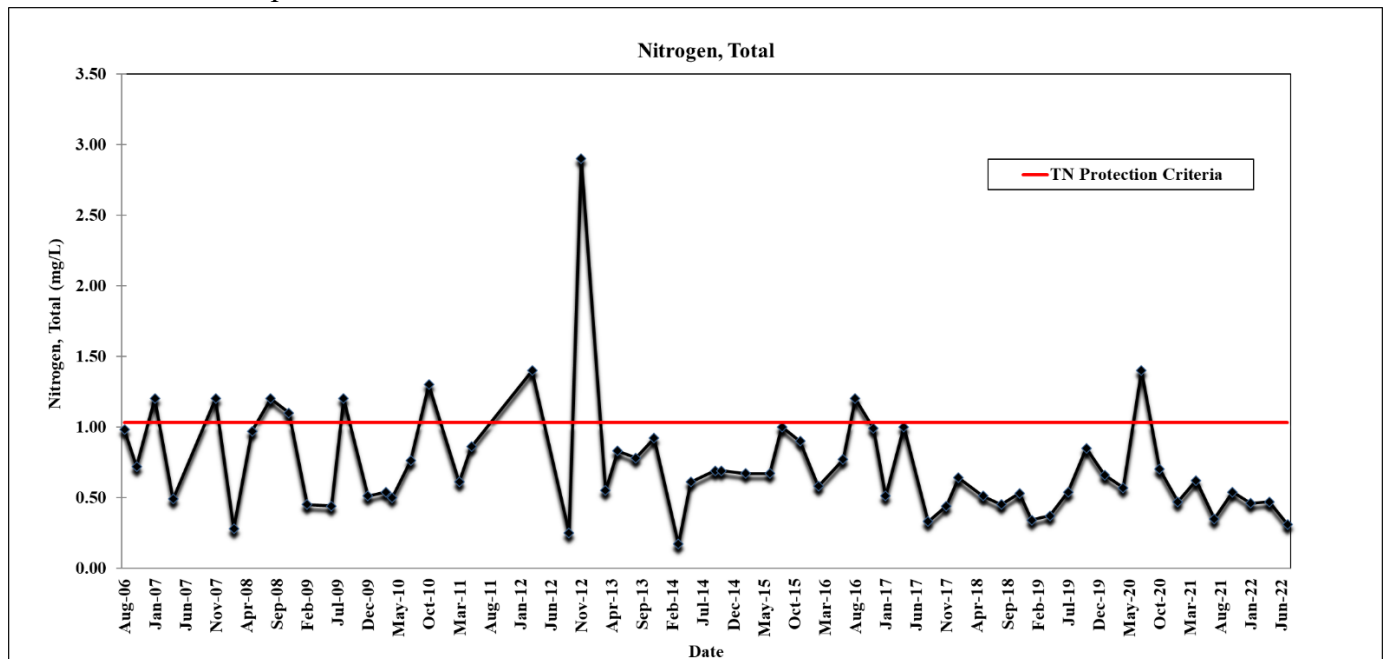
Due to low water conditions, FDEP data requirements for the NNC could not be met for 2010 through 2012 and 2022 for Station 1 (Table 1) and were only met once (2021) at Station 2 since 2007. While the NNC never exceeded the state criteria at Station 1, individual values were occasionally above the criteria (Figures 2 and 3).

Figure 2. Total Nitrogen results for Station 1 on Lafayette Creek.

While individual nutrient results occasionally spiked above threshold criteria, Lafayette Creek continued to meet the NNC thresholds for the East Panhandle Region. Elevated turbidity values were identified in past sampling and remain somewhat an issue for Lafayette Creek and could negatively affect the native creek fauna. *E. coli* levels at Station 2 exceeded Class III water quality standards several times over the sampling period. Exceedances are possibly the result of residential development in the watershed and/or domestic or wild animals. Several species of exotic plants line the bank of Lafayette Creek which may affect native wildlife dependent on native plants for food and shelter. Other water quality parameters appear to be normal for the area and no other impairments were noted.

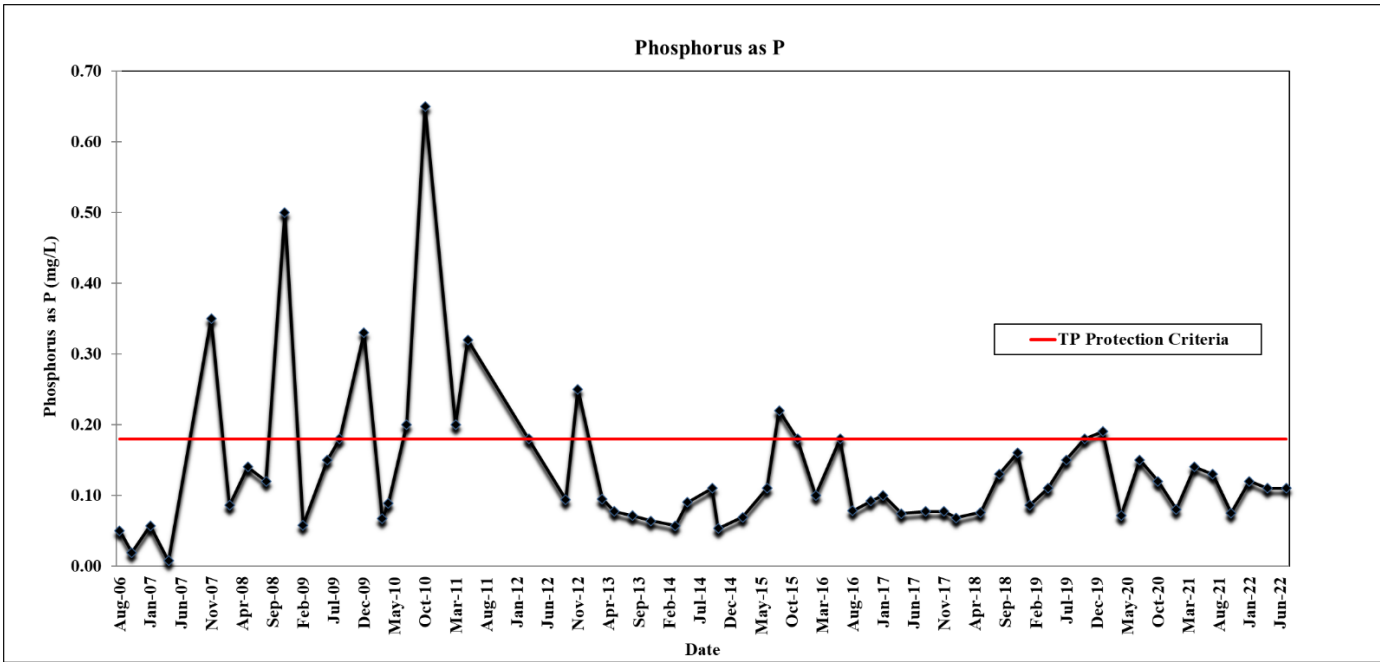
**Figure 3.** Total Phosphorus results for Station 1 on Lafayette Creek.

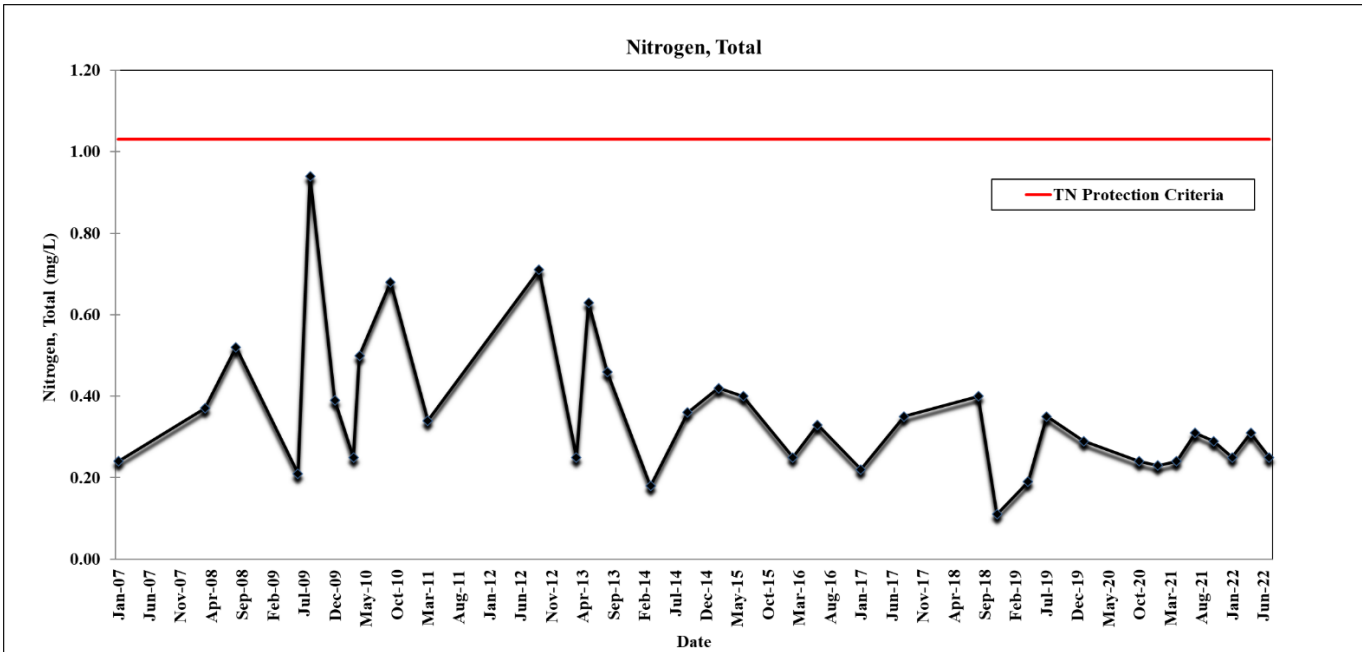
For illustrative purposes, individual data points were plotted for Station 2 to determine any possible trends (Figures 4 and 5). With only one exception in 2009 (phosphorus), individual values did not exceed the instream criteria for Total Nitrogen or Total Phosphorus.

**Figure 4.** Total Nitrogen results for Station 2 on Lafayette Creek.

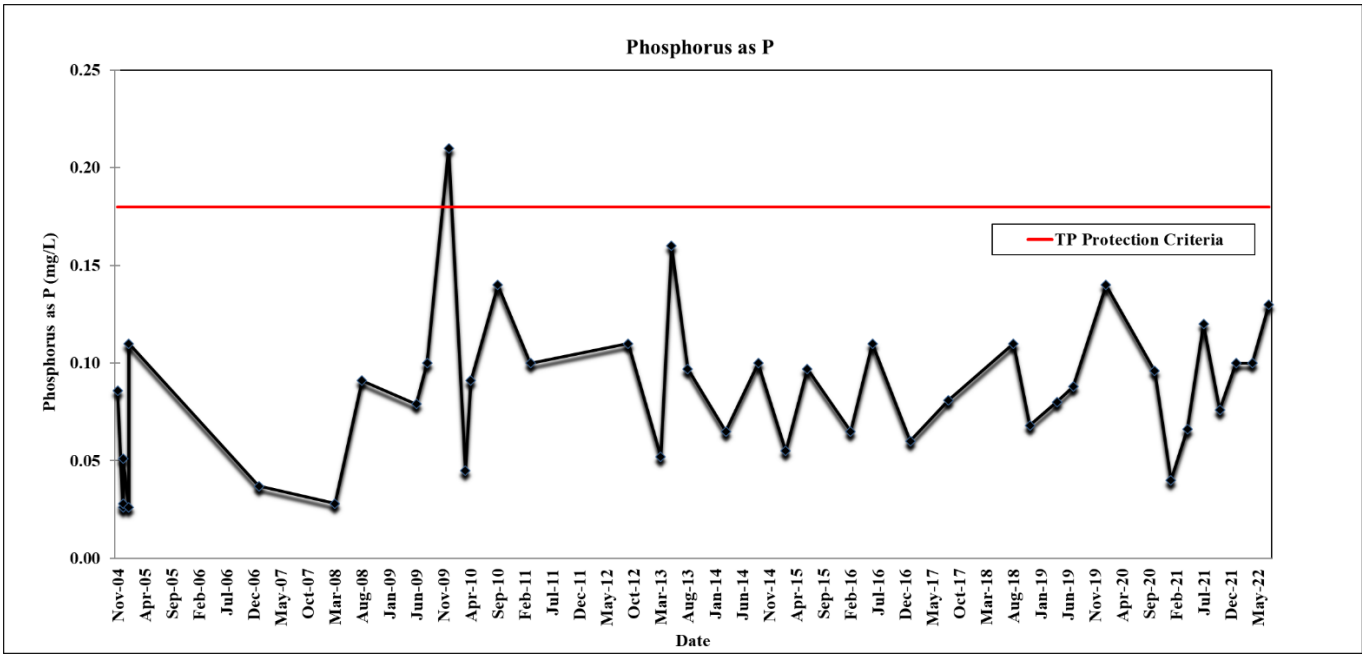
Figure 5. Total Phosphorus results for Station 2 on Lafayette Creek.
