## Waterbody: Meginnis Creek

# **Basin: Lake Jackson**

Meginnis Creek is a substantially altered, nitrogenlimited stream located in the northern part of Tallahassee and drains into Lake Jackson.

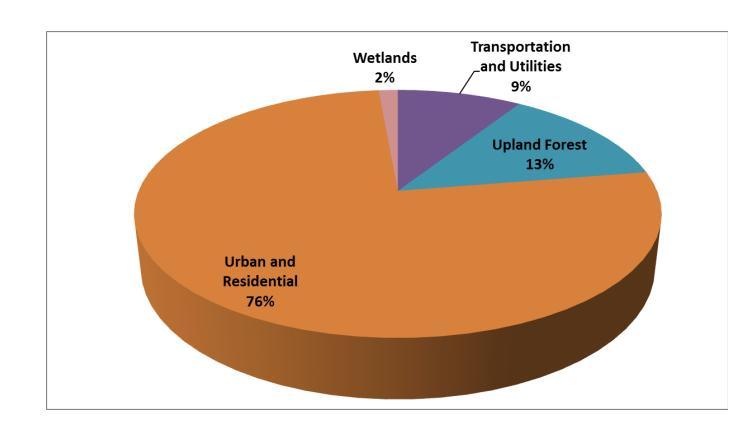
As shown in the pie chart below, residential, commercial and transportation uses make up approximately 85% of the 2,416-acre watershed. Increases in stormwater runoff and waterbody nutrient loads can often be attributed to these types of land uses.

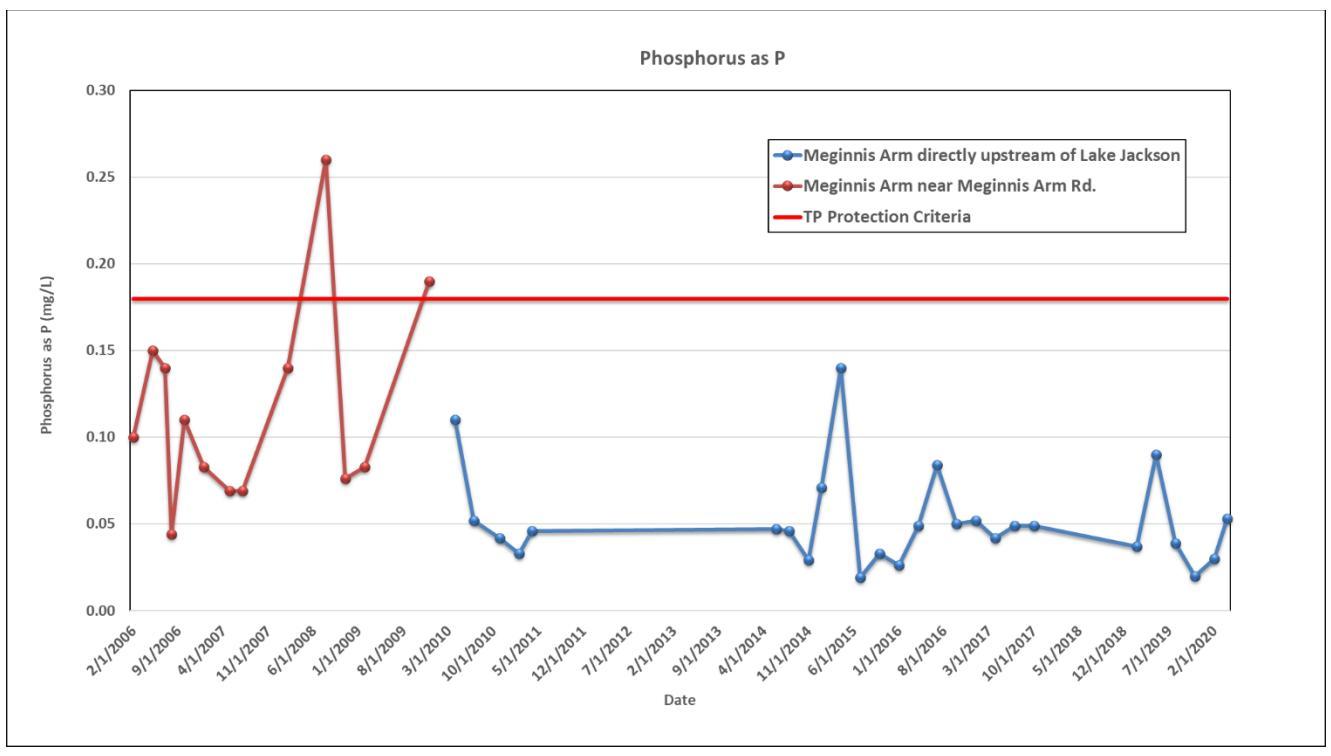
Figure 1. Total phosphorus results for Meginnis Creek.

For illustrative purposes, individual data points were plotted to determine any possible trends (Figures 1 and 2). With few exceptions, individual values did not exceed the instream criteria for total phosphorus and never exceeded the criteria for total nitrogen.

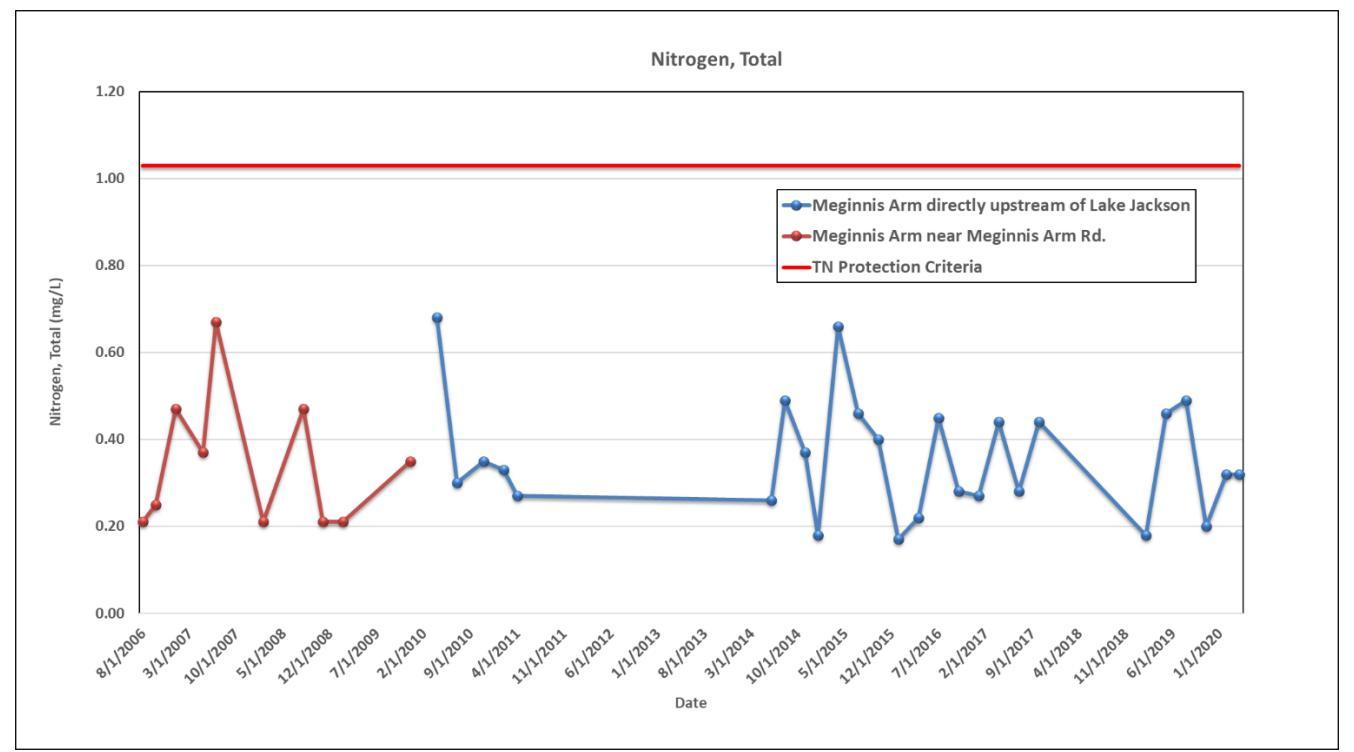
Figure 2. Total nitrogen results for Meginnis Creek.

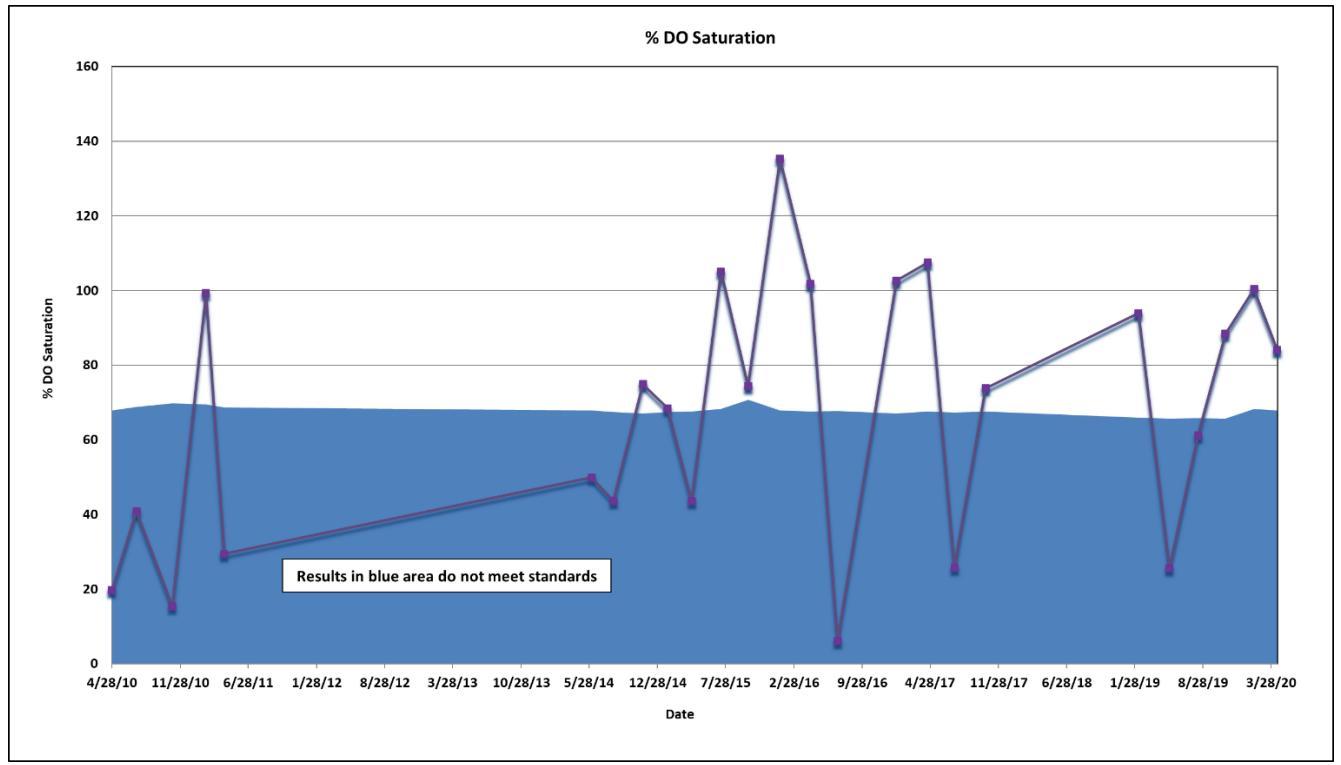
Figure 3. Dissolved Oxygen Percent Saturation results for Meginnis Creek.

Dissolved oxygen often did not meet Class III water quality standards (Figure 3). This is not surprising

since this system is a low velocity system. Lower velocity systems generally have lower levels of dissolved oxygen than high velocity systems because they are less aerated.
