Waterbody: Lake Miccosukee

Basin: Lake Miccosukee

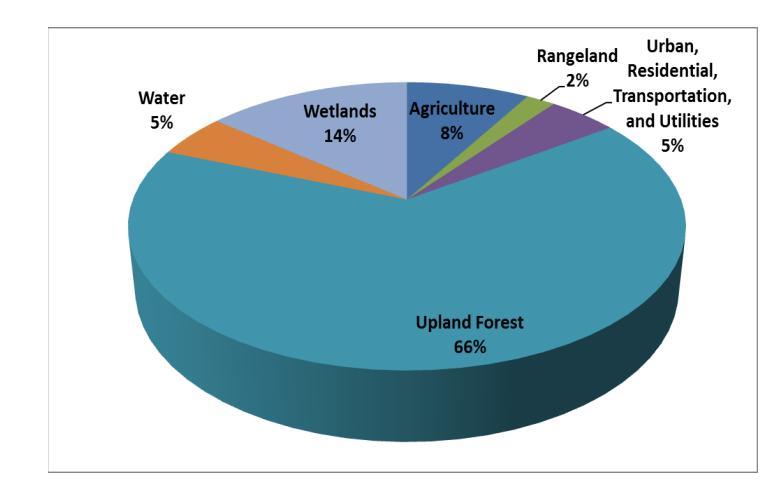
As shown in the following pie chart, approximately 15% of land use in the 147,861-acre Lake Miccosukee basin is agriculture, rangeland, transportation, utilities, urban and residential. Increases in stormwater runoff and waterbody nutrient loads can often be attributed to these types of land uses.

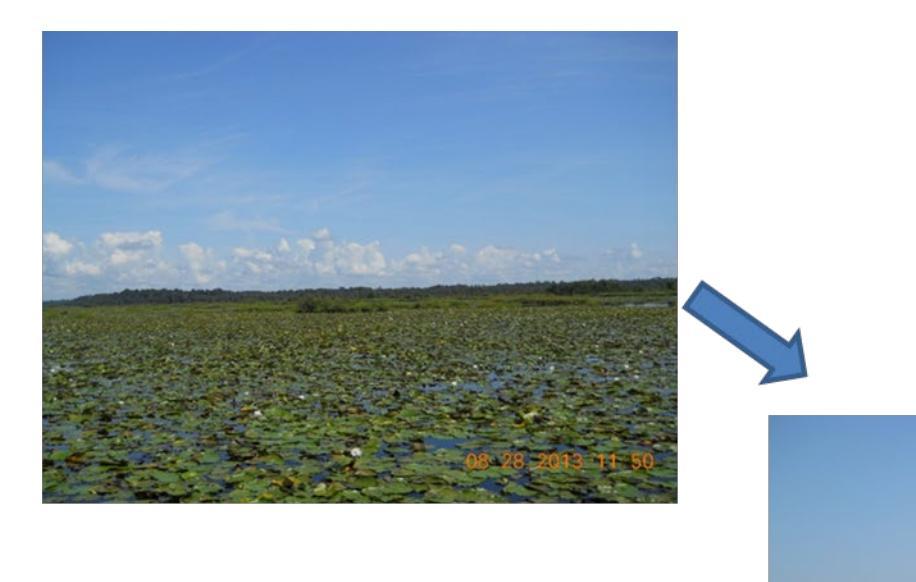
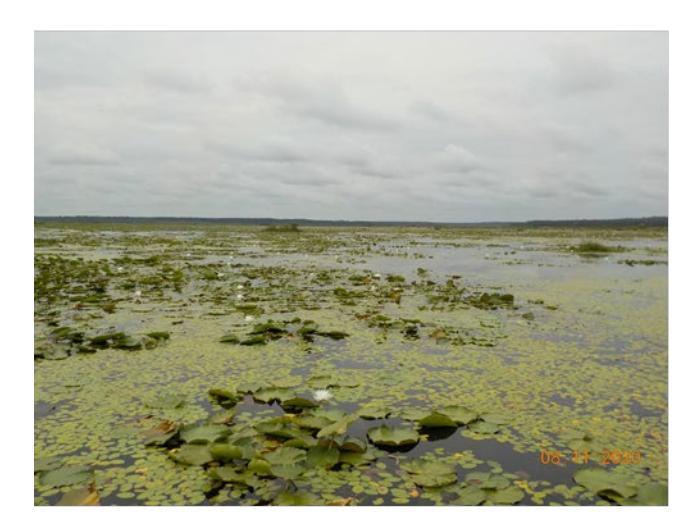
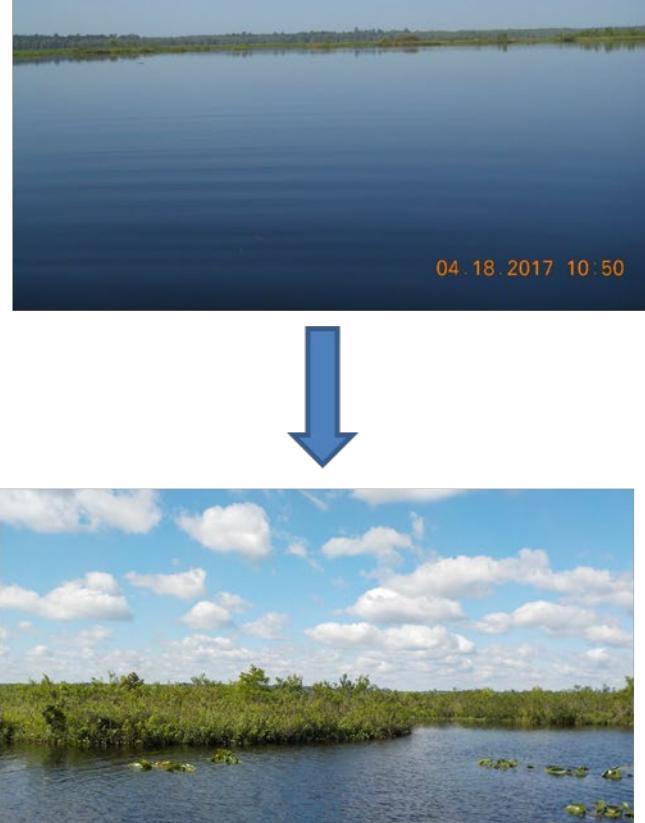
Figure 1. Station MI2 showing the variability of the plant community over time. Photos were taken in: 2013, 2017, 2018, and 2020.

Changes in the area around the station may have contributed to changes in nutrient concentrations (Figure 1). Previously, the area in the vicinity of station MI2 was dominated by *Nymphaea odorata*, the fragrant water lily. Florida Fish and Wildlife (FWC) contractors enlarged an open water area adjacent to the station that had encompassed the station area. More recently, emergent vegetation has again become more dominant, with the addition of floating tussock islands having formed, or floated into the sampling area. Because of the anthropogenic disturbances to the vegetative community, fluctuating water chemistry results have continued to occur.

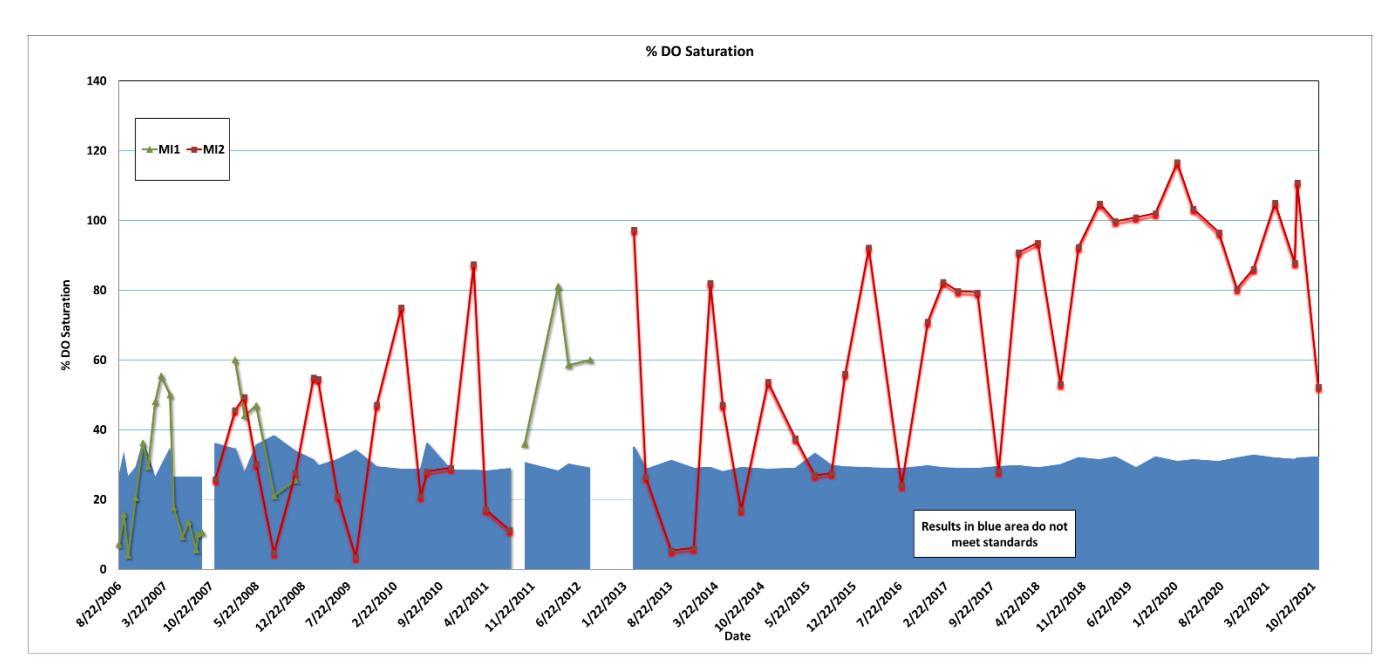
Figure 2. Dissolved Oxygen Percent Saturation results for Lake Miccosukee. Gaps in the data are due to low water, preventing sampling.

As Figure 2 shows, the Lake Miccosukee stations showed percent DO saturation values that did not meet Class III water quality criteria. Staff considers the low DO normal for this lake because the stations are shallow and normally covered with vegetation, preventing rapid water exchange with the larger area of the lake. Plant respiration (samples were often taken in the morning hours) and organic sediments also contributed to the low DO saturation values. Because station MI2 has become less vegetated, more water circulation is occurring along with less plant respiration, thus allowing DO saturation values to increase.
