Lake Cascade Lake Vegetation Index Results (9-14-2015)

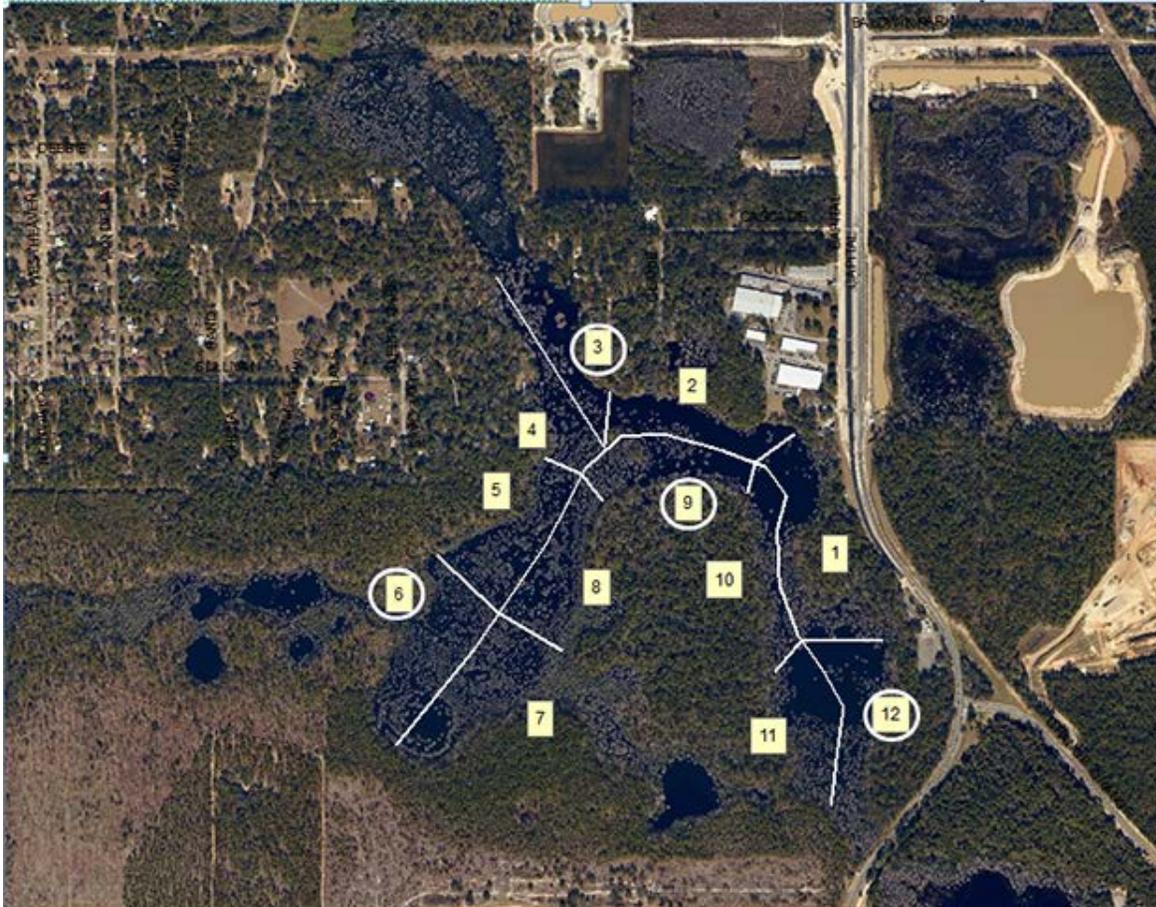
FIGURE 1. Lake Cascade showing unit divisions. Circled unit numbers denote surveyed units.

The LVI method is performed from a boat, and involves dividing a lake into 12 units and identifying plants in 4 of the 12 units (Figure 1). Plants are identified in the selected unit by a visual boat "drive by" and also via a transect approach. The resulting data is used to calculate the LVI and is evaluated according to the scoring system in Table 1.
