## Lake McBride Lake Vegetation Index Results (8-27-2015)

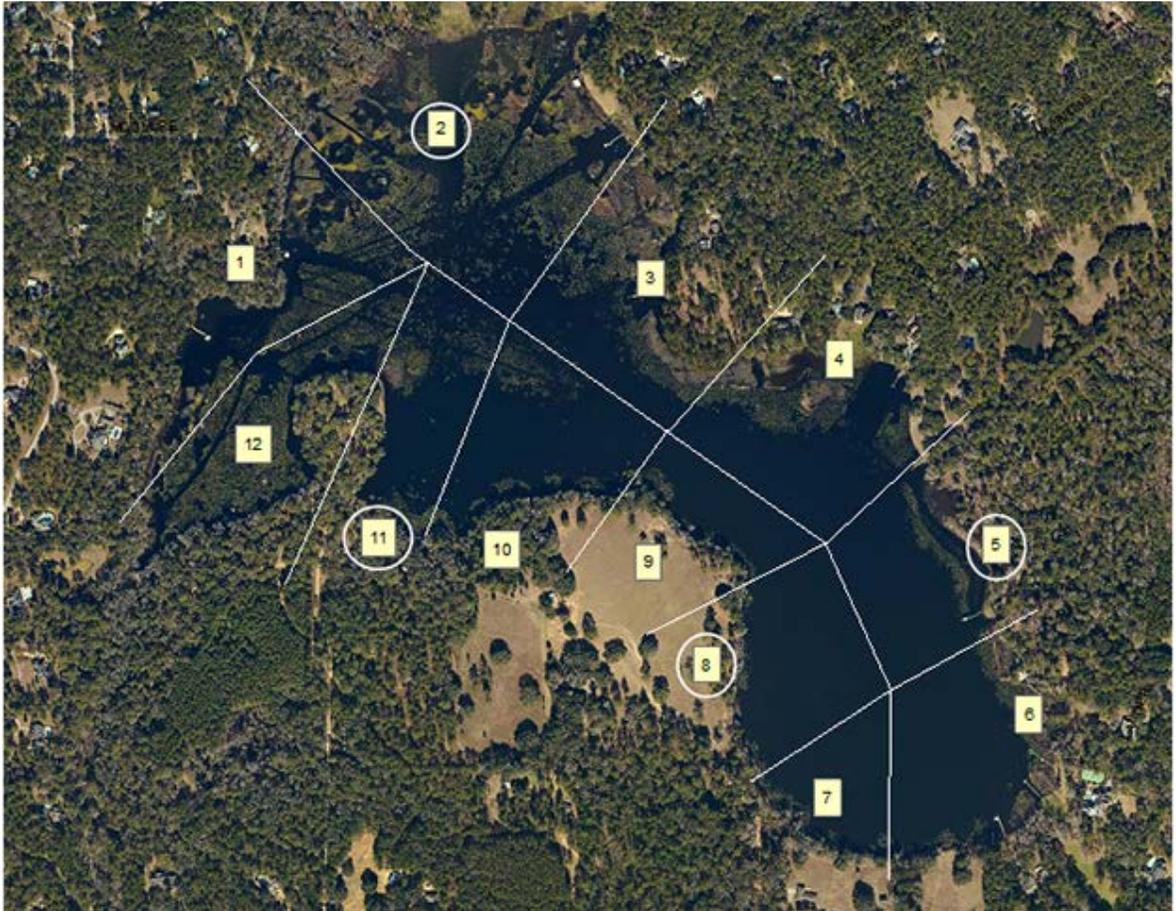
**FIGURE 1. Lake McBride showing unit divisions. Circled numbers denote surveyed units.**

The LVI method is performed from a boat, and involves dividing a lake into 12 units and identifying plants in 4 of the 12 units (Figure 1). Plants are identified in the selected unit by a visual boat “drive by” and also via a transect approach. The resulting data is used to calculate the LVI and is evaluated according to the scoring system in Table 1.
