# **Executive Summary Report**

ADA Physical Facilities Survey and Transition Plan for Leon County, Florida

May 21, 2002

Welch & Ward, Architects, Inc. 216 East Oakland Ave., Suite 06 Tallahassee, Florida 32301

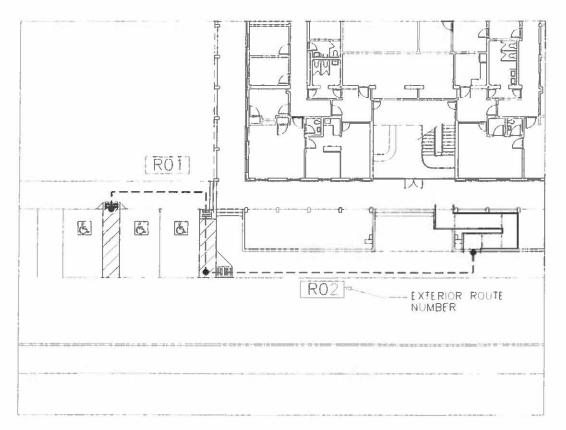
Each Site Plan indicates the location of the building facility relative to parking lots, driveways, sidewalks, etc. In cases where these site elements were not physically defined, an assumed area and exterior route are shown on the Site Plan in their apparent locations. **Exterior Routes** are indicated by a drawn line with a designation such as R01, R02, R03, etc. See Figure A. for typical example.

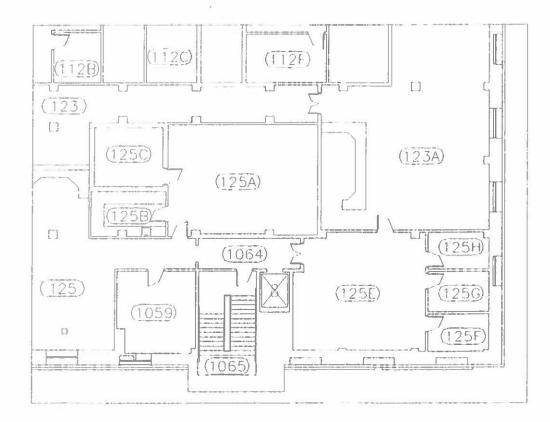
**Figure B**

Each Floor Plan indicates relative room and door locations within each surveyed facility. These plans are current as of the initial field survey date.

**Room numbers** are typically indicated by a letter and a 3 or 4-digit designation within an ellipse such as :

If the room is part of a suit of offices, as typically are found in these buildings, the interior offices identification will have a suffix A, B, C, etc. behind the main office number.

See Figure B. for typical example.

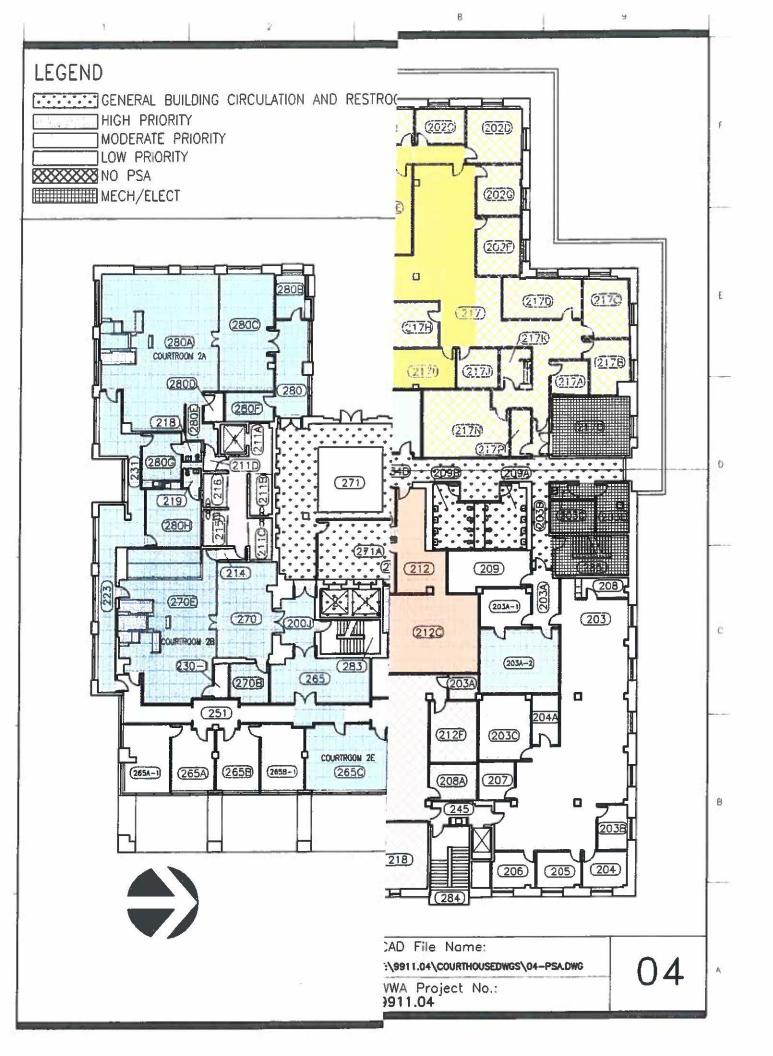
## c. Typical Graphic Plan

The Graphic Plans as shown also indicate the areas that have been prioritized in accordance with their actual interface with Programs, Services & Activities (PSA's) that are offered to the public. The plans are pattern coded to indicate High, Moderate or Low public interface and color-coded to indicate different County Departments in the building. Refer to Section 2d, Findings & Recommendations for criteria used to prioritize physical areas for achieving ADA accessibility.
