Summer Creek EcoSummary

Summer Creek is a slightly tannic stream located in northwestern Leon County and discharges to Lake Carr.

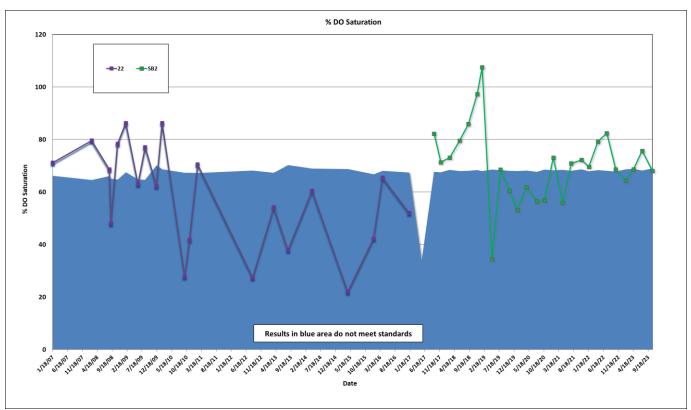
Figure 2. Dissolved Oxygen Percent Saturation results for Summer Creek.

As **Figure 2** shows, Summer Creek did not always meet the Class III criteria for DO. Staff believes the low DO in Summer Creek is due to

upstream wetlands and the naturally low gradient, low flow condition of the creek.

When sampling requirements were met, Summer Creek met the nutrient thresholds for the East Panhandle Region. Dissolved oxygen criteria were seldom met during the sampling period. The stream is a low gradient, low flow system that drains a wetland, so these results are not unexpected. The *E. coli* exceedances in 2023 could be the result of beaver activity or other wildlife in the area.

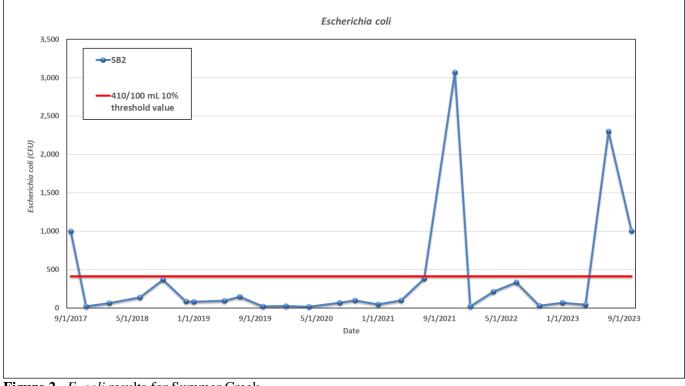
Figure 2. E. coli results for Summer Creek.

The *E. coli* water quality limit of > 410 in 10% of samples collected over a thirty-day period was exceeded at Station SB2 in 2023 (**Figure 3**) Elevated bacteria levels could be the result of beaver activity or other wildlife in the area.
